Bonus - Case Study #6

Dynamic Vibration Absorber

HISTORY & BACKGROUND

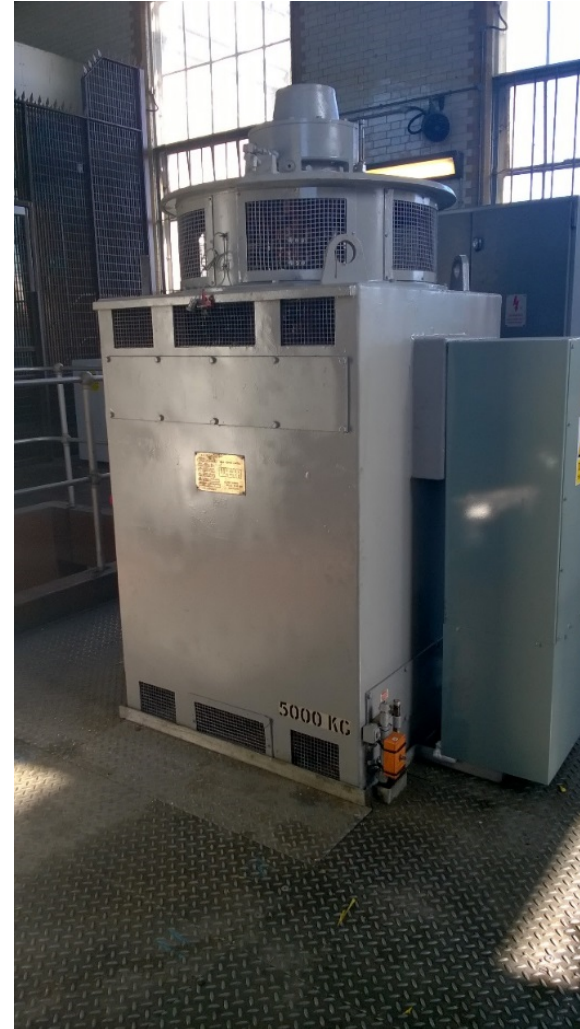
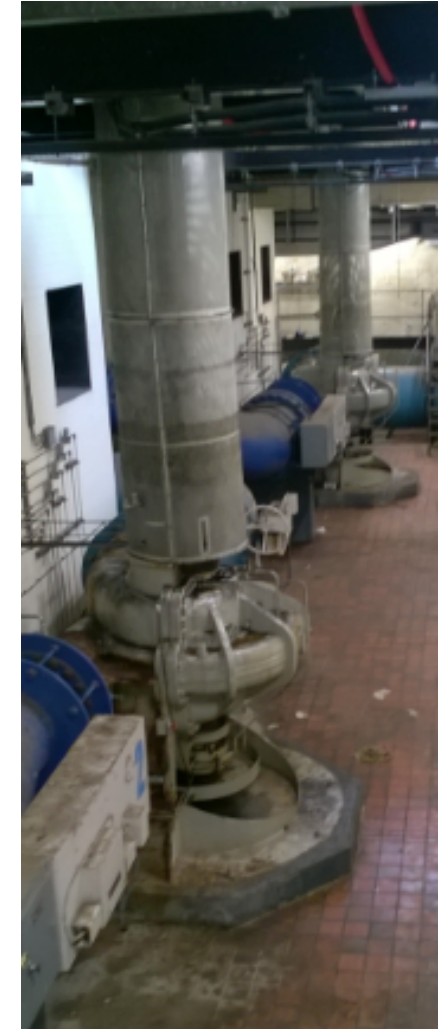
BEARING LOCATION

Tilting pad bearing location

Bed Plate – view from underneath

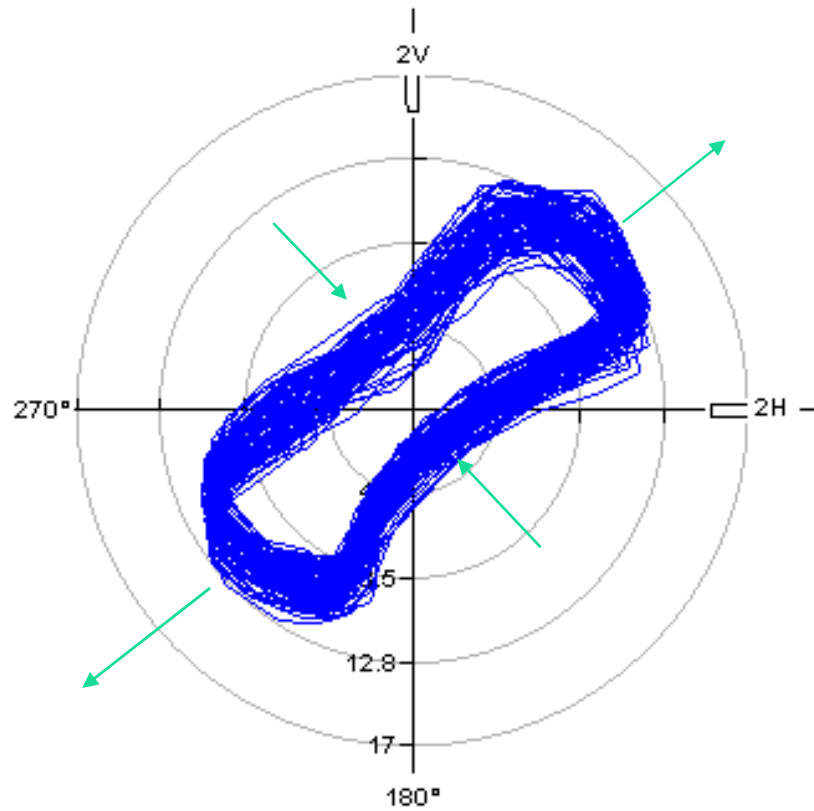
Raw Data

Units=mm/sec
 X Diff = 22.73
 Y Diff = 22.50
 LOAD = 100.0
 704.50 Rpm

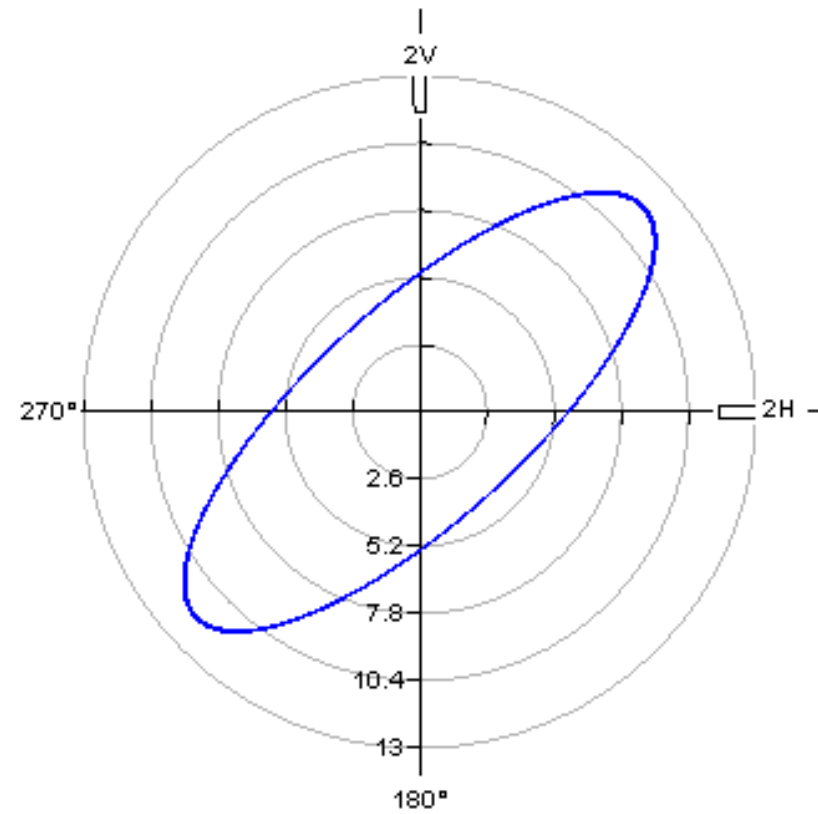
1 Order Filtered

Units=mm/sec
 Filter=1xBP
 X Diff = 18.31
 Y Diff = 17.07
 LOAD = 100.0
 704.50 Rpm

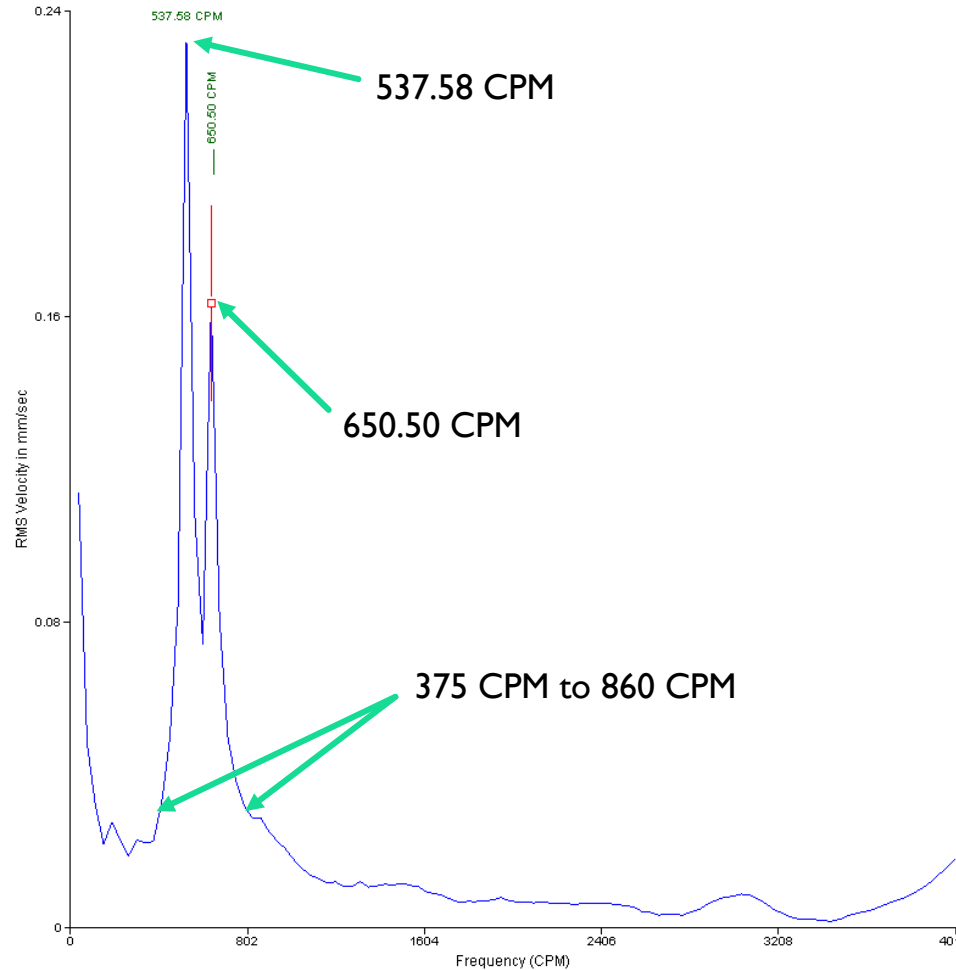
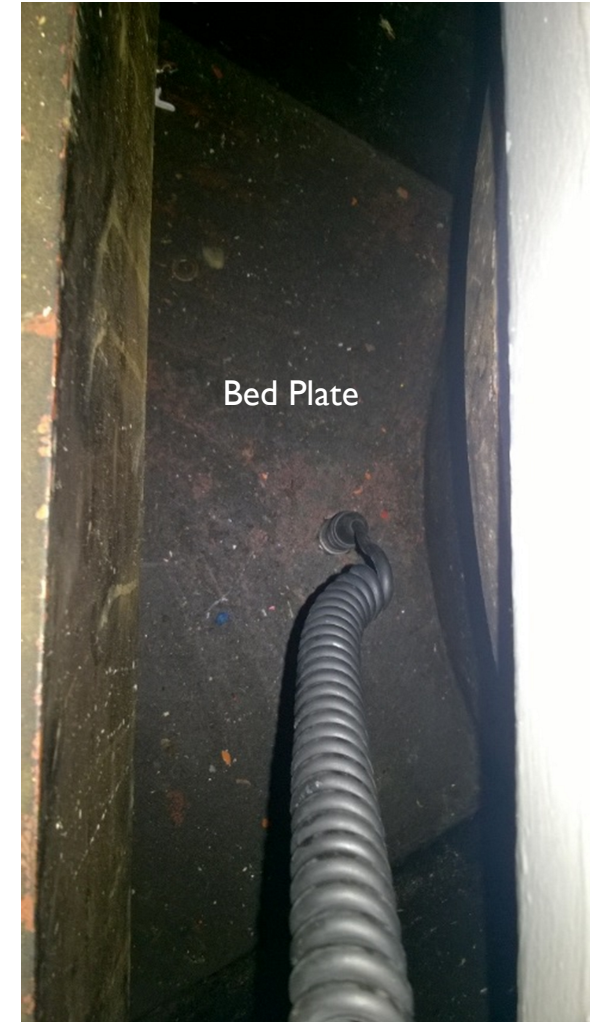
RESONANCE TEST 'BUMP TEST'

- Bump test indicating a structural resonance

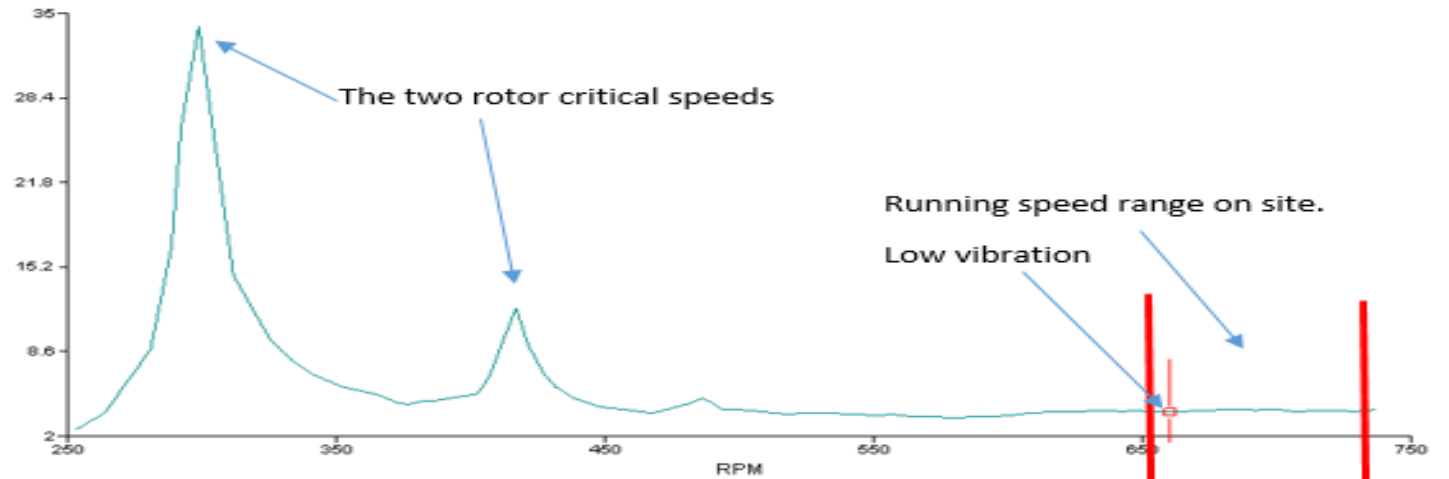
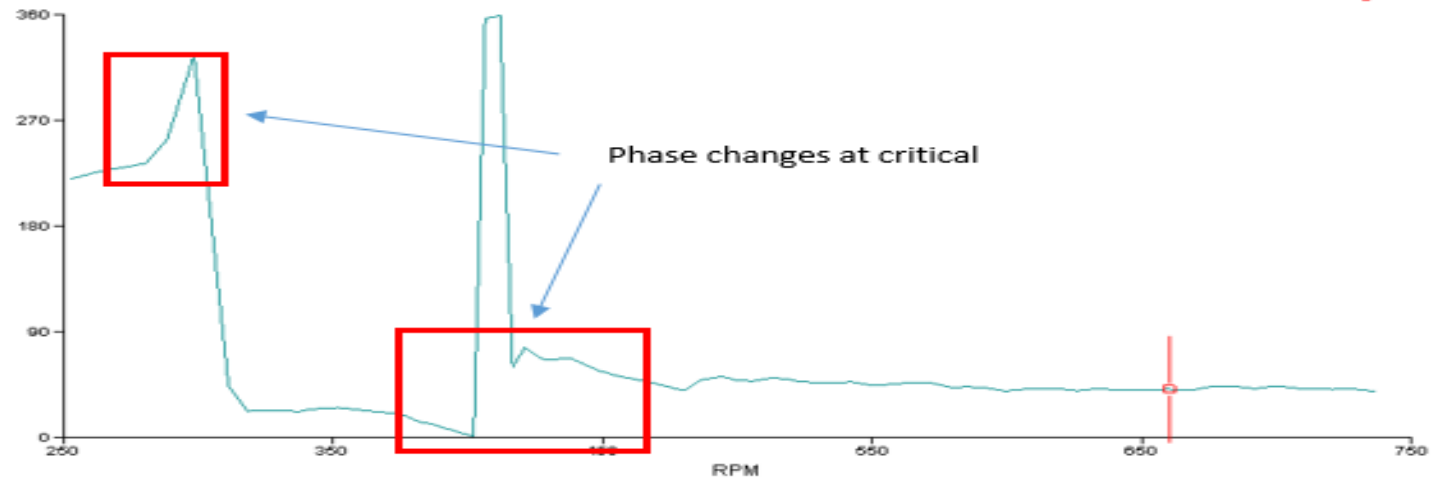
WORKSHOP: AMPLITUDE AND PHASE

- One order tracked
- Set up on a test bed no load
- Accelerometer location on the top of the motor (NDE)

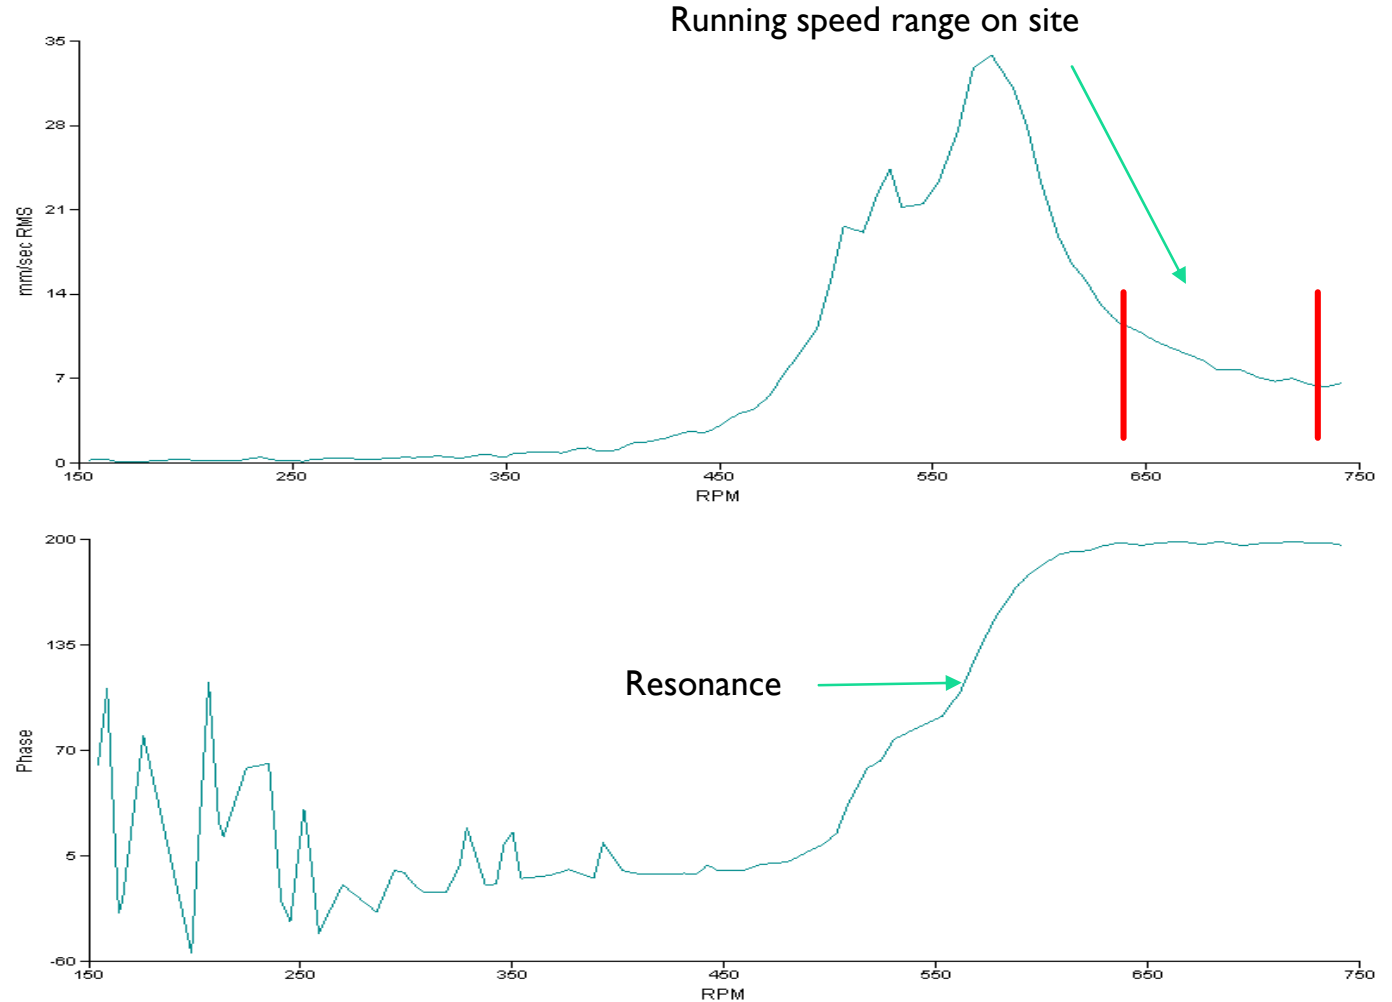
ON-SITE: AMPLITUDE AND PHASE

- One Order tracked
- Set up on foundation under normal operational load
- Note how the structure changes the motion

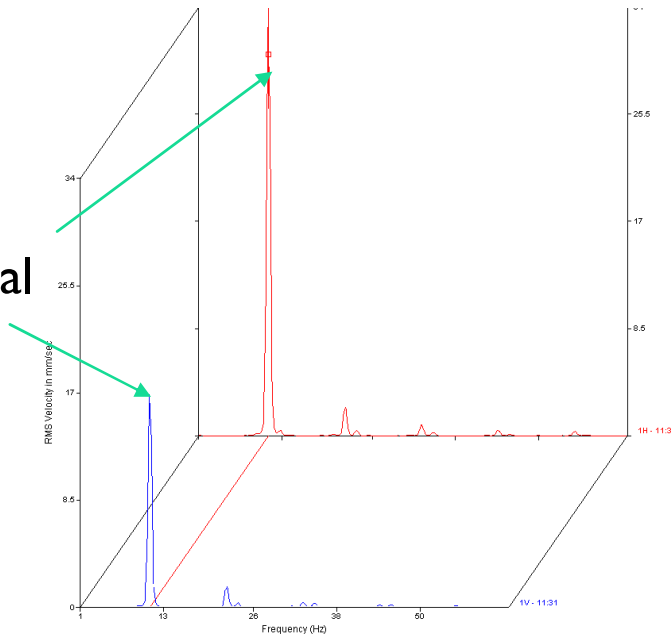
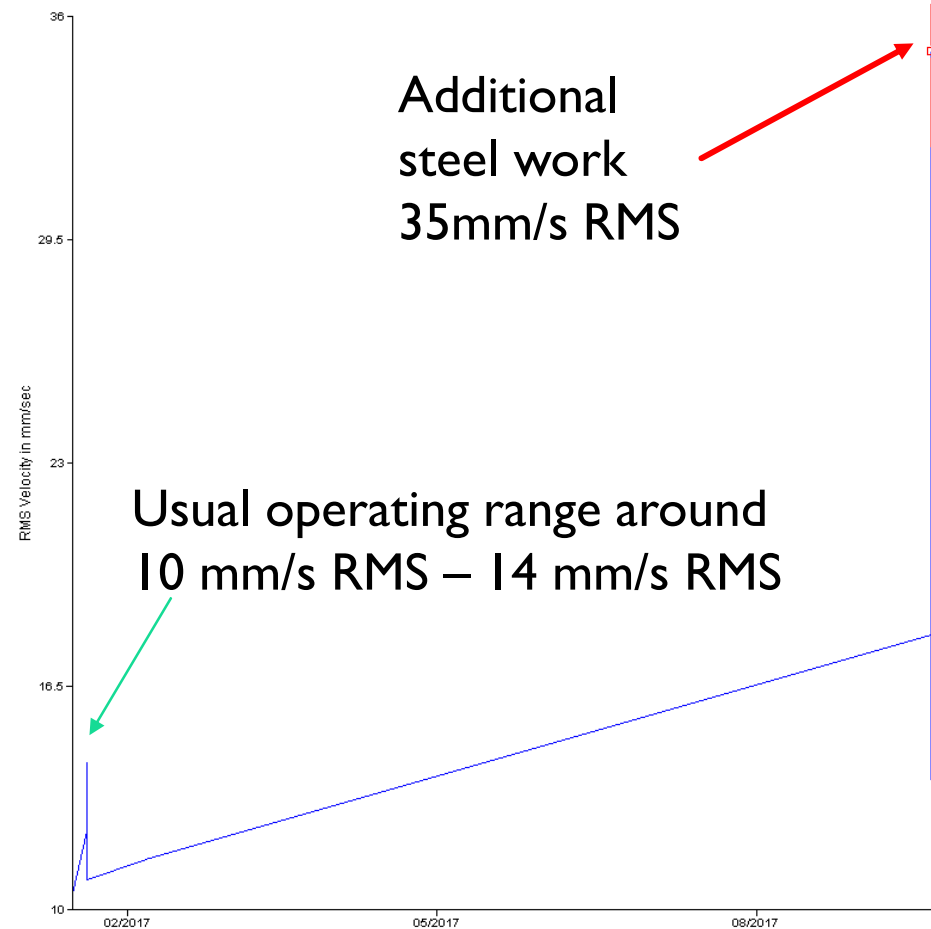
SUPPORT STEEL WORK: VIBRATION RESULTS

- Stiffening the structure increased the vibration levels to **35mm/s RMS**

Still high directional motion

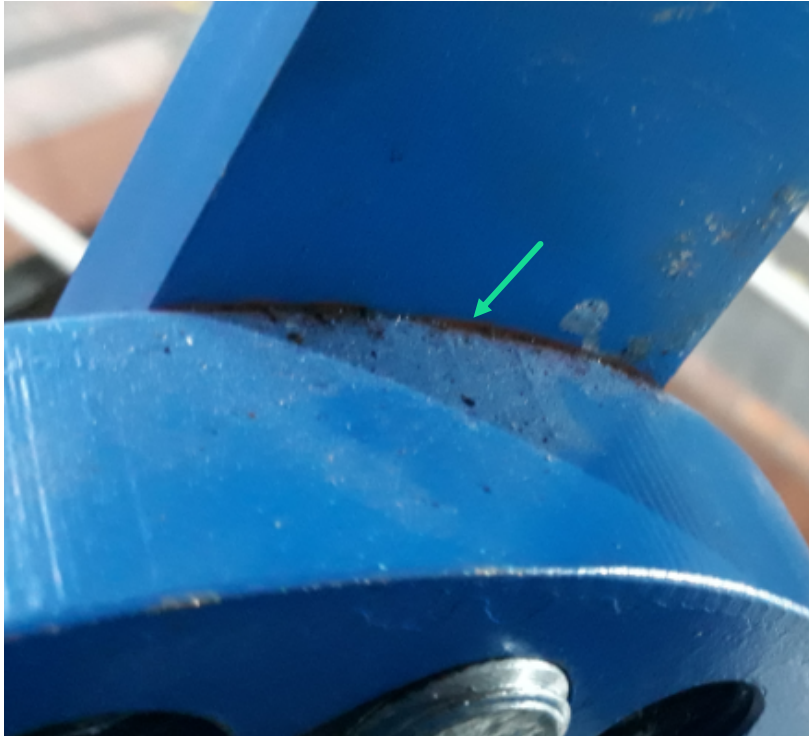
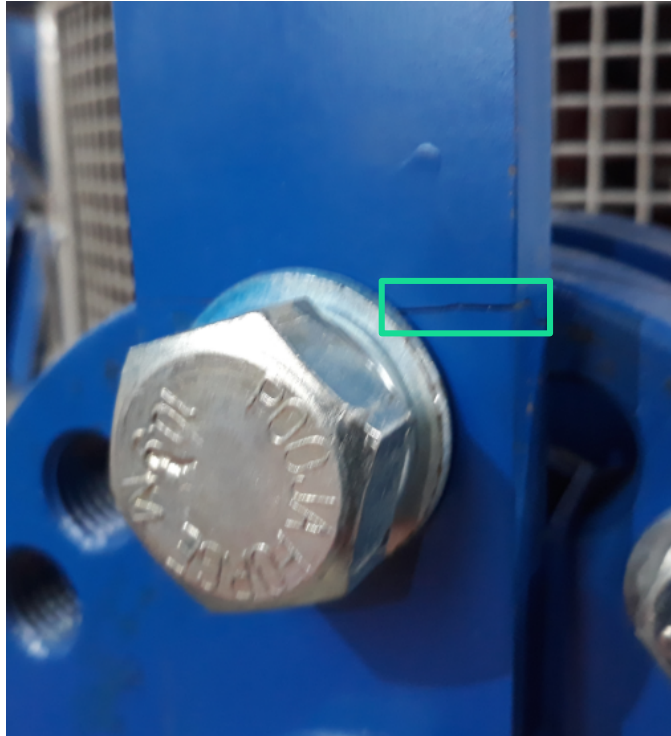
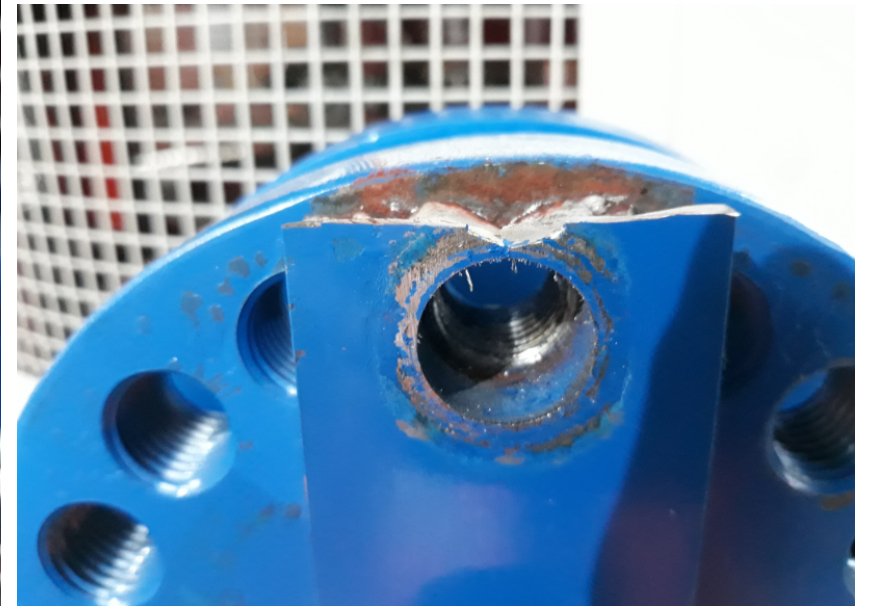
12 MONTH FOLLOW UP ON TRIAL

- The fatigue rate for the main arms of the Dynamic Vibration Absorbers are 11/12 months
