Re: JPS Reliability: Bearing Inspection Report

Executive Summary:

Failure of the non-drive end bearing NSK 6322

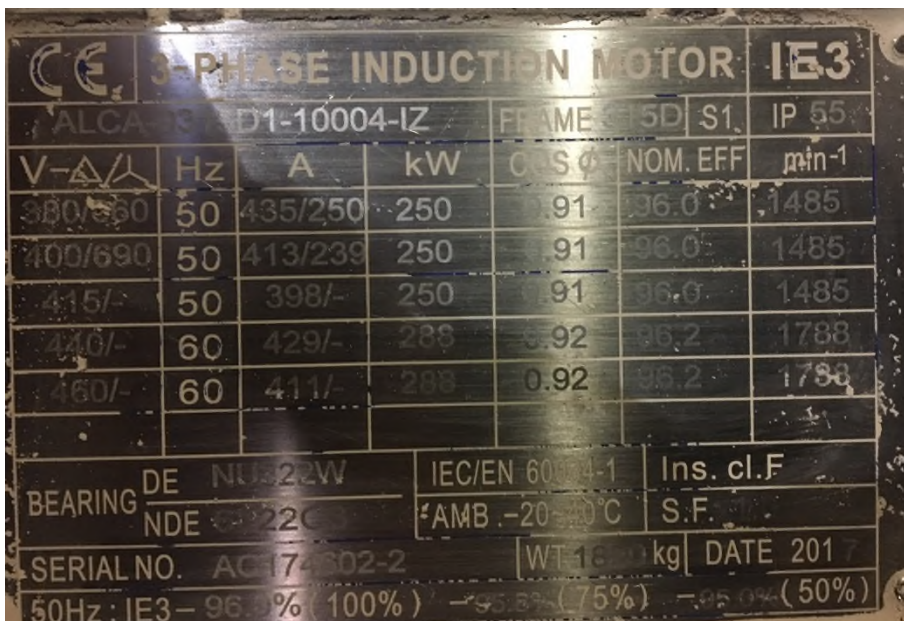
Name Plate from the motor.

Serial No. AC174602-2.

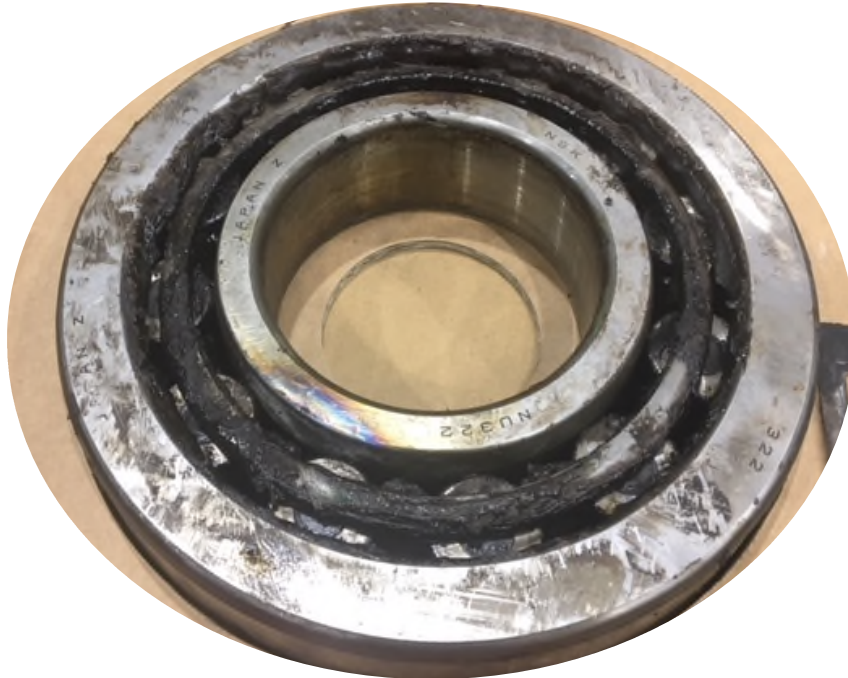
Motor Drive End Bearing

NSK NU322 uncleaned prior to sectioning.

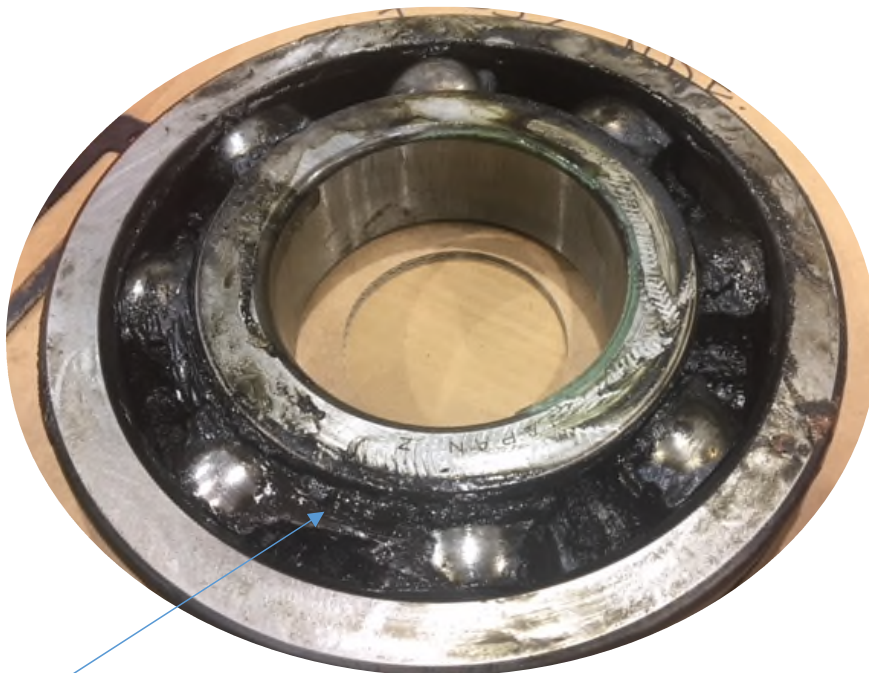
Motor Non-Drive End Bearing

NSK 6322 uncleaned prior to sectioning.

Note: The grease visually looks burnt and black. Current leakage can be the cause of the burnt grease.

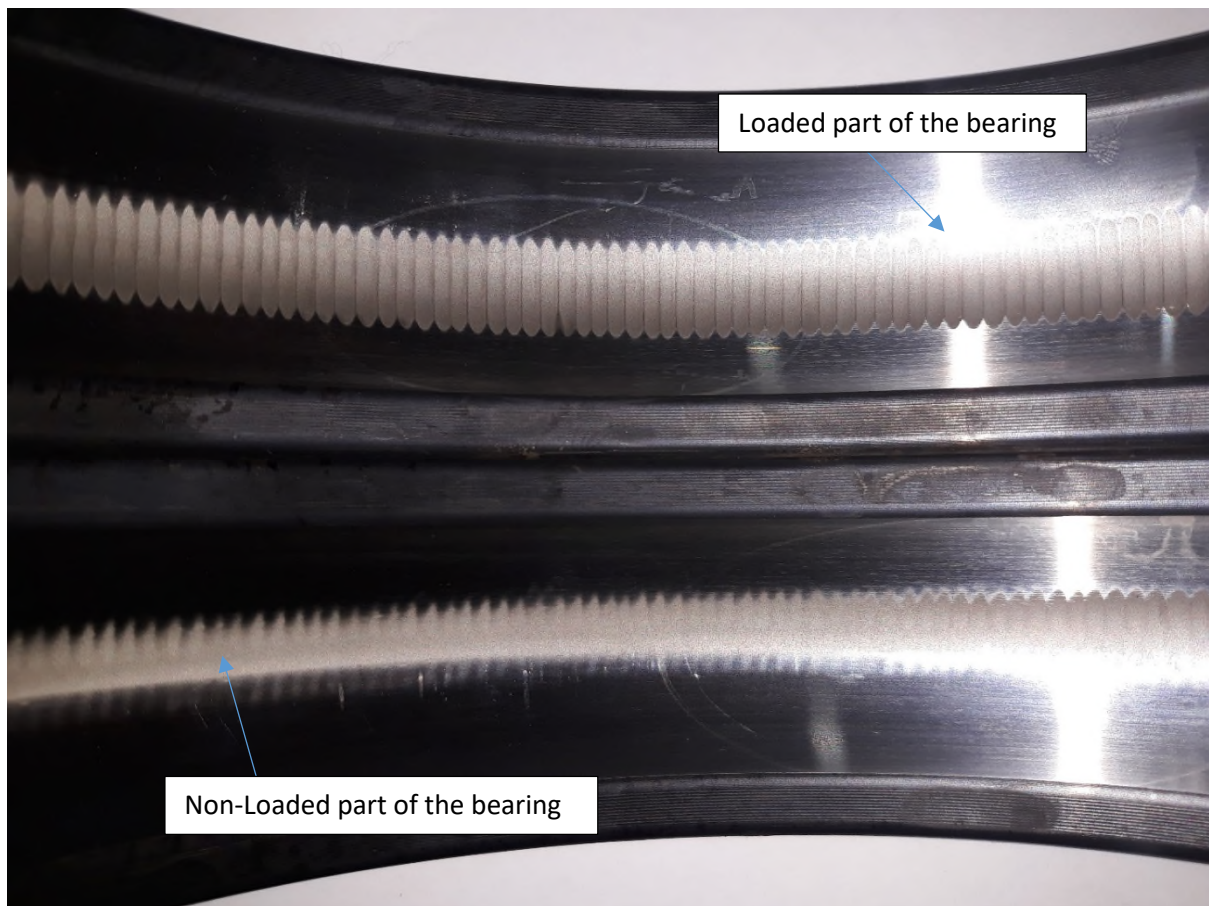
Image 1:

From inspection the failure mode as per ISO 15243:2004 is 5.4.3 Current Leakage Erosion.

This type of bearing current problems are caused by the High Frequency components in the VSD PWM voltage. The ideal solution to affect the high frequency bearing currents are a proper cabling and earthing system breaking the bearing current loops and damping the high frequency common mode current.

NSK 6322 bearing sectioned showing ISO 15243:2004-5.4.3 Current Leakage Erosion.

Image 1 is the non-drive end sectioned and cleaned.

- The above image displays development of flutes on raceways parallel to rolling axis with dull, light to dark grey discolouration.
- This defect would have been the source of the reported audible noise.

Corrective actions for this can range from:

- Fitment of an insulated bearing at the NDE.
- Use of symmetrical multicore VFD motor cables. The earth connector arrangement in the motor cable must be symmetrical to avoid bearing currents at fundamental frequency. An earthing conductor surrounding all the phase leads or a cable that contains a symmetrical arrangement of three phase leads and three earth conductors achieves this.
- Ensuring a short impedance path. The best and easiest way to do this is to use shielded motor cables; the shield must be continuous and of good conducting material and the connections at both ends needs to be made with 360° termination.
- Adding high frequency bonding connections between the installation and known earthing reference points to equalise the potential of affected items, use braided flat straps of copper 50-100 mm wide.

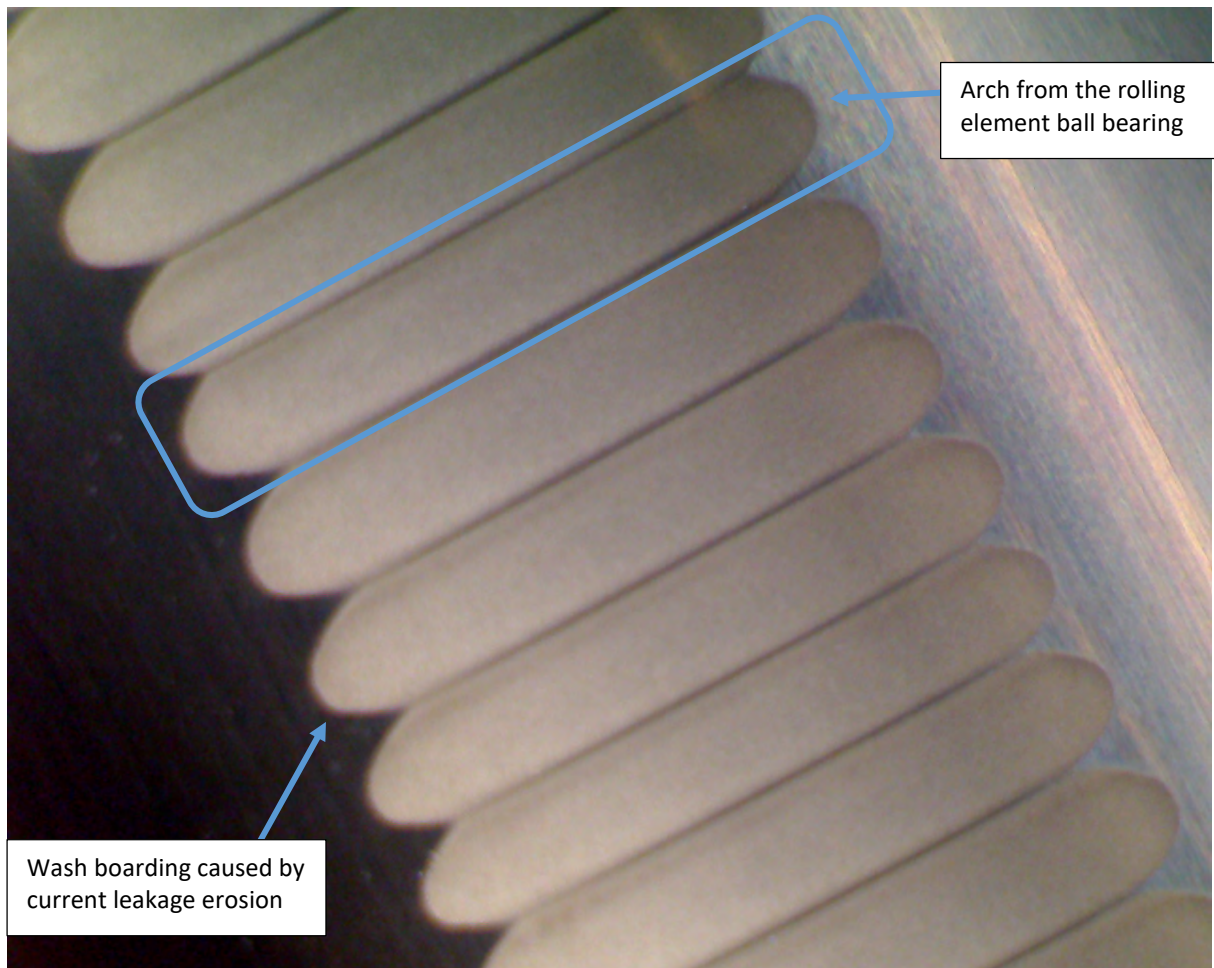
Image 2:

Image 2 is the loaded section of the non-drive end bearing.
