Re: JPS Reliability: Vibration Analysis Report

I would firstly like to thank you for the courtesy and co-operation shown to JPS Reliability Limited during my recent site visit. Following the survey at your facility I have pleasure in presenting for your attention a comprehensive Vibration Analysis Condition Monitoring report.

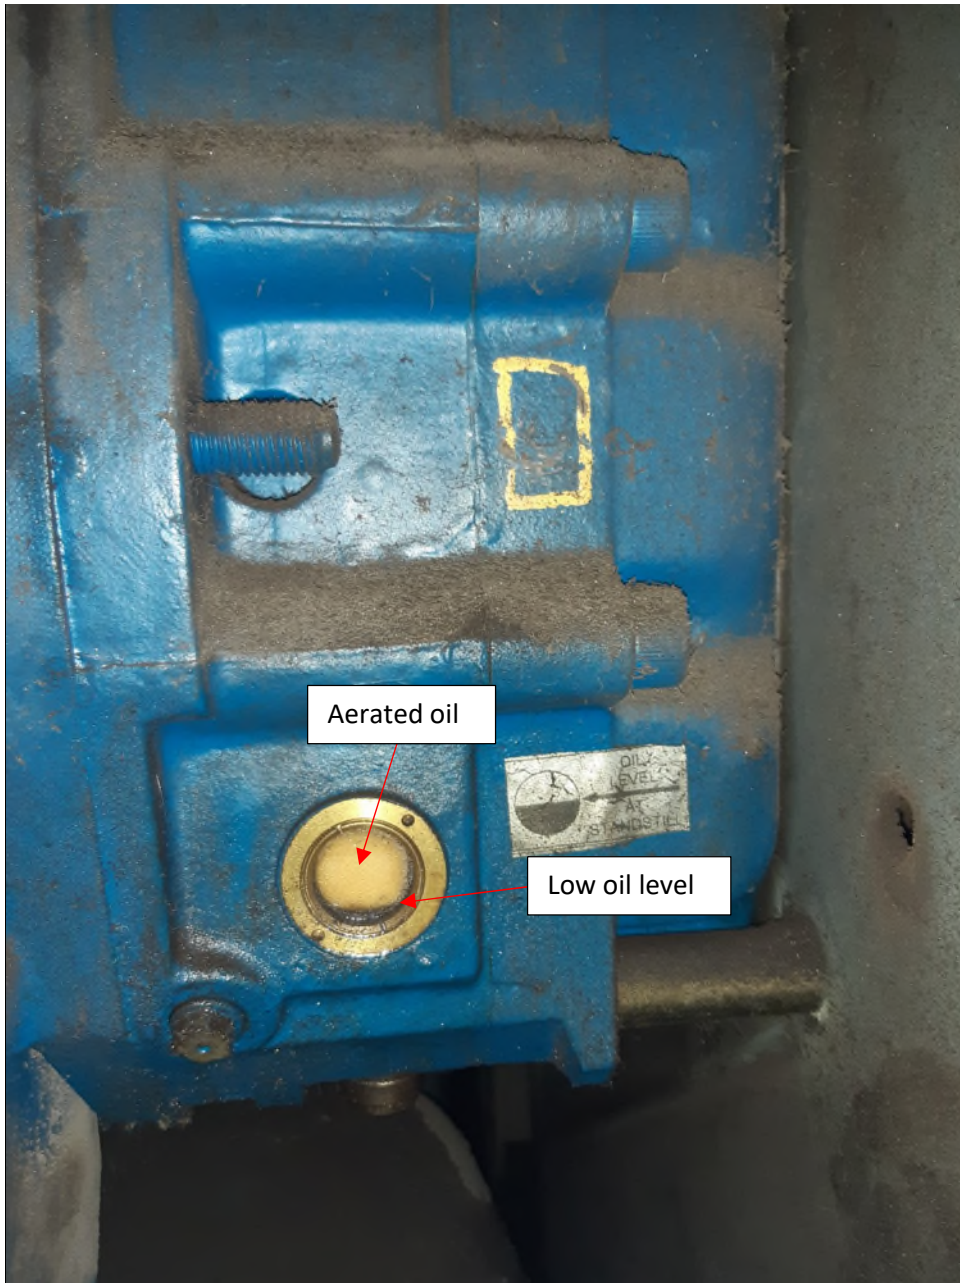
Image 1:

Blower 3: levels at the lobe pass frequency have increased slightly, the oil level in the sight glass appears low. First action check the oil level/condition and monitor **(See Image 1 and Figure 1)**

Image 1 is of the drive end oil level

1. Check the oil level/condition on Blower 3
2. Check with the OEM for the gear tooth count on the blower 6
3. Motor 1, 4 & 6 drive belts do not have the guarding on. To access you need to open the blower door, but best practice re-instate the guarding at the next opportunity
4. Motor 1 grease the non-drive end bearing
5. Motor 3 in long term plan schedule in bearing change
6. Motor 5 lubricate both motor bearings
7. Motor 6 lubricate drive end bearing

Check the oil level and condition

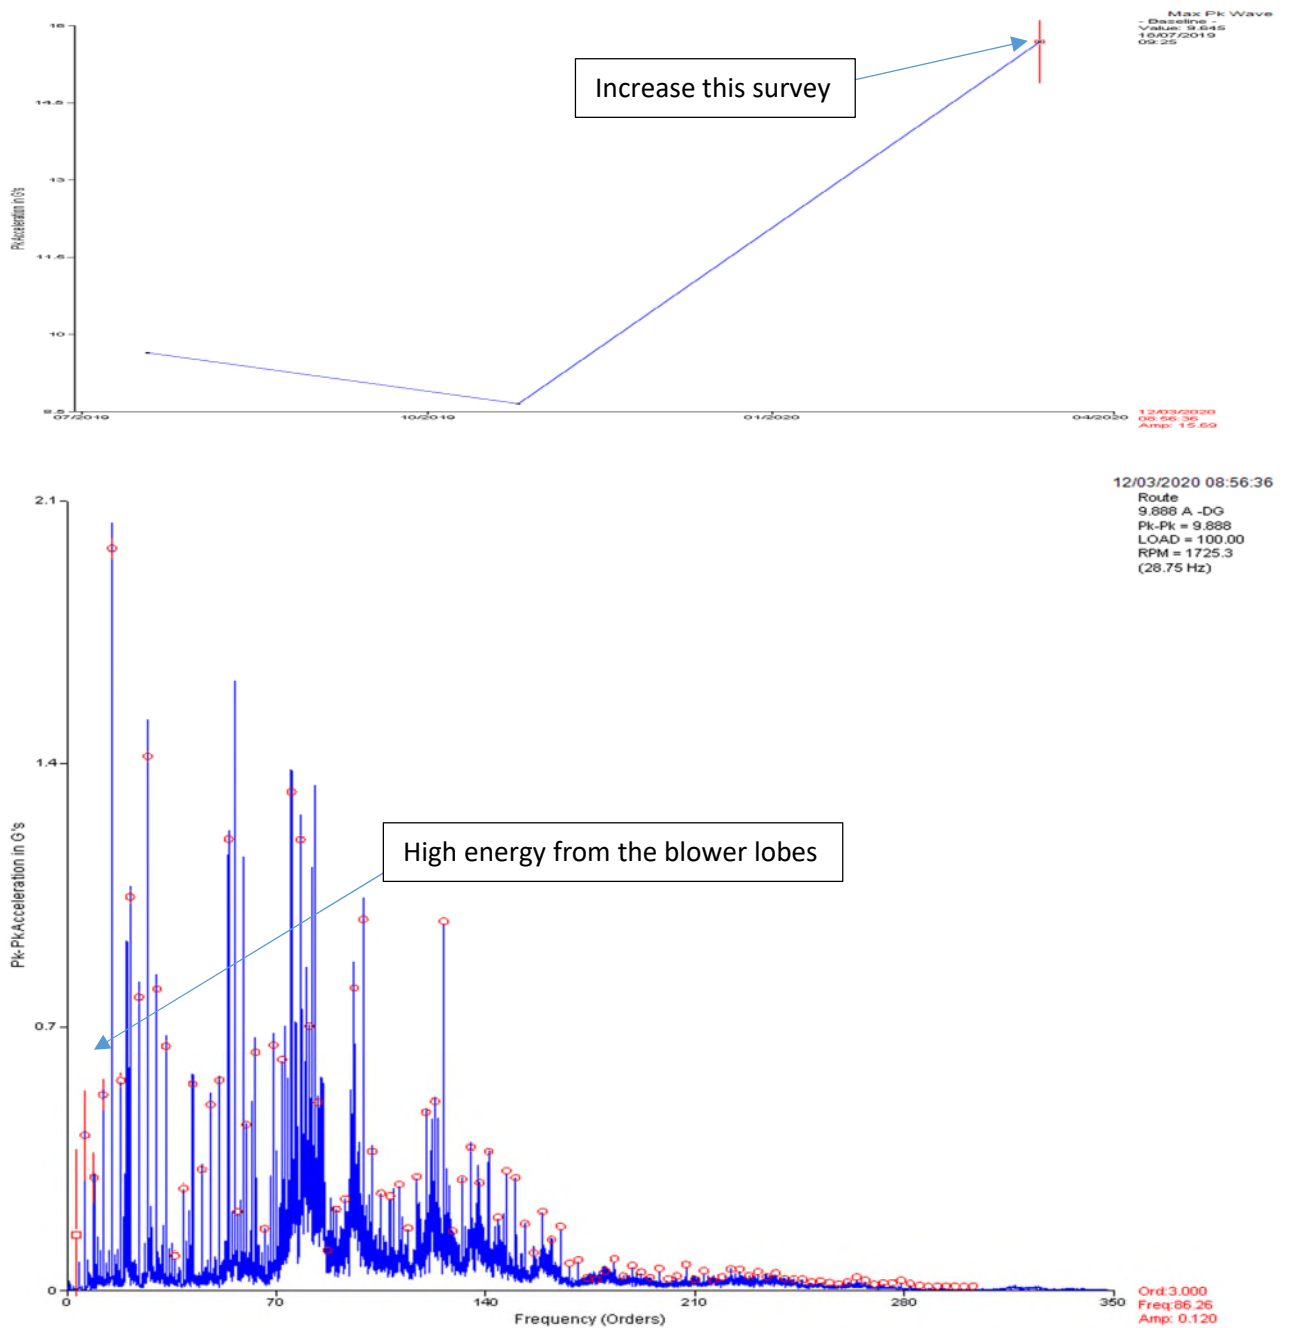
Fig 1:

Figure 1 top trend shows the Acceleration Peak trend and the increase this survey. The bottom plot is the Acceleration spectrum and shows that the highest energy is occurring at 3 Orders, the pulse frequency of the blower.

Check the oil condition and level as it appears low.

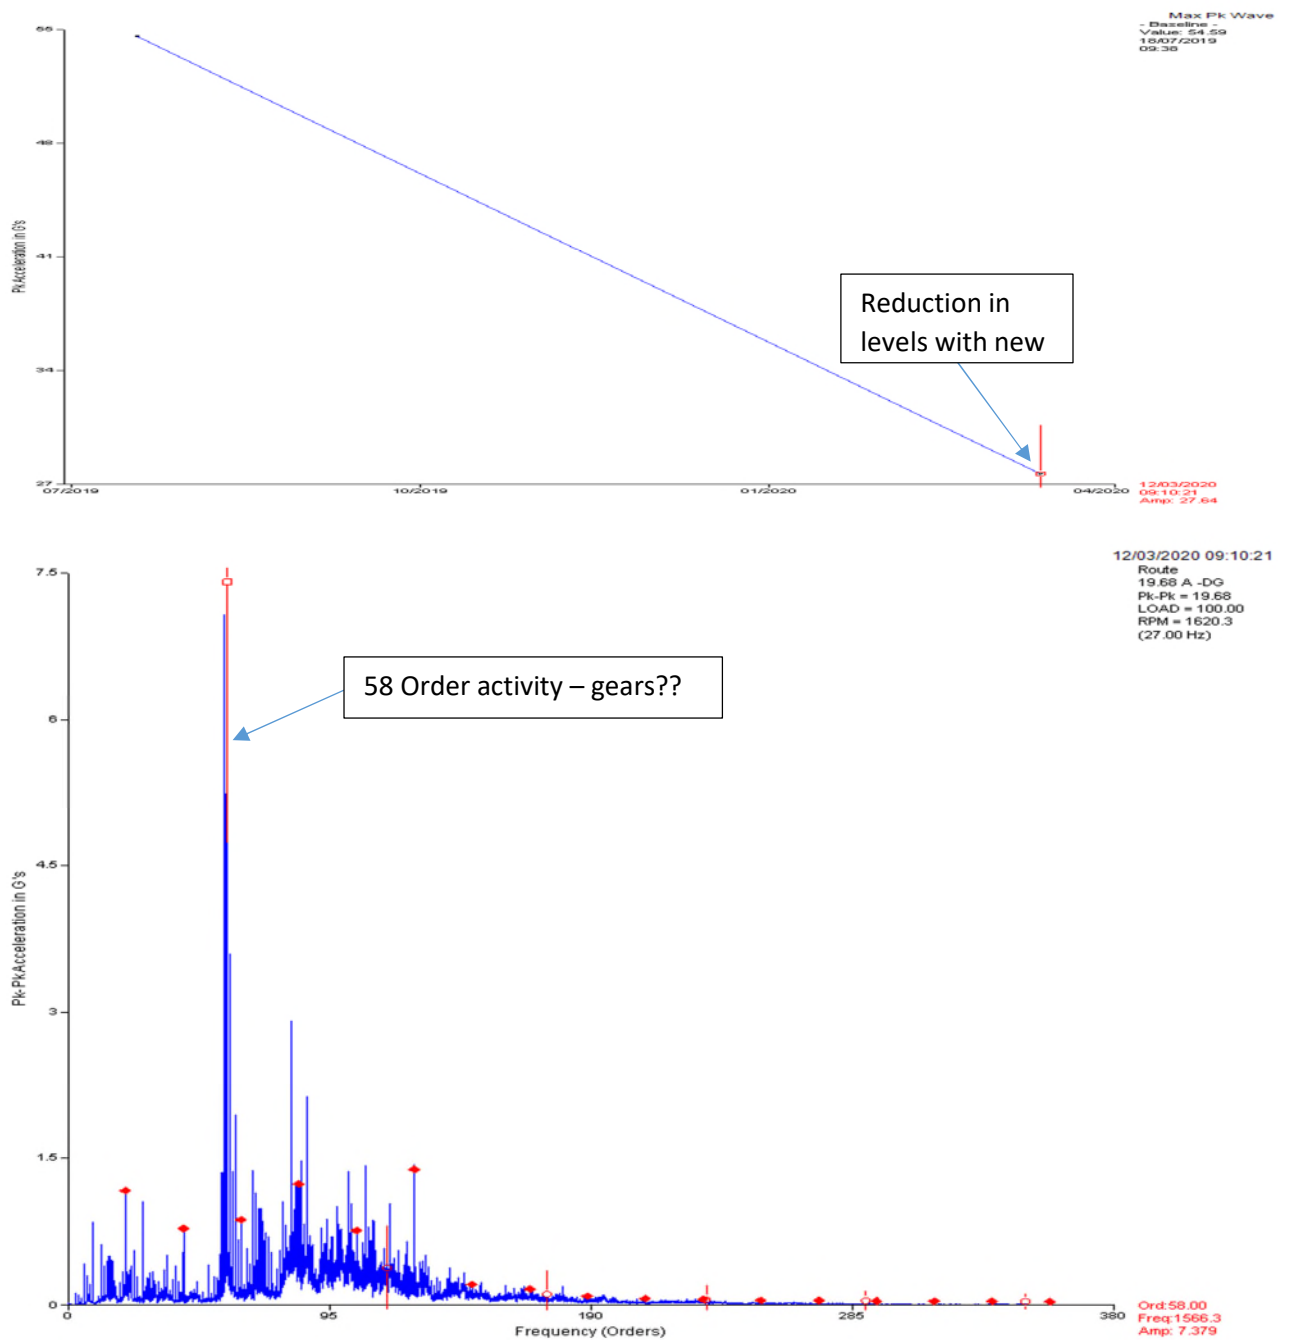
Fig 2:

Blower 6: The levels have greatly reduced on the initial unit, however this blower has the highest levels and the blower drive end is hot to the touch. Continue to monitor. Please ask the OEM for the gear tooth count on the blower. **(See Figure 2)**

Figure 2 top trend shows the Acceleration Peak trend and the reduction with the new blower end, it is still elevated compared to the other units. The bottom Acceleration spectrum shows a peak at around 58 Orders sidebanded by running speed.

Please ask the OEM for the gear tooth count in the blower.

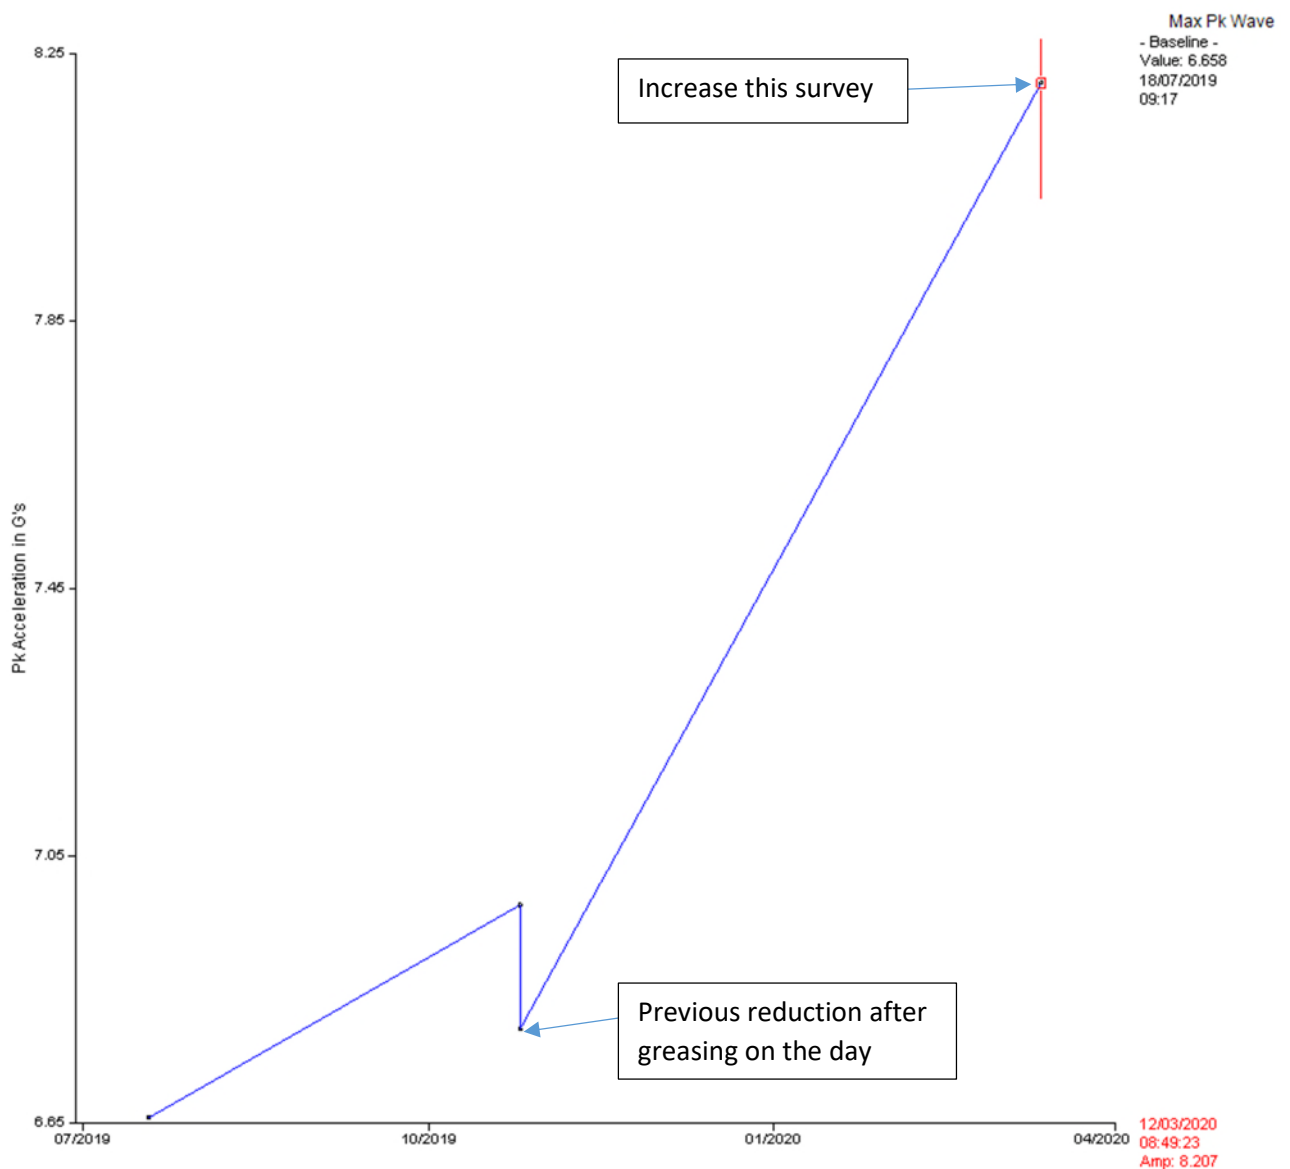
Fig 3:

Motor 1: The drive end bearing defect is steady. The non-drive end stress levels have increased, please grease the non-drive end bearing. **(See Figure 3)**

Figure 3 is the PeakVue Acceleration trend from the motor non-drive end bearing.

This shows the reduction last survey after lubrication and the subsequent increase this survey.

Ensure that the motor non-drive end is lubricated.

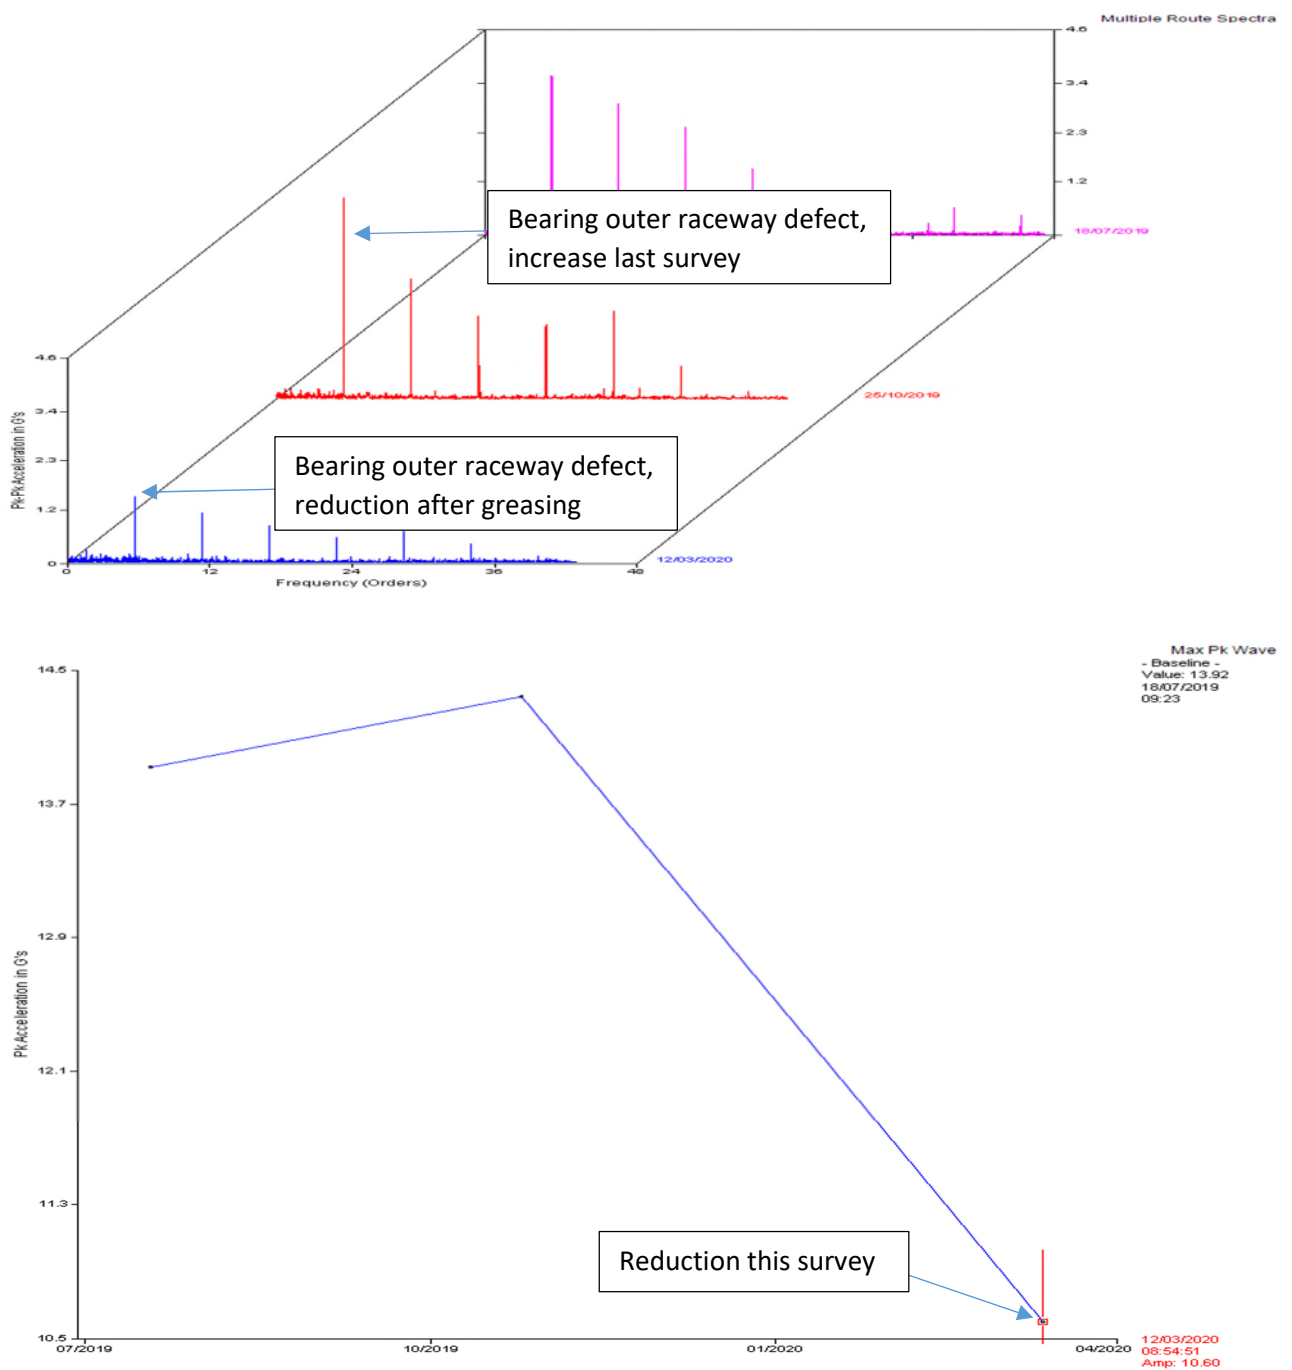
Fig 4:

Motor 3: The defect at the drive end remains steady after lubrication, continue to trend and plan in bearing change. **(See Figure 4)**

Figure 4 top plot is the PeakVue spectra's from the drive end of the motor, this shows the increase last survey and the reduction in the amplitude of the defect this month. The bottom plot is the PeakVue Acceleration trend and shows the previous increase and reduction after lubrication this survey.

Continue with lubrication schedule and long-term plan in bearing change.

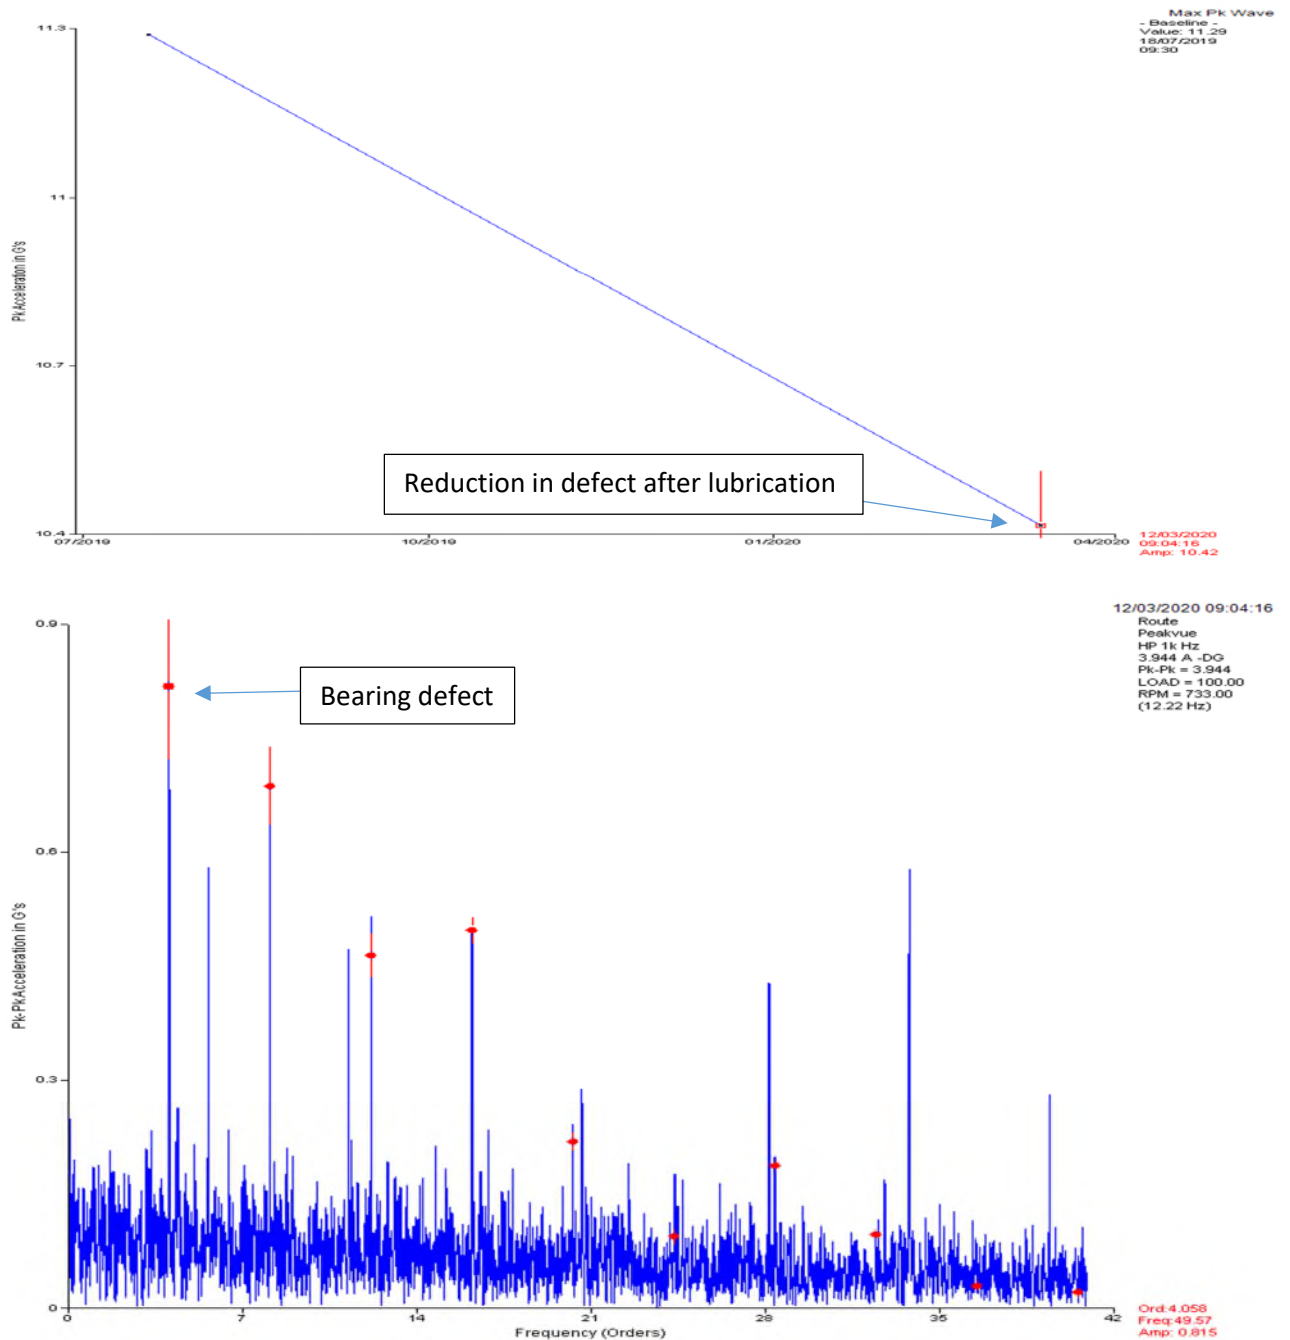
Fig 5:

Motor 4: The bearing defect at the motor drive end remains steady after lubrication. **(See Figure 5)**

Figure 5 top plot is the PeakVue trend and it shows a reduction in the bearing defect. The bottom plot is the PeakVue spectrum and this shows the bearing defect is still evident.

Continue with lubrication schedule.

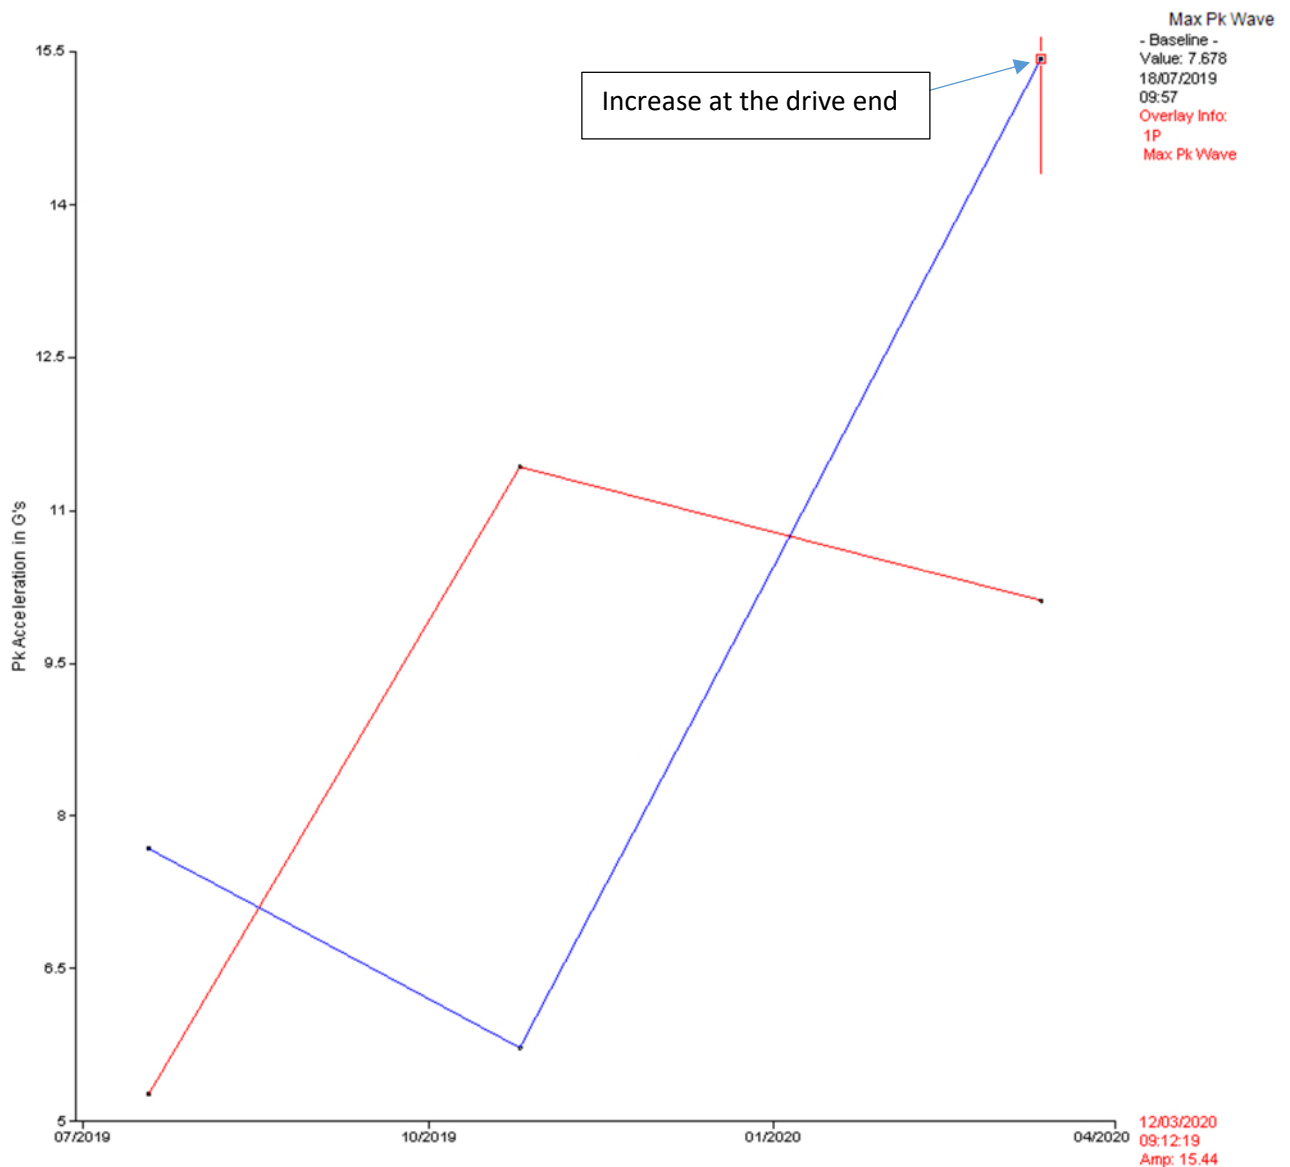
Fig 6:

Figure 6 compares the drive and non-drive end PeakVue bearing trends.

This shows steady levels at the non-drive end and an increase at the drive end.

Motor 5: Grease both motor bearings. **(See Figure 6)**

Please lubricate both motor bearings.

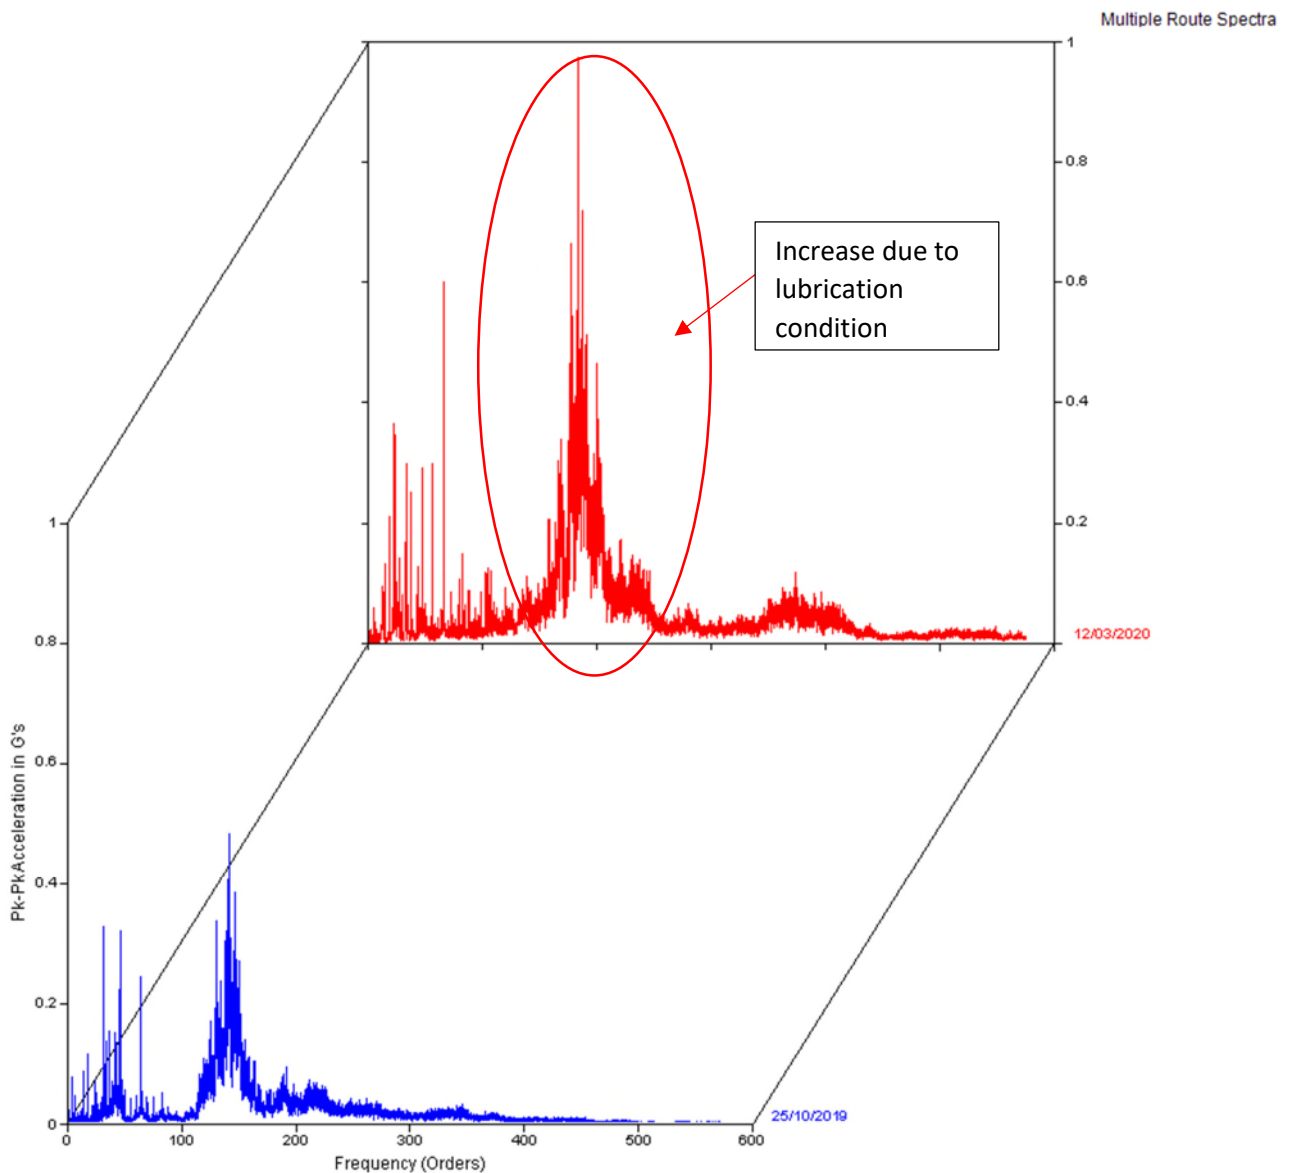
Fig 7:

Motor 6: Bearing defect is steady. However the drive end grease needs to be replenished. **(See Figure 7)**

Figure 7 shows the last two Acceleration spectra's, this shows the mound of high frequency activity has increased due to the reduction of the lubrication condition.

Please lubricate the motor drive end bearing.

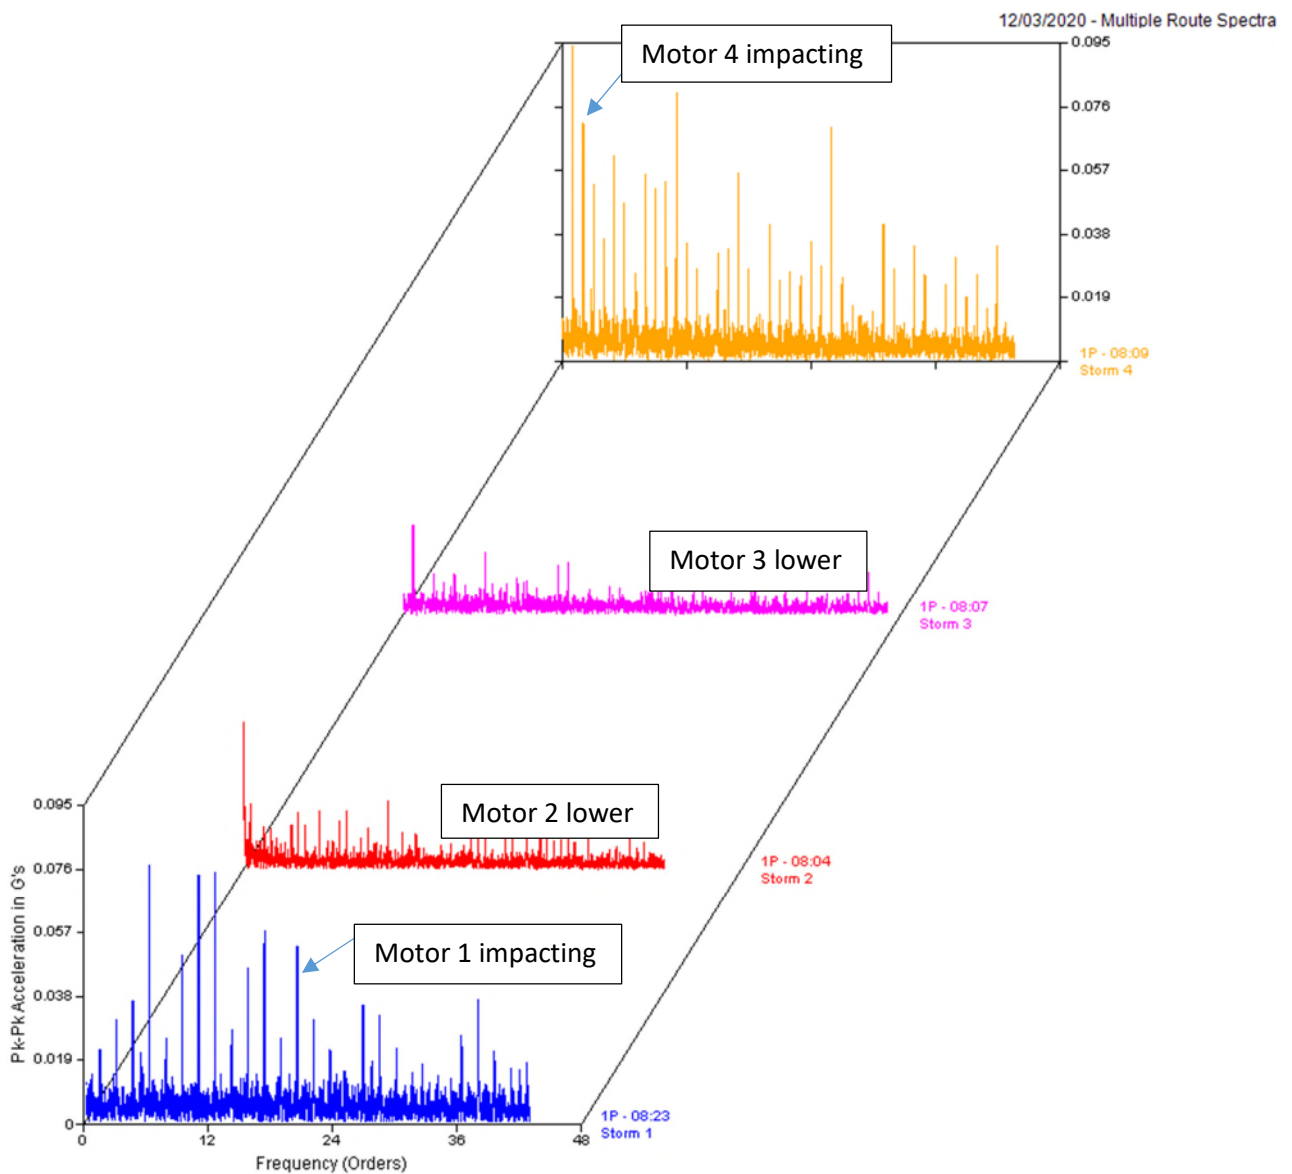
Fig 8:

Motors: Motor 1 and 4 show an increase in the periodic impacting at the top (non-drive end). This may be related to the brush condition or looseness in the bearing. **(See Figure 8)**

Figure 8 compares the PeakVue spectra's from the non-drive end of the motors.

Motor 1 and 4 show an increase in the periodic impacting at the top (non-drive end). This may be related to the brush condition or looseness in the bearing as it is occurring once per revolution of the shaft.

1. Motor 1 and 4 Inspect the carbon brush condition and lubricate bearings
2. Lubricate the pump bearings

First action grease the bearings and inspect the brush condition.

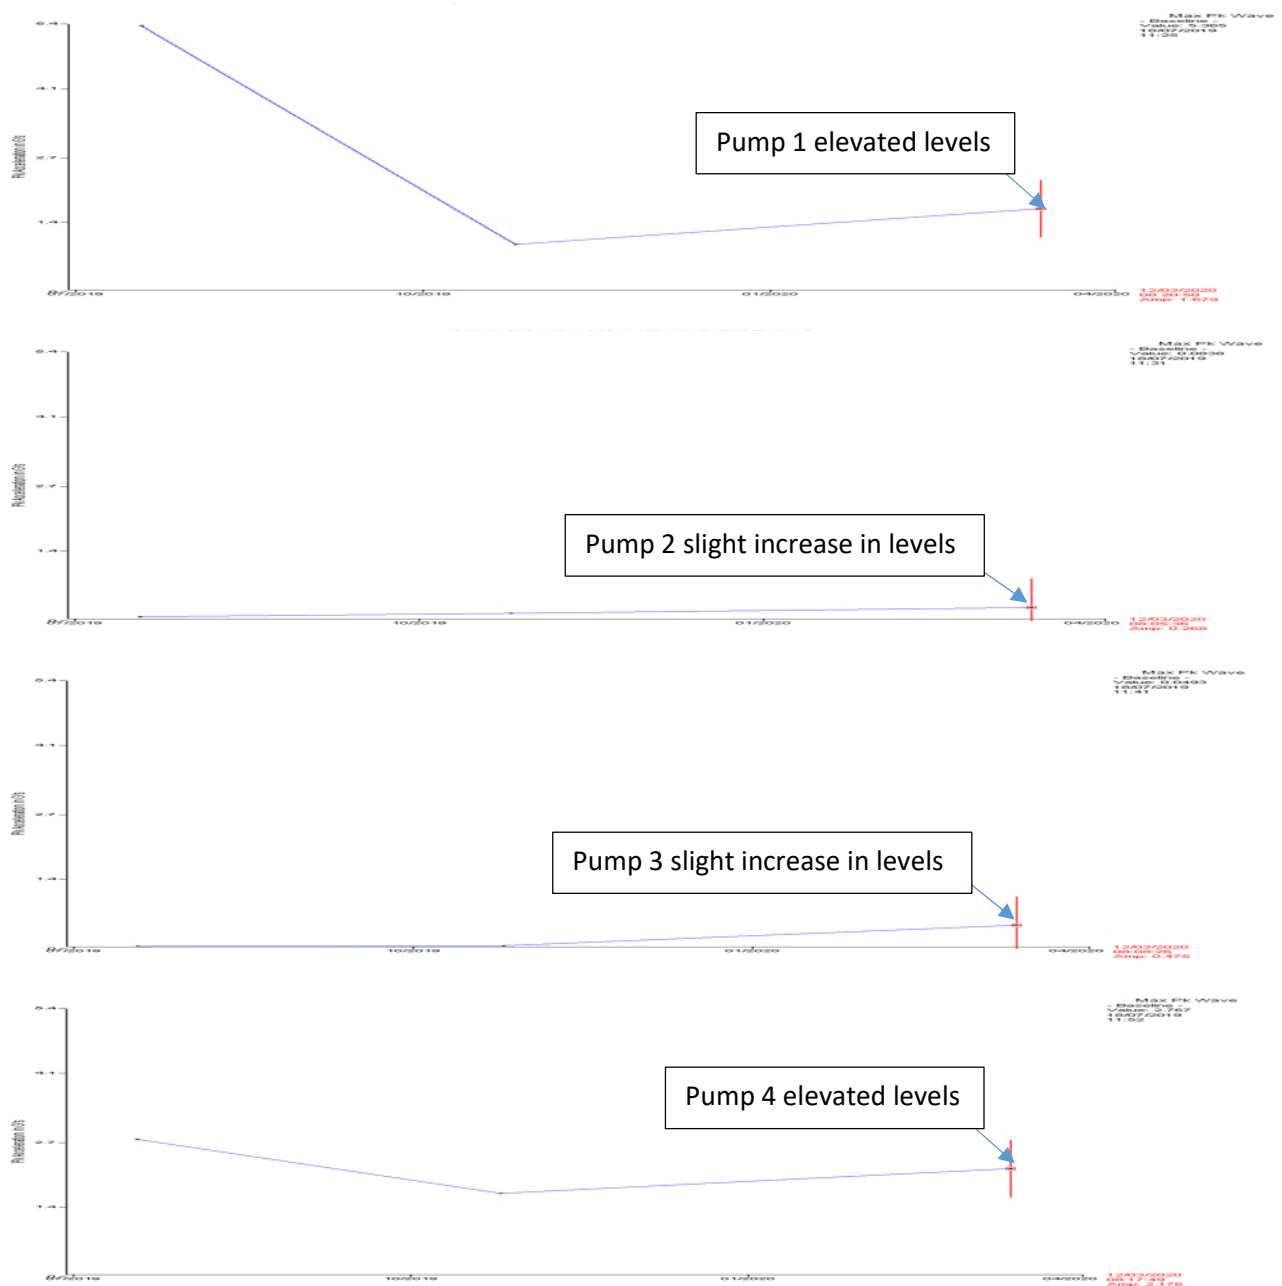
Fig 9:

Pumps: Pump 1 and 4 still have the highest bearing impacting levels. They have remained steady. Lubricate and continue to trend the impacting levels. **(See Figure 9)**

Figure 9 compares the top drive end bearing Peak Acceleration trends from the pump barrels.

There has been a slight increase on Pump 2 and 3, the impacting levels from Pump 1 and 4 remain high but steady.

Lubricate the pump bearings, the additional lubrication is extending the bearing life.

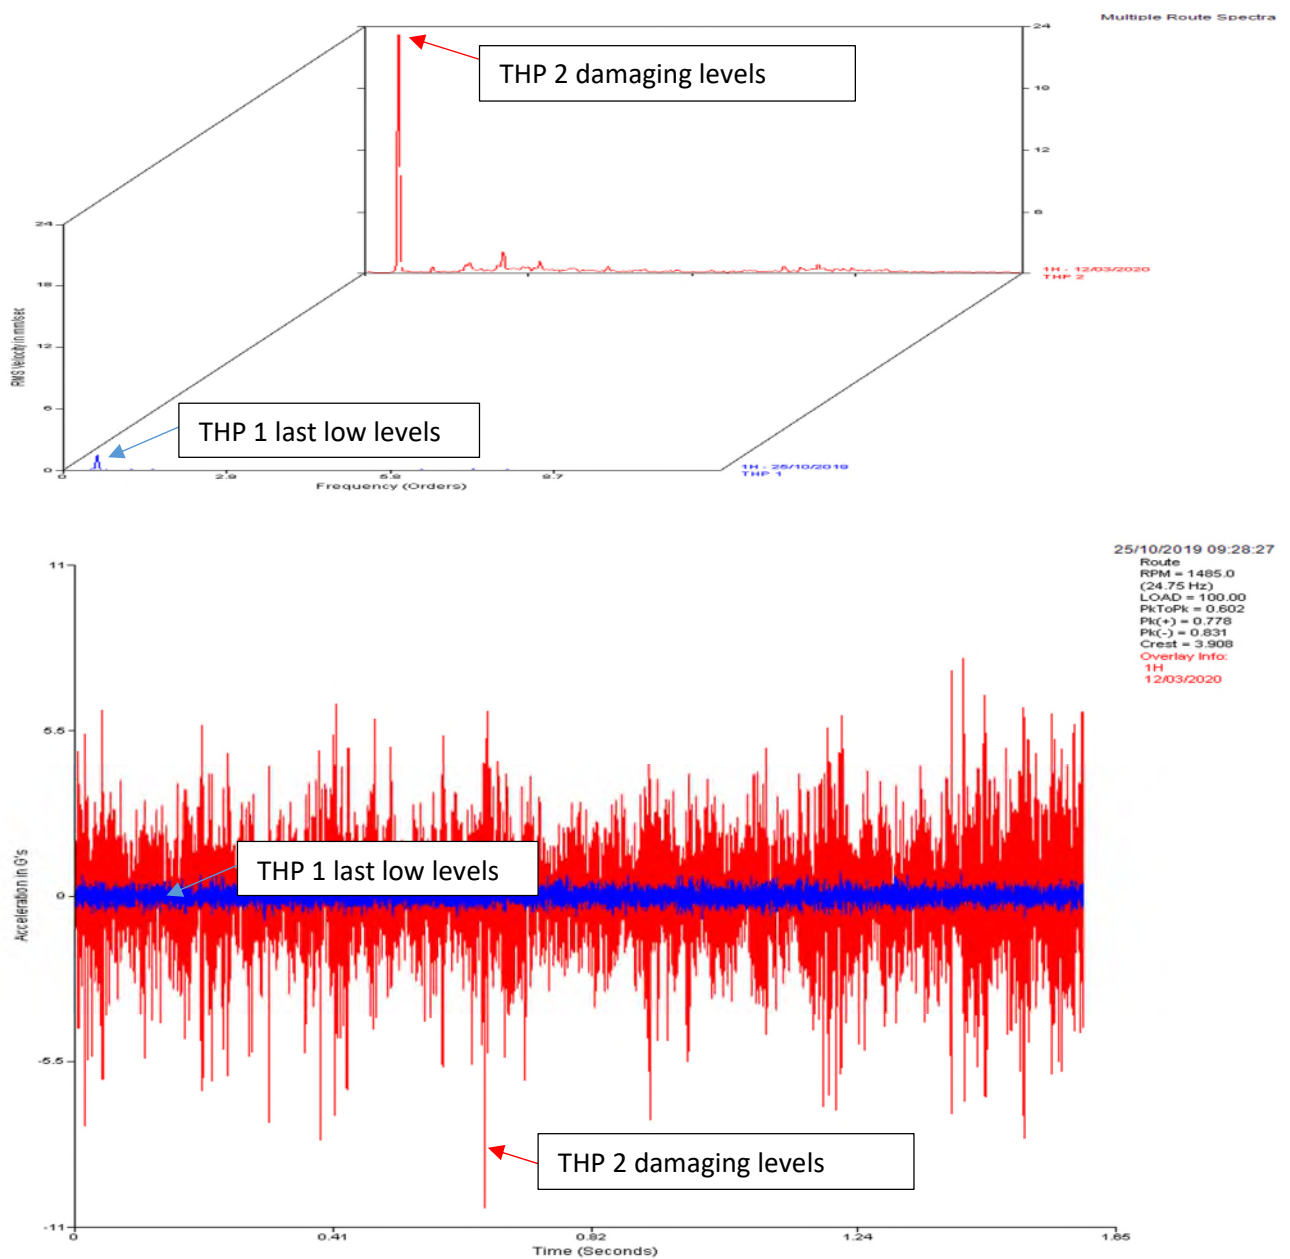
Fig 10:

Figure 10 top plot shows THP 1 last level at 1.51mm/s RMS compared to the very high THP 2 at 23.149 mm/s RMS. The bottom plot compares the last THP 1 impacting levels at 1.609g's compared to the very high damaging levels THPO 2 at 18.26g's.

This is the first set of data and the motor is running in a damaged mode. This is visually and audibly loud and knocking. Site have lubricated the bearings with little affect.

1. Motor 2 remove from service for inspection/overhaul

Remove the motor for service, check the gearbox oil and drive coupling condition.

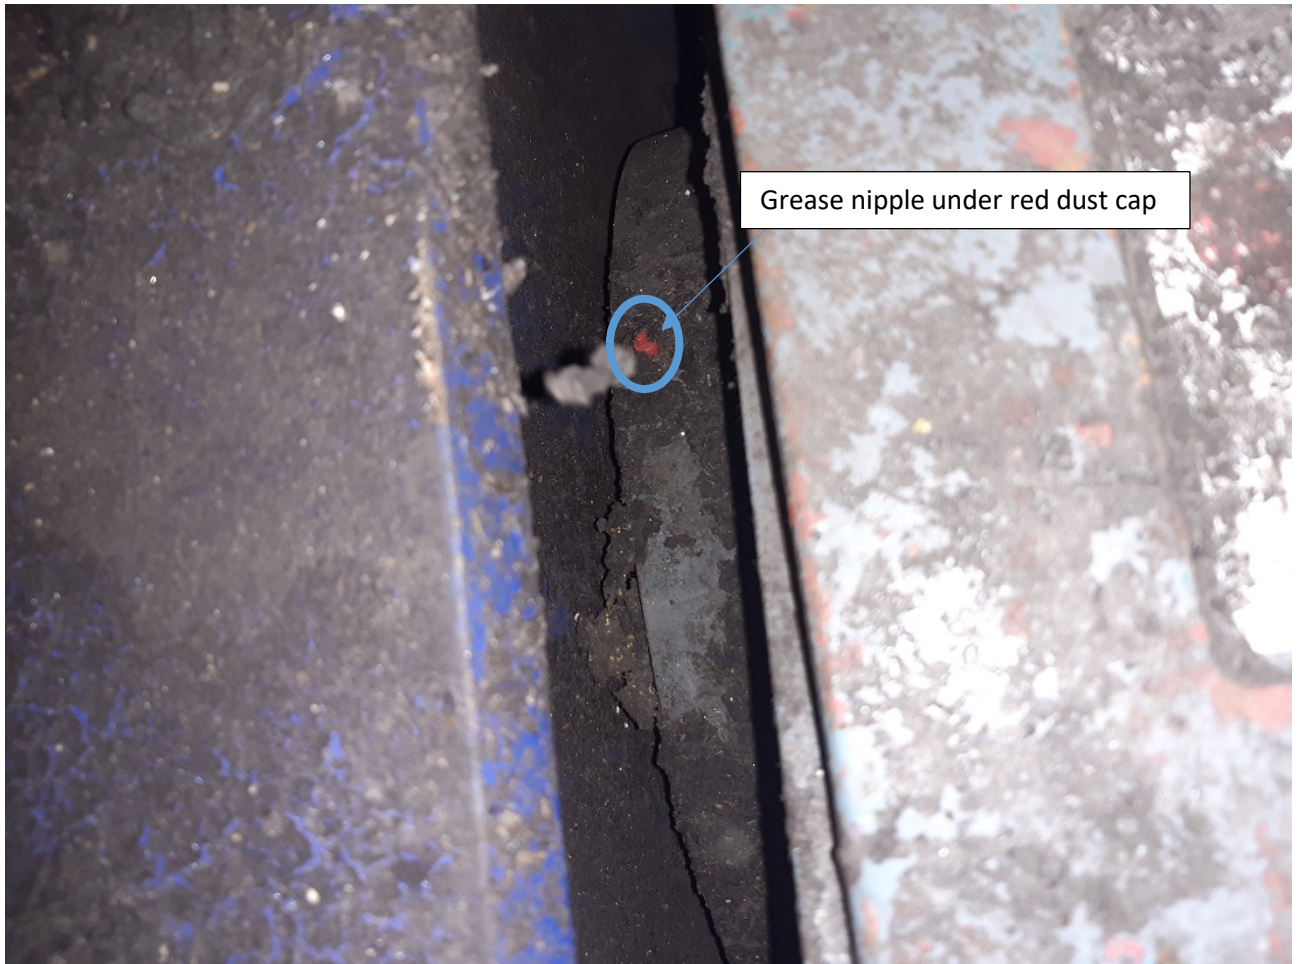
Image 2:

Image 2 shows that the motor drive end bearing is in a tight location.

It is important that the motor bearings are greased.

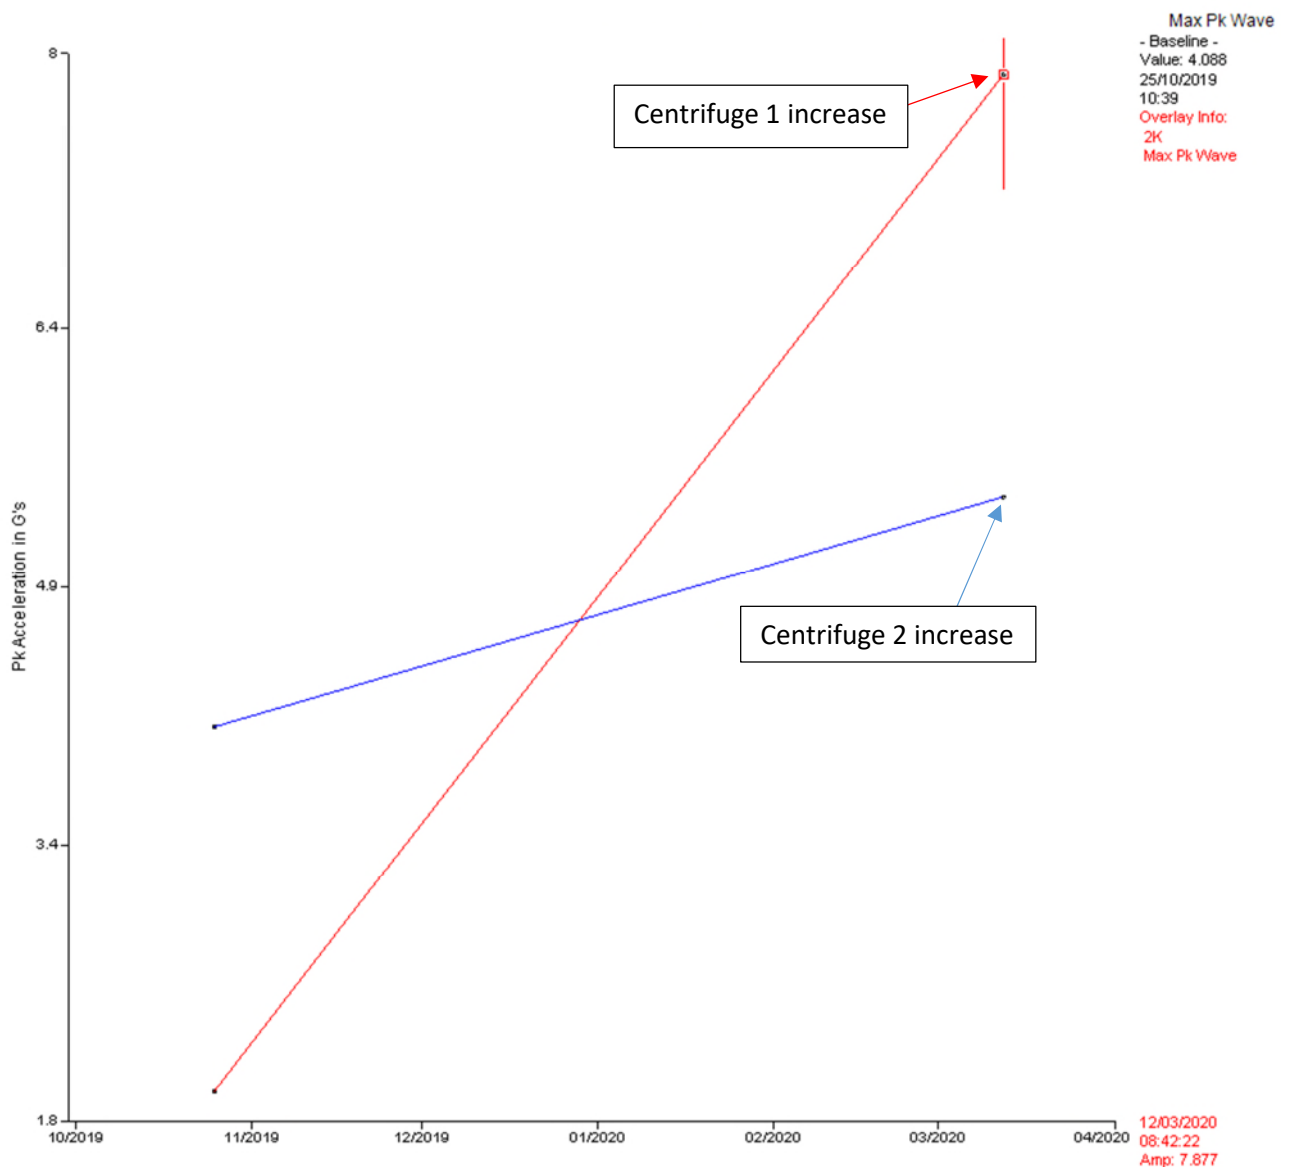
Fig 11:

Motors: Both the motors require lubrication. **(See Image 2 and Figure 11)**

Figure 11 is the Acceleration trend from the drive end bearing on the two centrifuges.

This was flagged up last survey as requiring lubrication, it has increased further this survey.

It is important that the motor bearings are fully greased, note the difficulty in accessing the drive end grease nipple.
