Re: JPS Reliability: Vibration Analysis Report

I would firstly like to thank you for the courtesy and co-operation shown to JPS Reliability Limited during my recent site visit. Following the survey at your facility I have pleasure in presenting for your attention a comprehensive Vibration Analysis Condition Monitoring report.

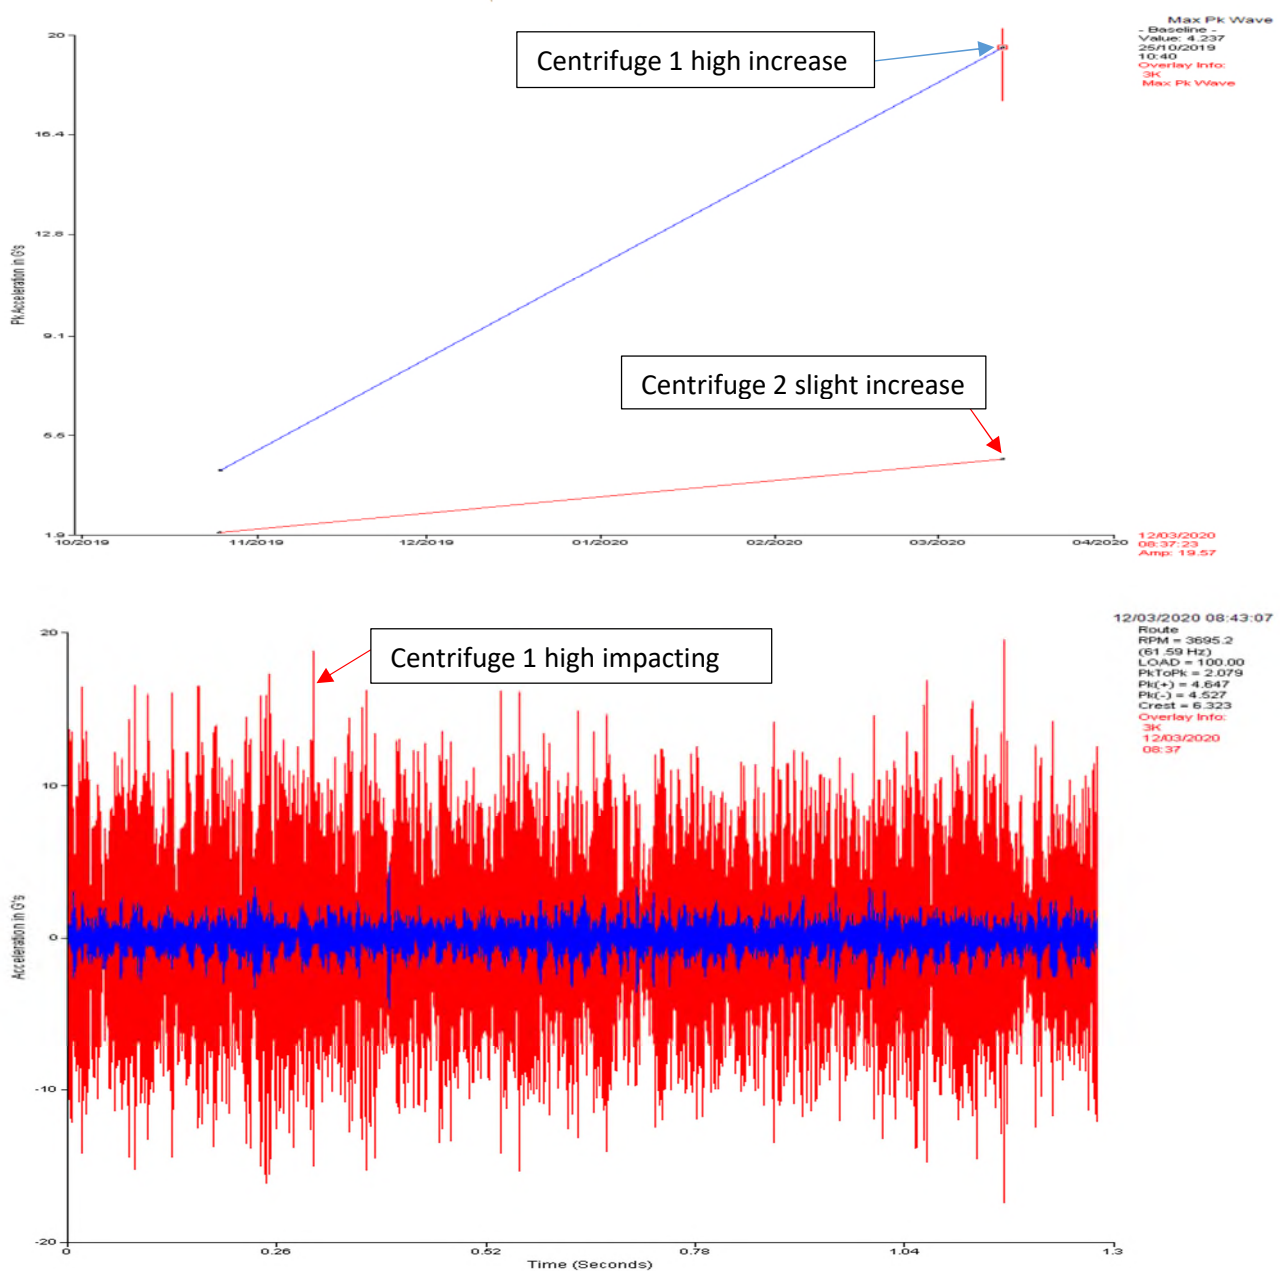
Fig 12:

Main Rotors: There is a concerning increase at the drive end bearing of Centrifuge 1. The impacting is very high. First action change the drive belts checking the belt pulley condition. Fully grease purge Centrifuge drive end bearing and then re-gather data to see if this reduced the impacting from the bearing. **(See Figure 12)**

Figure 12 top plot compares the drive end centrifuge bearing showing the high increase on Centrifuge 1. The bottom compares the Acceleration time waveforms from Centrifuge 1 at 36.99 g's (red data) and Centrifuge 2 at 9.2 g's (Blue data).

There is a concerning increase at the drive end bearing of Centrifuge 1. The impacting is very high.

1. Motors require greasing at the drive end, an extension for the grease gun will be required
2. Centrifuge 1 maint rotor drive end bearing. First action change the drive belts checking the belt pulley condition. Fully grease purge Centrifuge drive end bearing and then re-gather data to see if this reduced the impacting from the bearing.

First action, change the drive belts checking the belt pulley condition. Fully grease purge Centrifuge drive end bearing and then re-gather data to see if this reduced the impacting from the bearing.
