Re: JPS Reliability: Infrared Thermography Report

Customer name - Site  
Thermographic Survey Check List

## JPS Reliability Services Thermographic Survey For

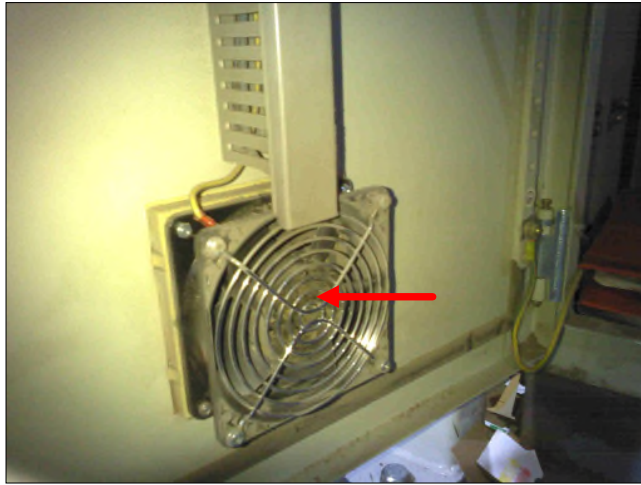
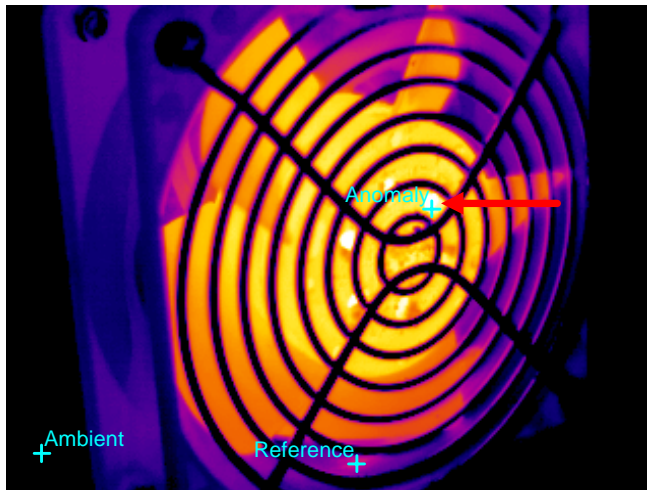
<b>Area</b>	Heat Recovery Control Panel
<b>Equipment</b>	Door Cooling Fan
<b>Item</b>	Fan

Additional Information:  
Replace Fan ASAP.

Label	Value
Anomaly	116.3°C
Reference	69.5°C
Ambient	26.0°C

There is a very high localised temperature on the fan unit, the fan unit is defective, and this will reduce the cooling within the control panel.

Replace the fan unit.

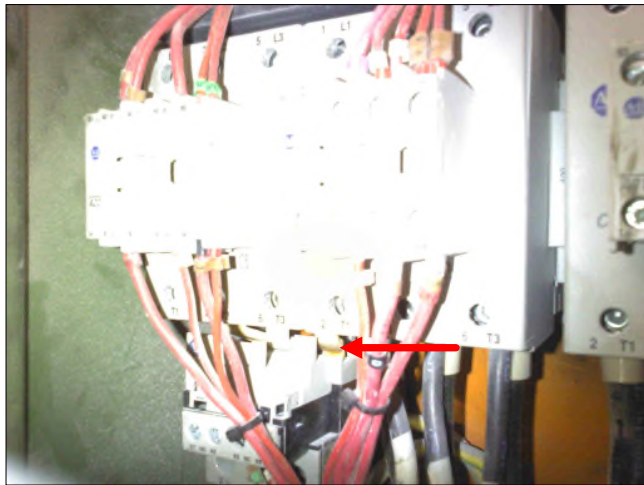
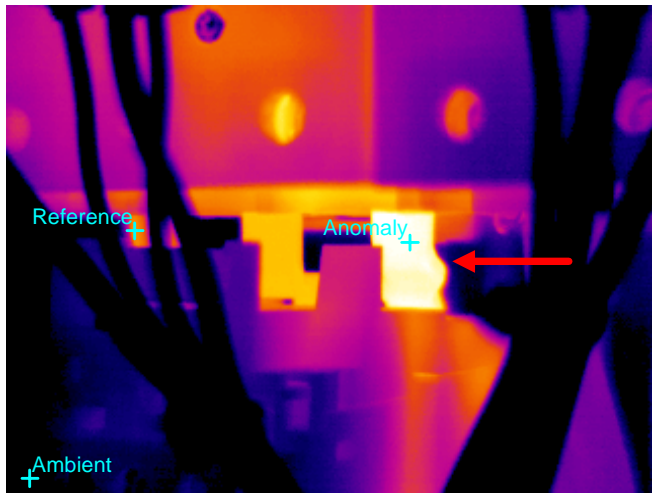
<b>Area</b>	Reel trolley panel right	
<b>Equipment</b>	KM1	
<b>Item</b>	Overload Connection

**Additional Information:**  
 Replace Units.

Label	Value
Anomaly	95.4°C
Reference	58.9°C
Ambient	26.3°C

There is localised temperature increase / high resistive connection at the phase three connection, this is probably due to a loose, corroded or sub-standard electrical contact.

Due to the high temperature source spare units and replace.

Isolate supply, disassemble components, clean, inspect for damage and replace where necessary. Reassemble; tighten to the correct torque ensuring security of connections and electrical integrity of the circuit.

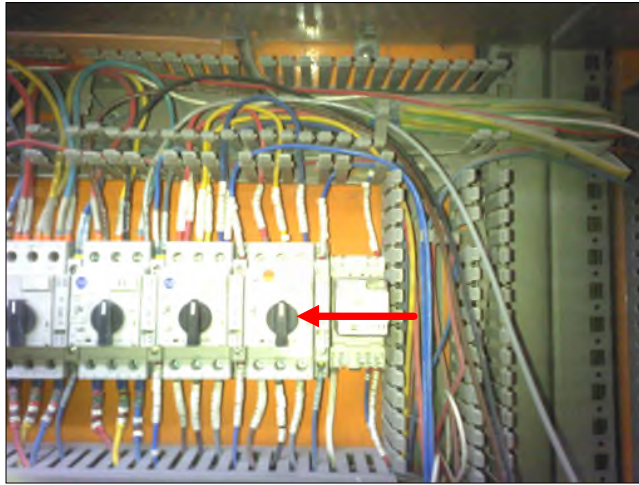
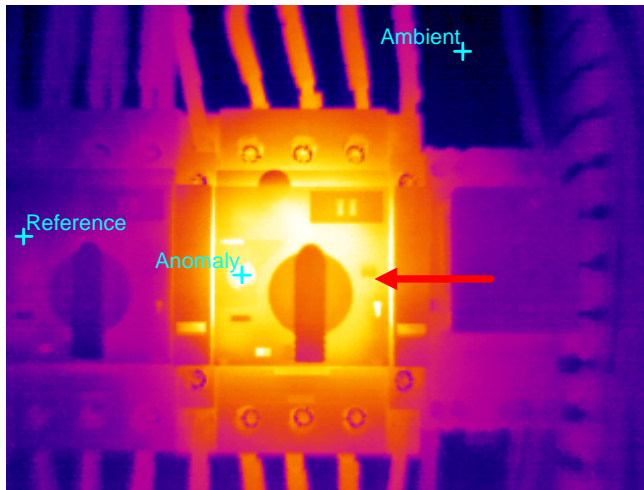
Area	Starch CP-1-2-16-6 Left
Equipment	ABB Unit 2A
Item	Internal

Additional Information:  
Replace Unit.

Label	Value
Anomaly	89.8°C
Reference	34.7°C
Ambient	31.7°C

There is localised temperature increase on the body of this unit, the problem could be defective internal contacts.

Replace the whole unit.

Isolate supply, disassemble components, clean, inspect for damage and replace where necessary. Reassemble; tighten to the correct torque ensuring security of connections and electrical integrity of the circuit

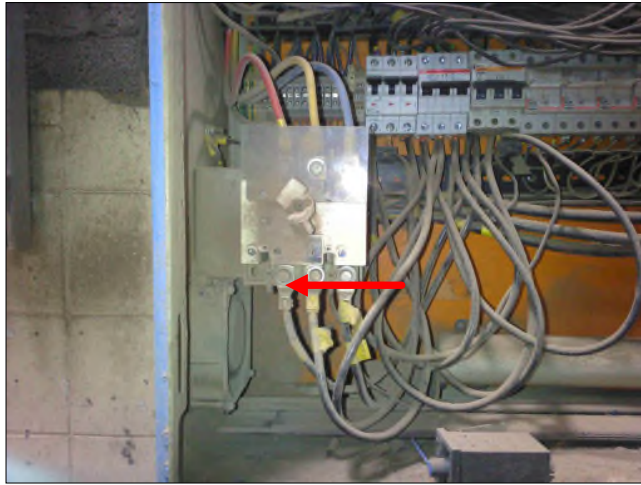
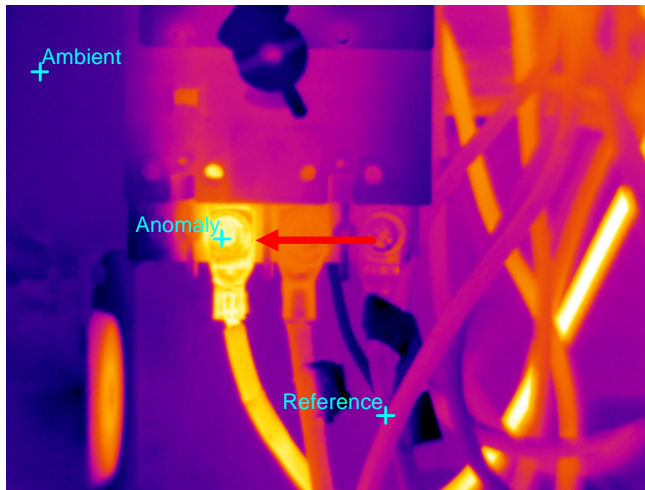
<b>Area</b>	DB1-2-16-5-7 Pump Panel	
<b>Equipment</b>	Door Isolator	
<b>Item</b>	L1 Connection

Label	Value
Anomaly	51.4°C
Reference	26.8°C
Ambient	23.7°C

There is localised temperature increase / high resistive connection at the L1 connection of main door isolator, this is probably due to a loose, corroded or sub-standard electrical contact.

Isolate supply, disassemble components, clean, inspect for damage and replace where necessary. Reassemble; tighten to the correct torque ensuring security of connections and electrical integrity of the circuit.

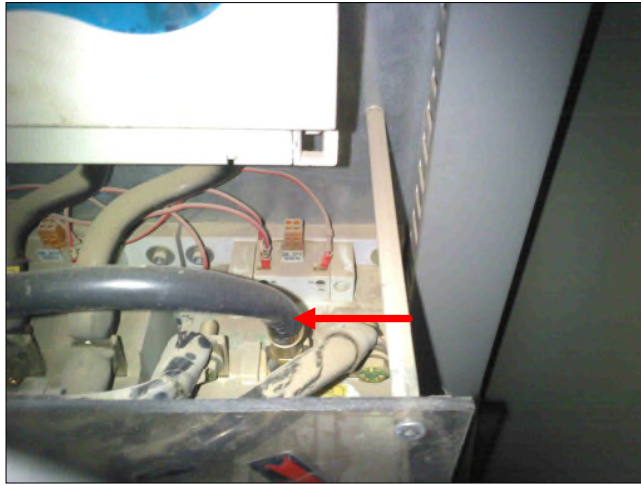
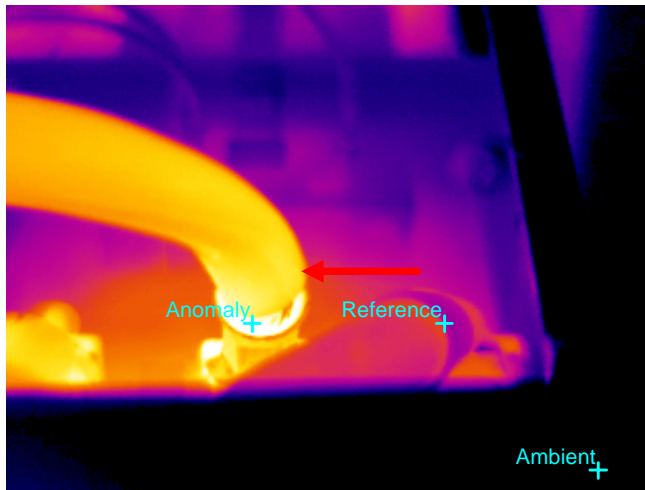
<b>Area</b>	Facer 2 Extract Panel
<b>Equipment</b>	Main Isolator
<b>Item</b>	Top Connection

Additional Information:  
Repair ASAP

Label	Value
Anomaly	122.0°C
Reference	58.3°C
Ambient	31.9°C

There is localised temperature increase / high resistive connection at the top connection of main isolator, this is probably due to a loose, corroded or sub-standard electrical contact.

This was reported on the day to ensure that site has a spare isolator as due to the very high temperature there will be probable damage withing the isolator.

Isolate supply, disassemble components, clean, inspect for damage and replace where necessary. Reassemble; tighten to the correct torque ensuring security of connections and electrical integrity of the circuit.

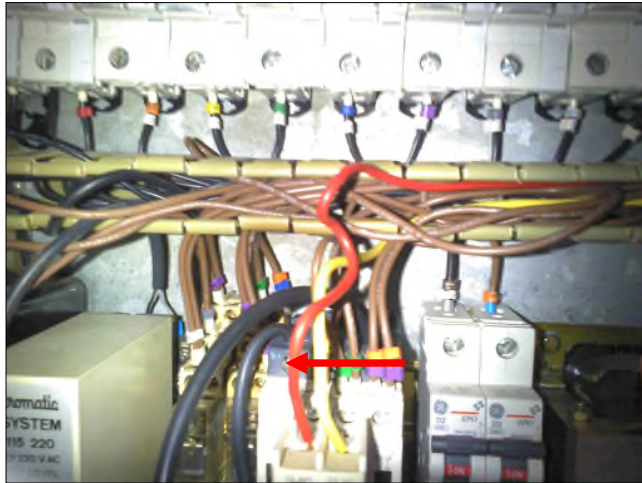
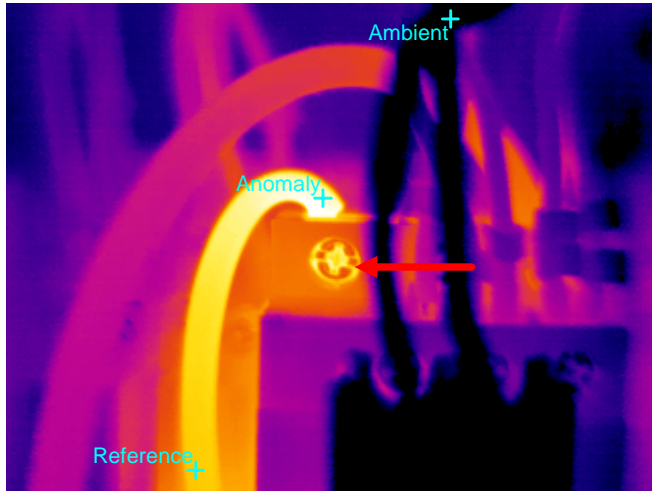
<b>Area</b>	Starch Chiller
<b>Equipment</b>	K2M
<b>Item</b>	L1 Connection

**Additional Information:**  
 Replace Unit and cable.

Label	Value
Anomaly	102.2°C
Reference	86.4°C
Ambient	39.0°C

There is localised temperature increase / high resistive connection at the L1 connection of K2M, this is probably due to a loose, corroded or sub-standard electrical contact.

The concern here is that this is at over 100 degrees Celsius, this needs repairing at the soonest opportunity, this was reported on the day.

Isolate supply, disassemble components, clean, inspect for damage and replace where necessary. Reassemble; tighten to the correct torque ensuring security of connections and electrical integrity of the circuit.

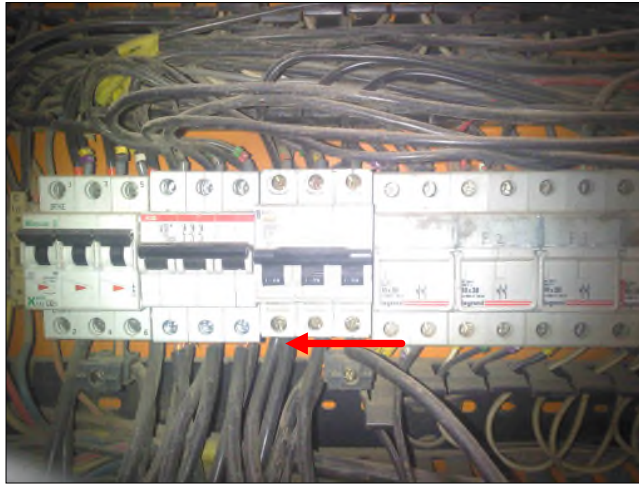
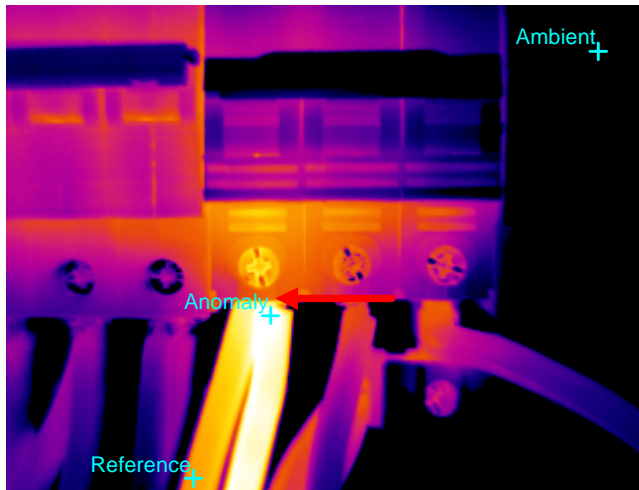
<b>Area</b>	Facer 2 control panel CP-2-22
<b>Equipment</b>	Trip 3
<b>Item</b>	Bottom Left Connection

Label	Value
Anomaly	66.2°C
Reference	49.8°C
Ambient	29.0°C

There is localised temperature increase / high resistive connection at the bottom left connection of trip 3, this is probably due to a loose, corroded or sub-standard electrical contact

Isolate supply, disassemble components, clean, inspect for damage and replace where necessary. Reassemble; tighten to the correct torque ensuring security of connections and electrical integrity of the circuit.

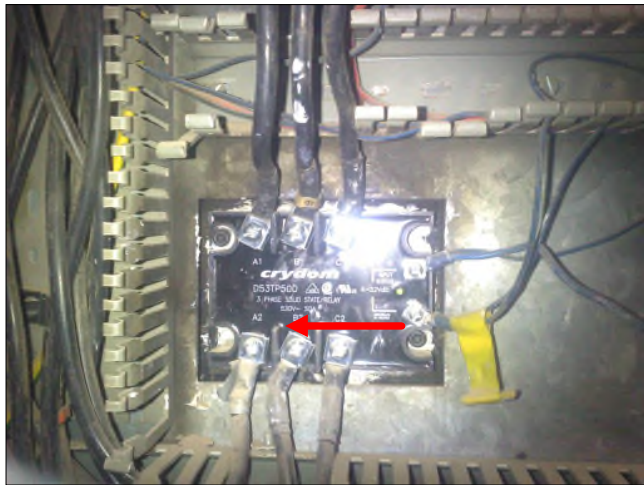
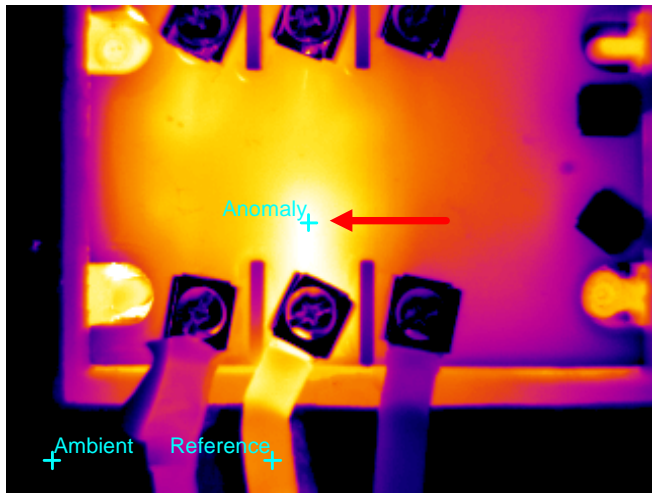
<b>Area</b>	Facer 2 Fan Control Panel	
<b>Equipment</b>	Crydom Unit	
<b>Item</b>	Internal - B2

**Additional Information:**  
 Repalce Unit.

Label	Value
Anomaly	62.7°C
Reference	52.1°C
Ambient	31.2°C

This survey shows that the wires at the contacts are at a lower temperature than the body of the Crydom Unit. This indicates that the defect is at the internal contact.

Isolate supply, disassemble components, clean, inspect for damage and replace where necessary. Reassemble; tighten to the correct torque ensuring security of connections and electrical integrity of the circuit.

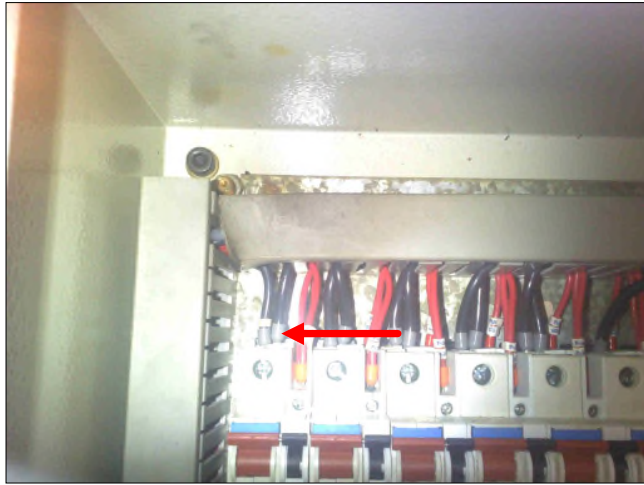
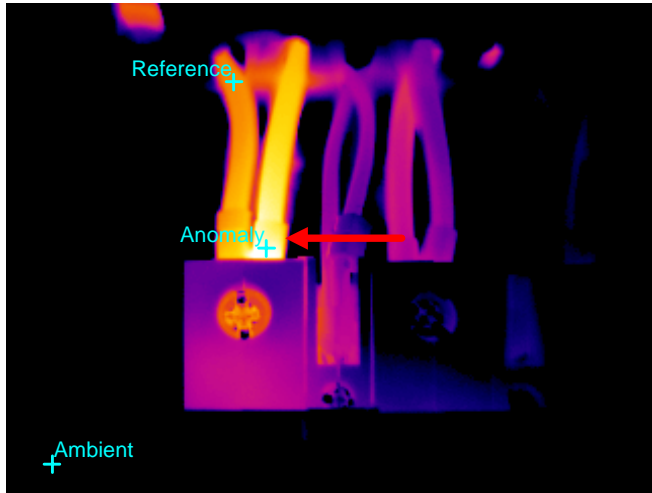
<b>Area</b>	DB-2-2-8-4	
<b>Equipment</b>	Top Left Trip	
<b>Item</b>	Top Connection

**Additional Information:**  
Strip connection.

Label	Value
Anomaly	80.6°C
Reference	63.2°C
Ambient	37.6°C

There is localised temperature increase / high resistive connection at the top left connection of top left trip, this is probably due to a loose, corroded or sub-standard electrical contact.

Isolate supply, disassemble components, clean, inspect for damage and replace where necessary. Reassemble; tighten to the correct torque ensuring security of connections and electrical integrity of the circuit.

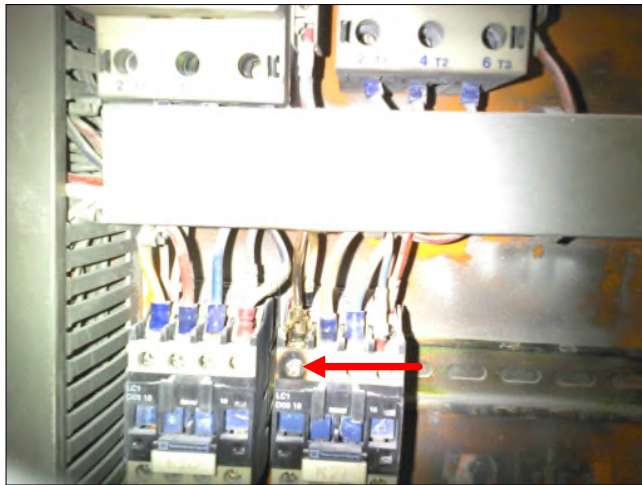
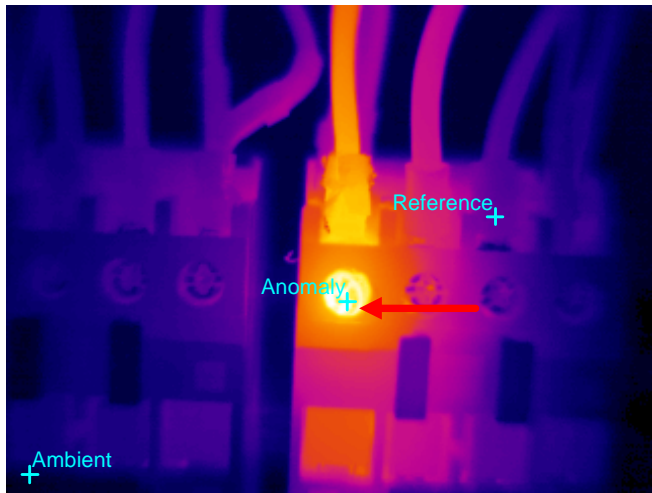
<b>Area</b>	Return Panel 2A
<b>Equipment</b>	K21
<b>Item</b>	Top Left Connection

**Additional Information:**  
 STOP MACHINE FIRE HAZZARD - REPORTED ON DAY

Label	Value
Anomaly	307.3°C
Reference	46.5°C
Ambient	30.4°C

There is localised temperature increase / high resistive connection at the top left connection of K21, this is probably due to a loose, corroded or sub-standard electrical contact.

This was reported on the day as a fire risk at 307 Degrees Celsius and visual signs of burning.

Isolate supply, disassemble components, clean, inspect for damage and replace where necessary. Reassemble; tighten to the correct torque ensuring security of connections and electrical integrity of the circuit.

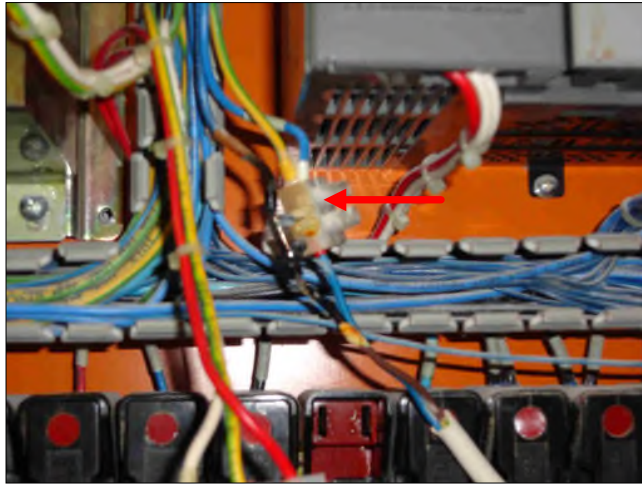
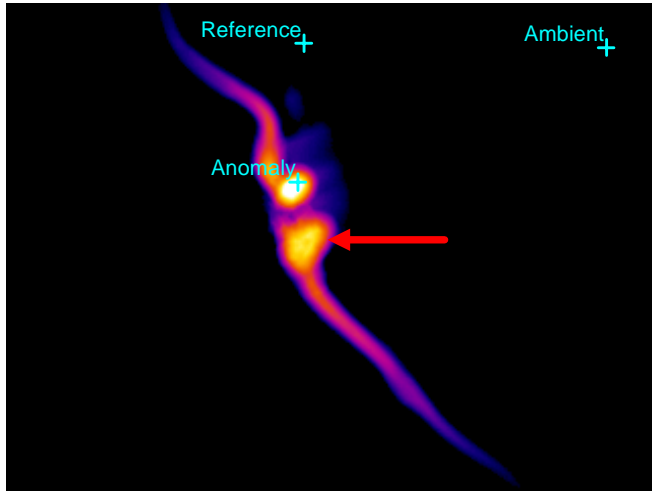
<b>Area</b>	CP-1-1-1 Extraction Fans
<b>Equipment</b>	Connection Block
<b>Item</b>	Connection

**Additional Information:**  
 Shut machine down ASAP due to visual signs of smoke at connection.

Label	Value
Anomaly	219°C
Reference	45°C
Ambient	33°C

This was reported on the day due to high temperature of over 219 degrees Celsius and visual signs of smoke.

Replace cables.

Isolate supply, disassemble components, clean, inspect for damage and replace where necessary. Reassemble; tighten to the correct torque ensuring security of connections and electrical integrity of the circuit.
