Re: JPS Reliability: Infrared Thermography Report

*Customer name - Site*  
**Thermographic Survey Check List**

## JPS Reliability Services Thermographic Survey For

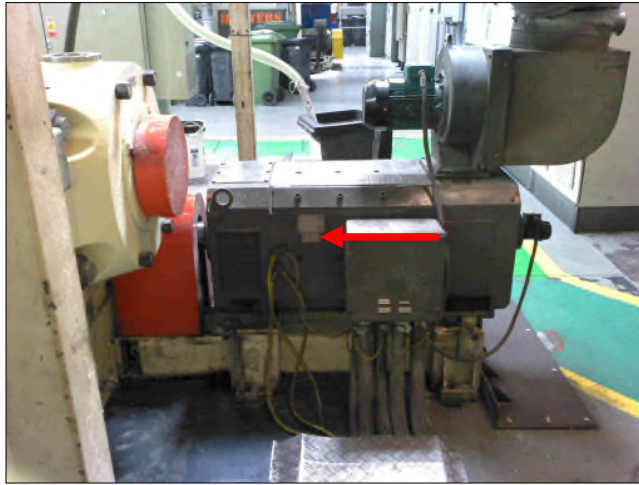
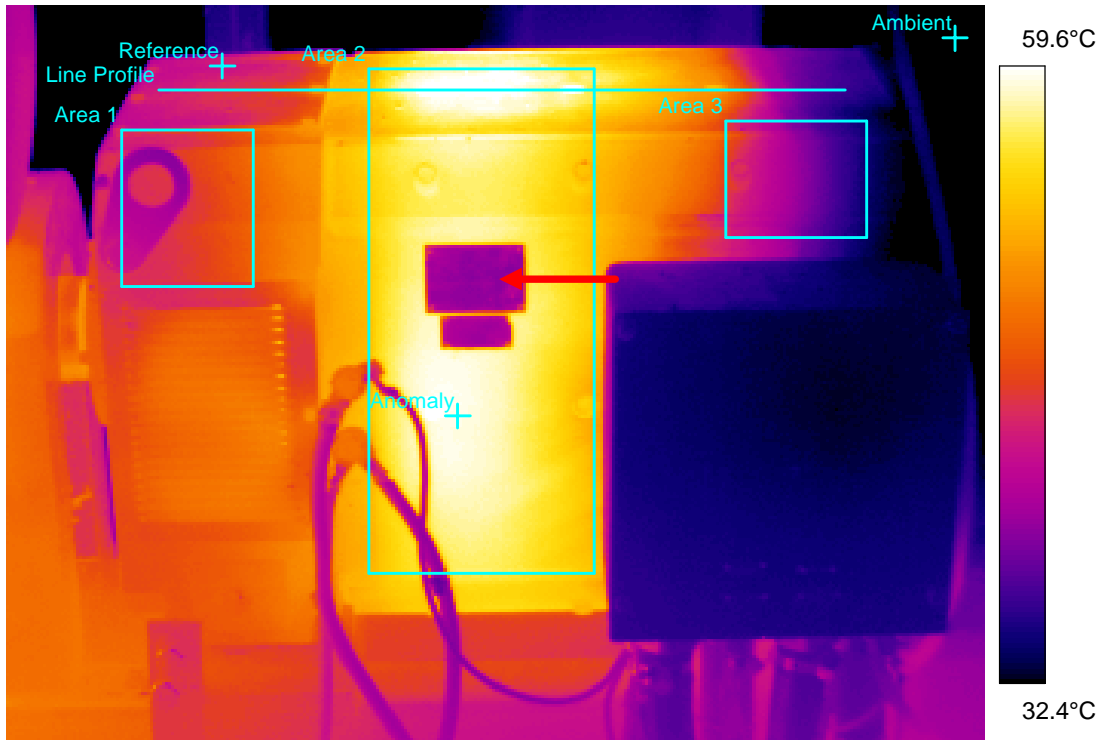
<b>Area</b>	Extruder Line A
<b>Equipment</b>	Main Drive
<b>Item</b>	DC Motor

Additional Information:  
150mm production run.

Label	Value
Anomaly	58.9°C
Reference	43.4°C
Ambient	30.7°C

For Trending.

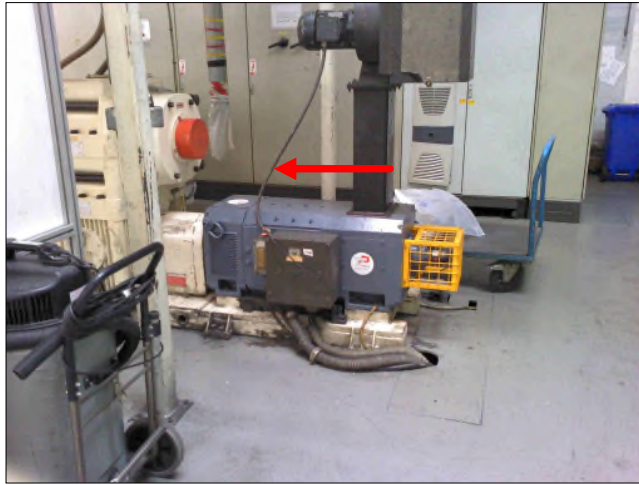
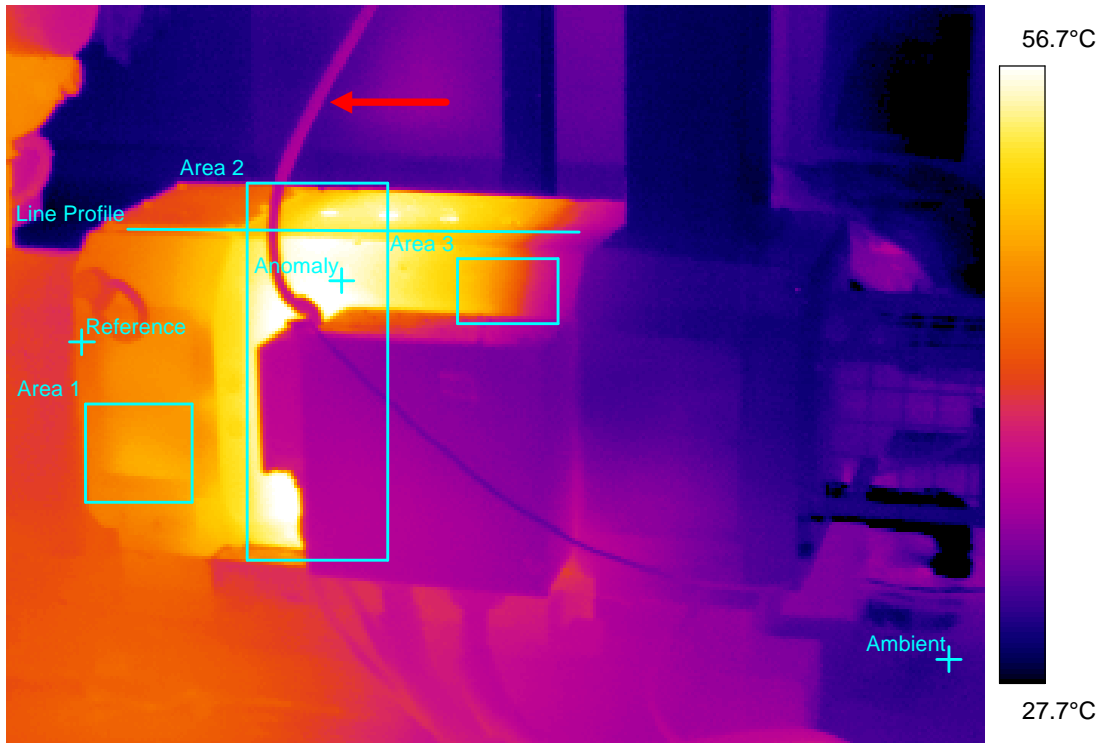
<b>Area</b>	Extruder Line B
<b>Equipment</b>	Main Drive
<b>Item</b>	DC Motor

Additional Information:  
120mm production run.

Label	Value
Anomaly	55.8°C
Reference	38.6°C
Ambient	29.4°C

For trending.

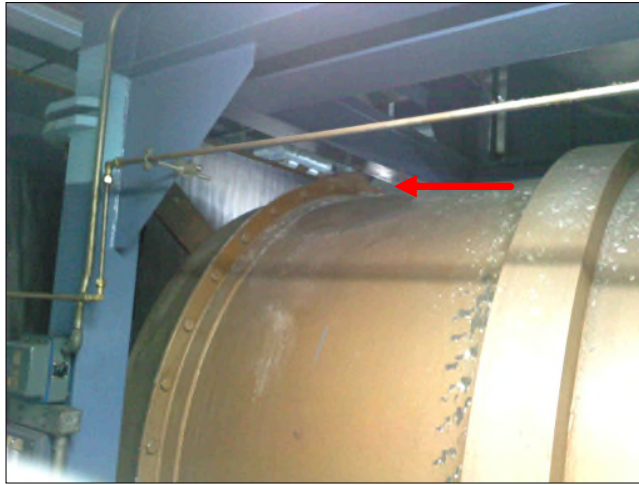
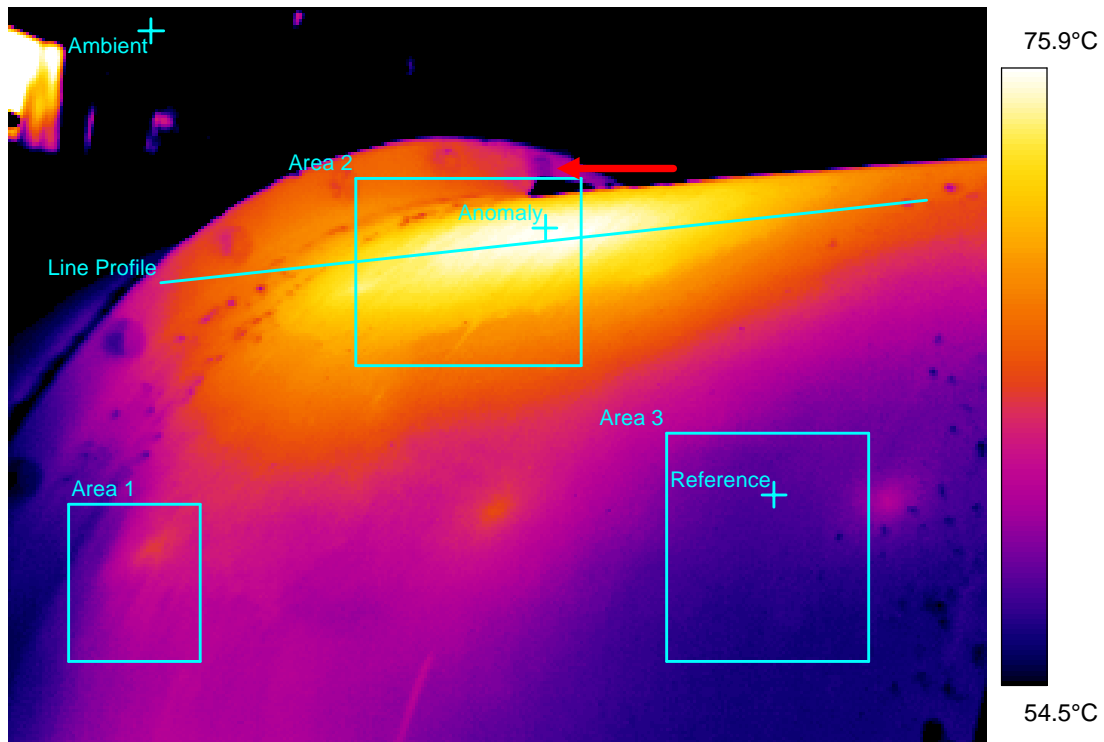
<b>Area</b>	Boiler Room
<b>Equipment</b>	External Lagging
<b>Item</b>	Top Left Area

Additional Information:  
Loss of energy.

Label	Value
Anomaly	74.7°C
Reference	57.6°C
Ambient	29.0°C

At next shut replace section of insulation.

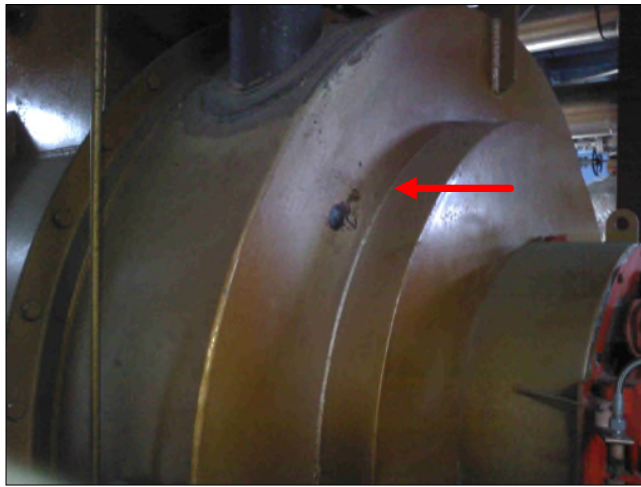
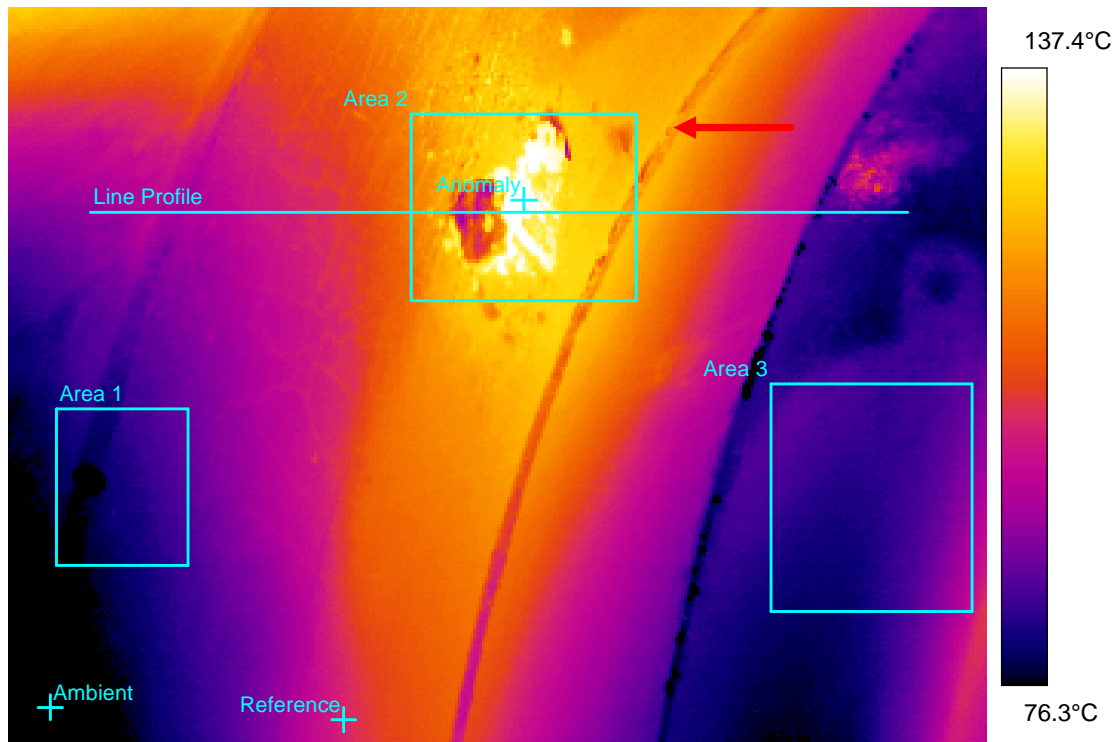
<b>Area</b>	Boiler Room
<b>Equipment</b>	Eternal Lagging
<b>Item</b>	Inlet Left Side

Additional Information:  
Loss of energy.

Label	Value
Anomaly	143.3°C
Reference	93.4°C
Ambient	73.4°C

At next shut replace section of insulation.

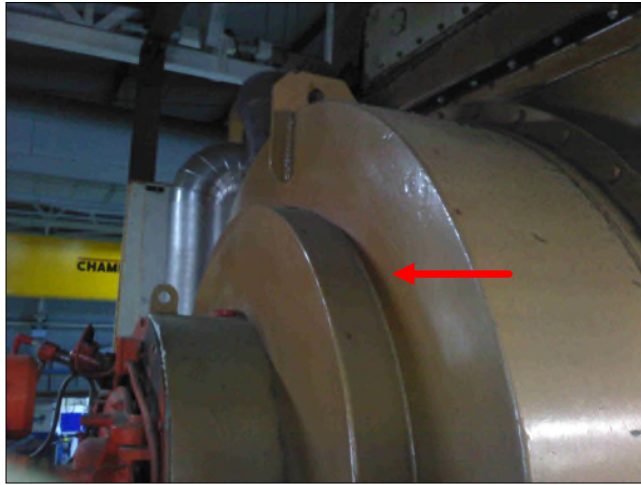
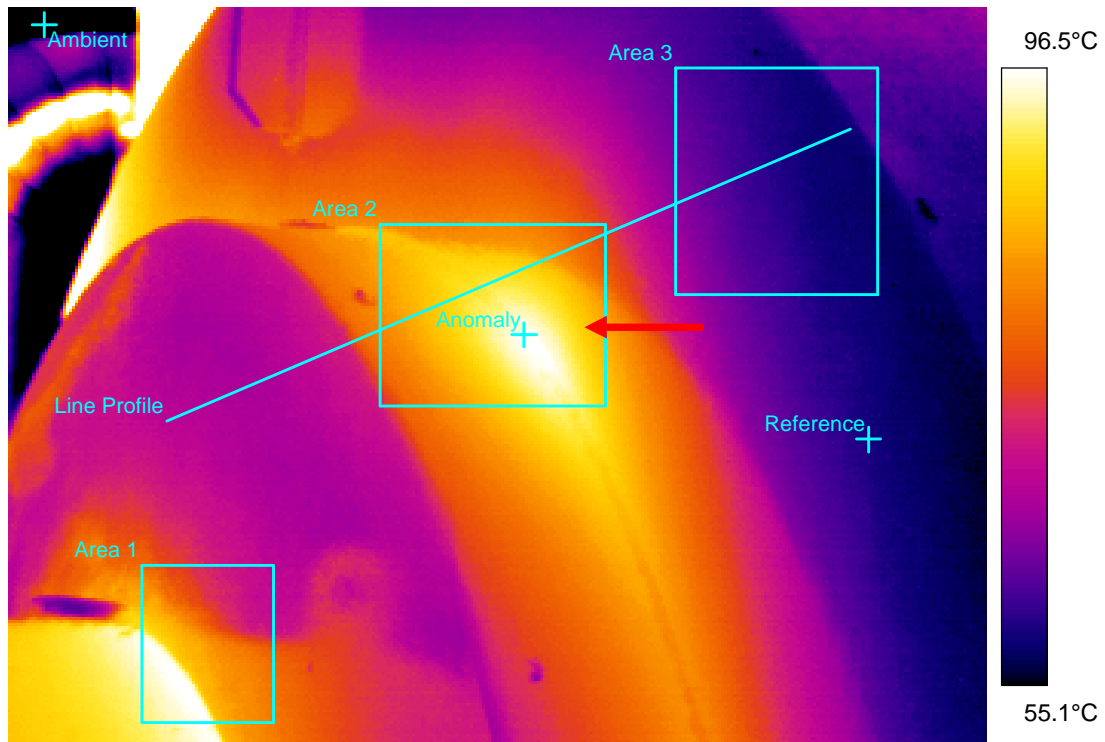
<b>Area</b>	Boiler Room
<b>Equipment</b>	Eternal Lagging
<b>Item</b>	Inlet Right Side

Additional Information:  
Loss of energy.

Label	Value
Anomaly	95.2°C
Reference	58.6°C
Ambient	34.0°C

At next shut replace section of insulation.

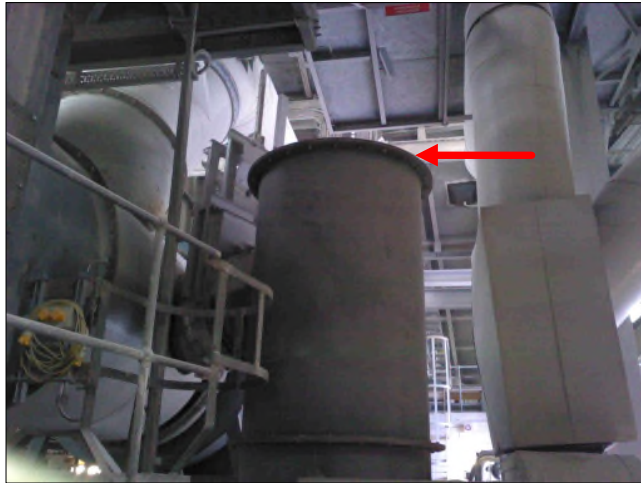
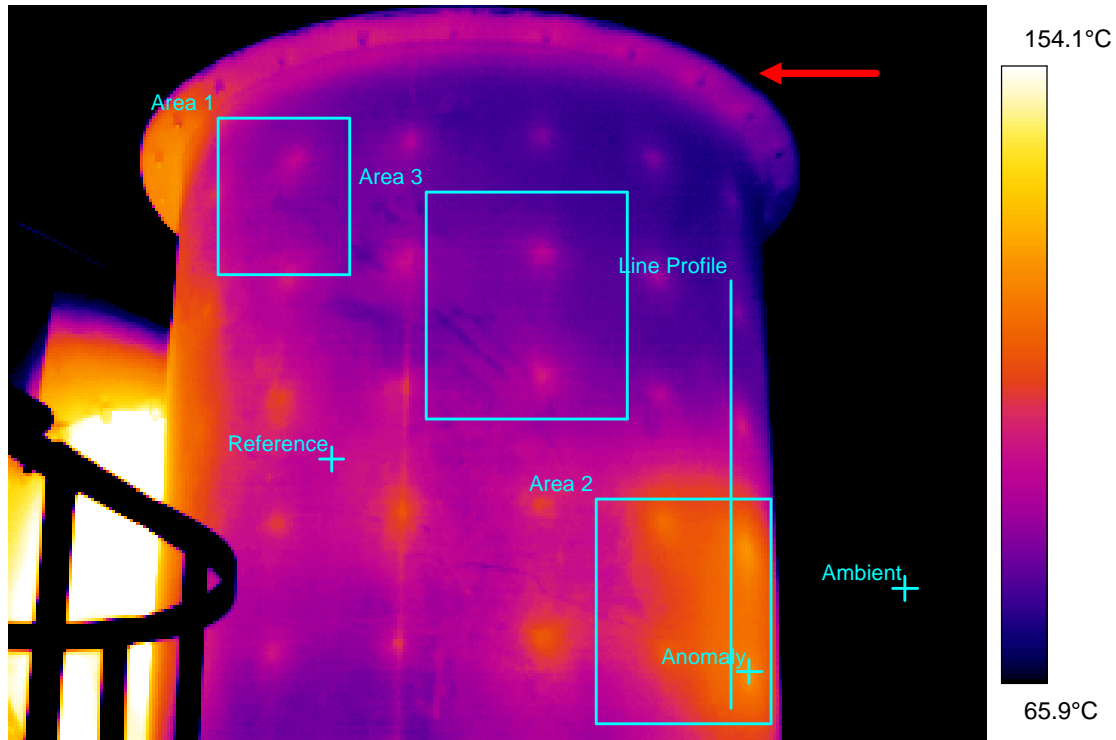
Area	Vessel
Equipment	Vessel
Item	Refractory Condition

Label	Value
Anomaly	103.0°C
Reference	84.0°C
Ambient	28.5°C

Loss of energy and safety potential hazard, closely trend the deterioration of the internal refractory.

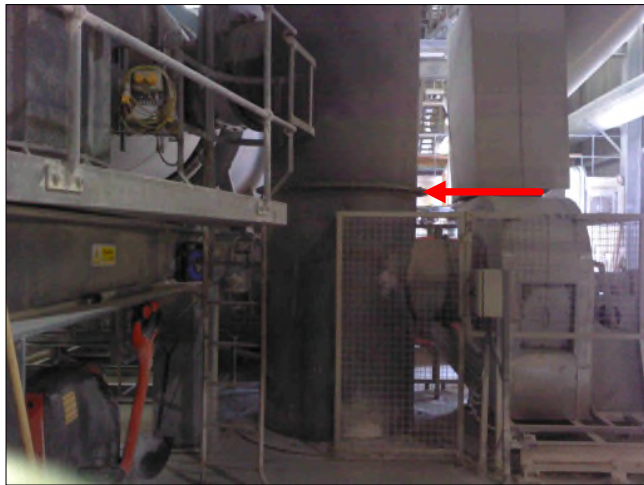
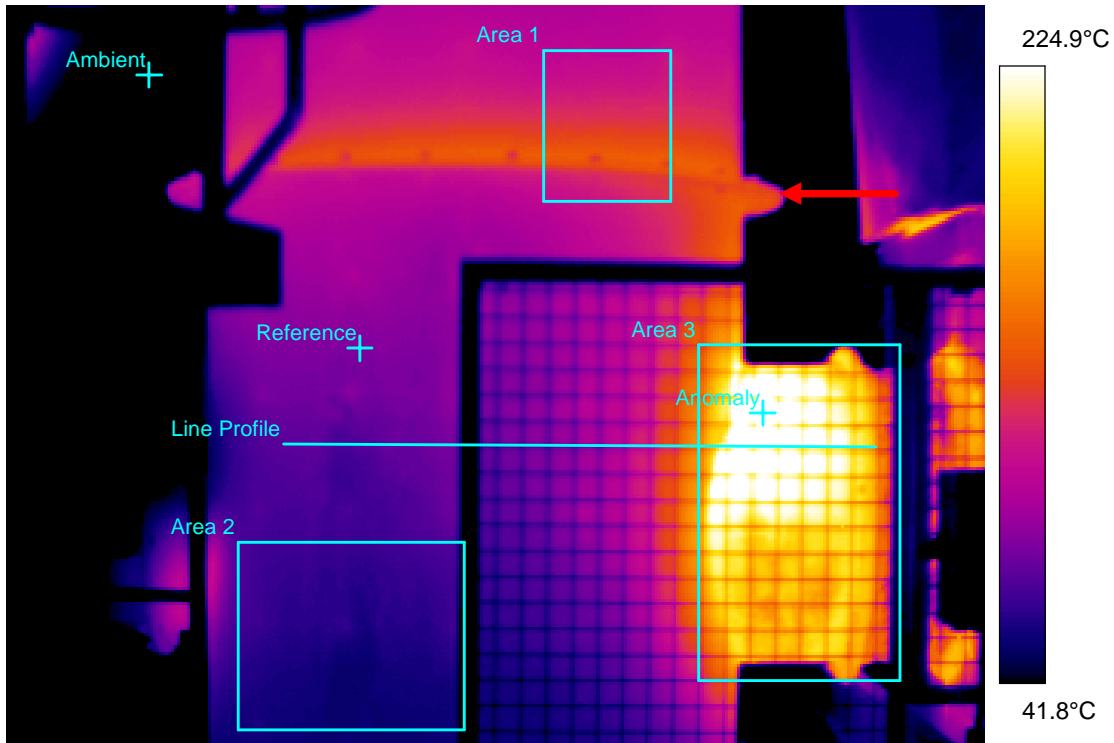
<b>Area</b>	Vessel
<b>Equipment</b>	Inlet Fan
<b>Item</b>	Inlet Ducting Insulation

**Additional Information:**  
Safety risk.

Label	Value
Anomaly	264.5°C
Reference	69.8°C
Ambient	29.4°C

There are two areas of concern, the first is the inlet fan ducting to the vessel (Area 3) and the other is the ring of refractory just above the flanged section (Area 1).

Make a safe area around the vessel and repair refractory at the soonest opportunity.

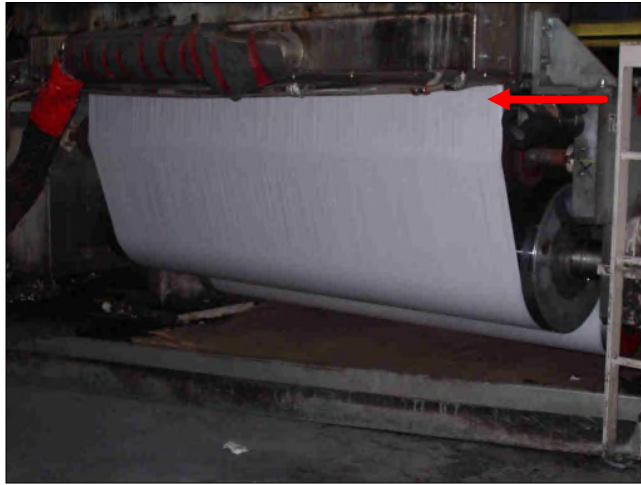
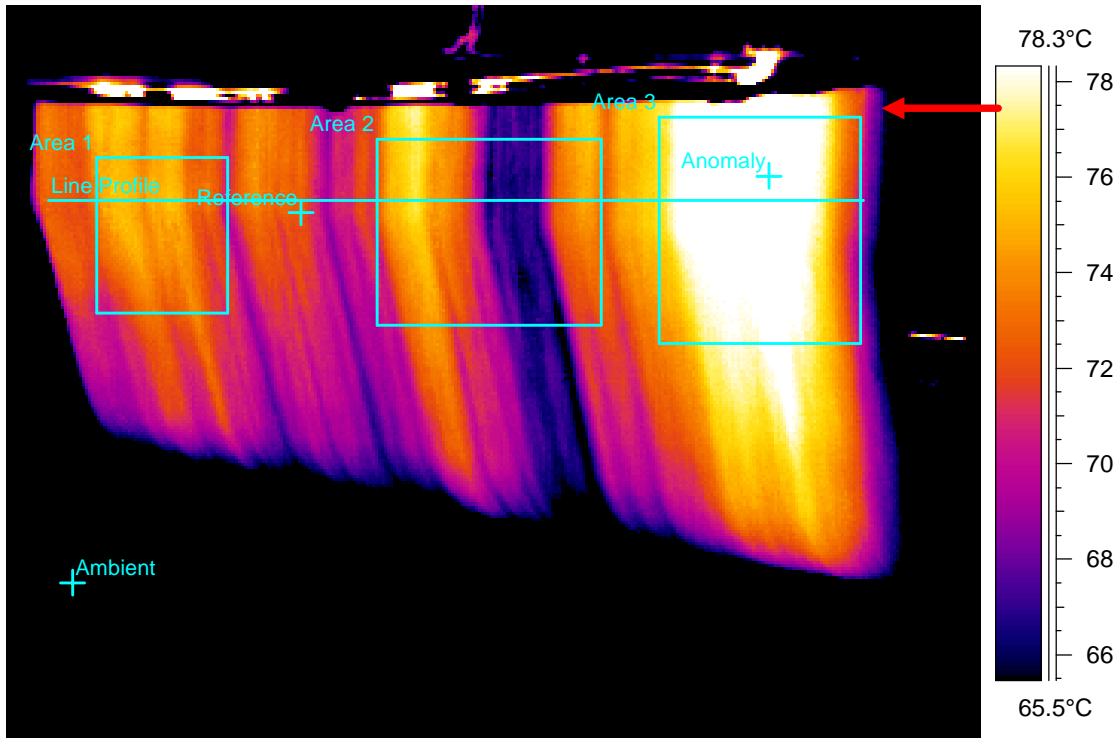
<b>Area</b>	Paper Line A
<b>Equipment</b>	Steam Box
<b>Item</b>	Outlet Steam Profile

Label	Value
Anomaly	81.9°C
Reference	72.3°C
Ambient	24.3°C

The above thermogram shows and unbalanced steam box where there is too much steam on the right side of the outlet.

Adjust steam valves to reduce and re-test.

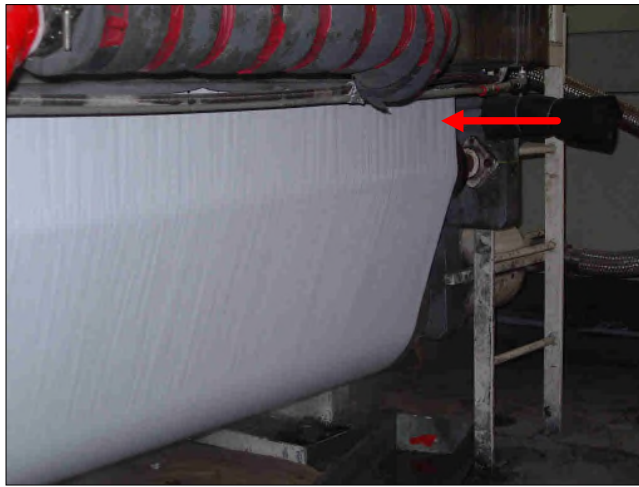
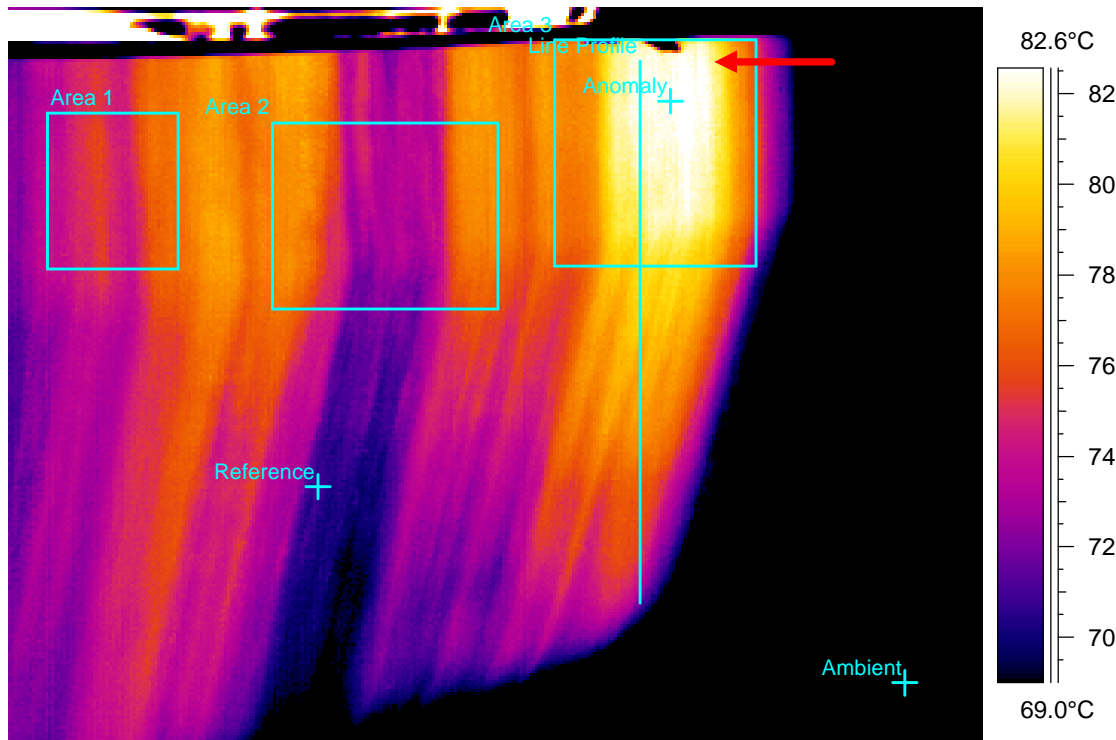
<b>Area</b>	Paper Line B
<b>Equipment</b>	Steam Box
<b>Item</b>	Outlet Steam Profile

Label	Value
Anomaly	82.6°C
Reference	70.9°C
Ambient	26.8°C

The above thermogram shows an unbalanced steam box where there is too much steam on the right side of the outlet.

Adjust steam valves to reduce and re-test.

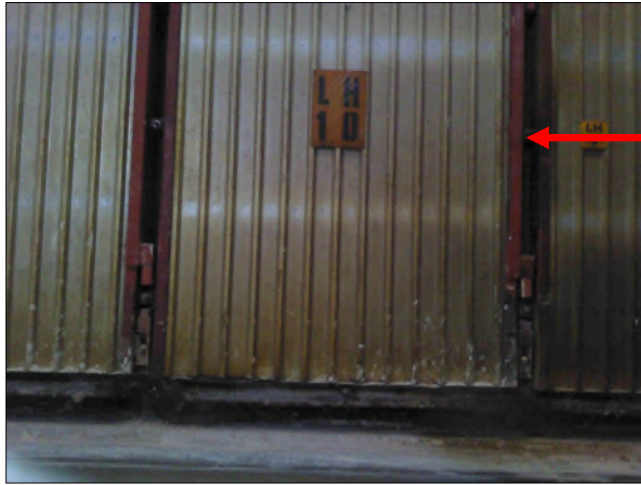
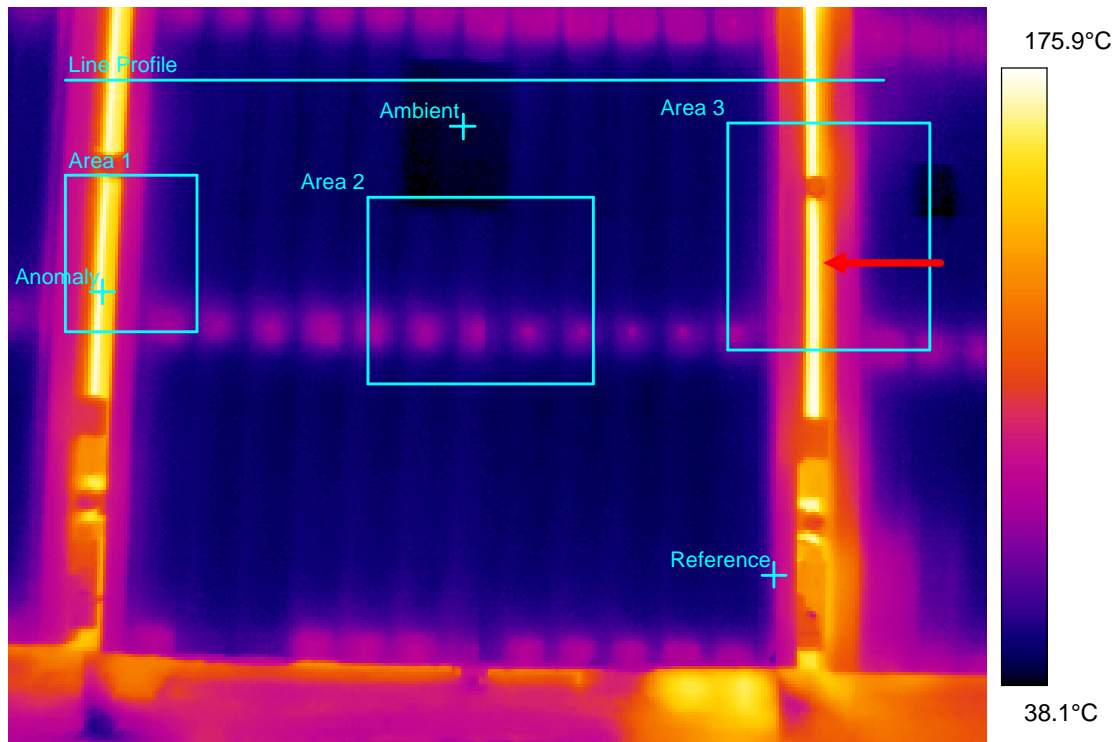
Area	Main Dryer
Equipment	Right Dryer Door Energy Loss
Item	Door Sealing

Label	Value
Anomaly	163.3°C
Reference	51.3°C
Ambient	39.2°C

This is an example of a heat loss survey using thermal imaging. The total energy loss is calculated from the thermal profile and used as a cost payback / justification on replacing the door seals.

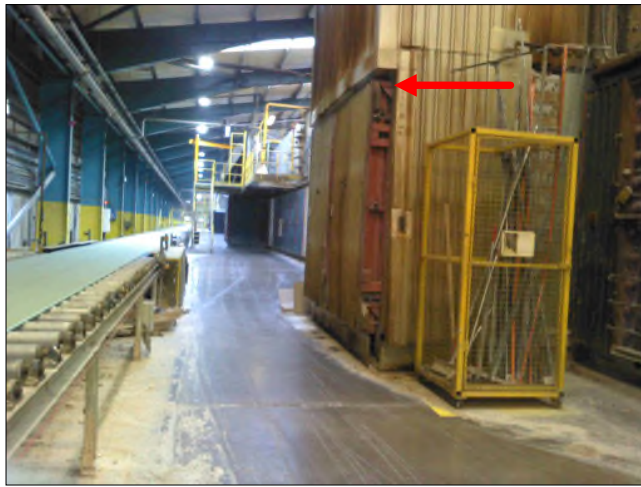
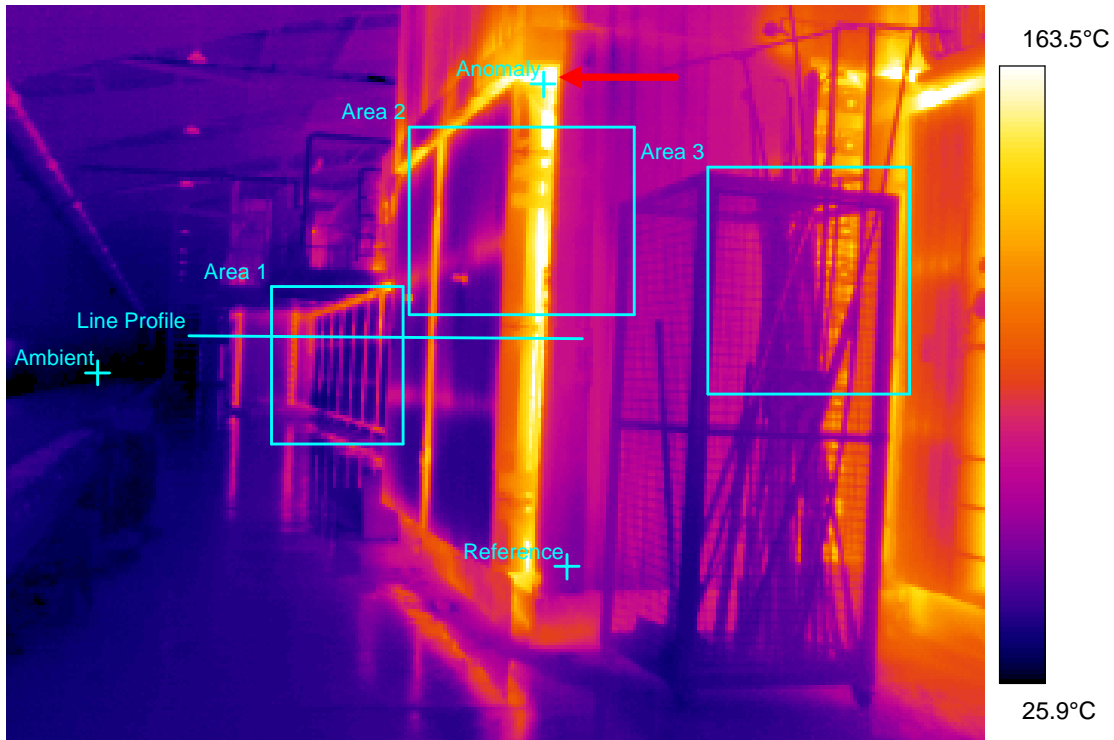
Area	Main Dryer
Equipment	Left Dryer Door Energy Loss
Item	Door Sealing

Label	Value
Anomaly	190.7°C
Reference	46.4°C
Ambient	25.6°C

This is an example of a heat loss survey using thermal imaging. The total energy loss is calculated from the thermal profile and used as a cost payback / justification on replacing the door seals.

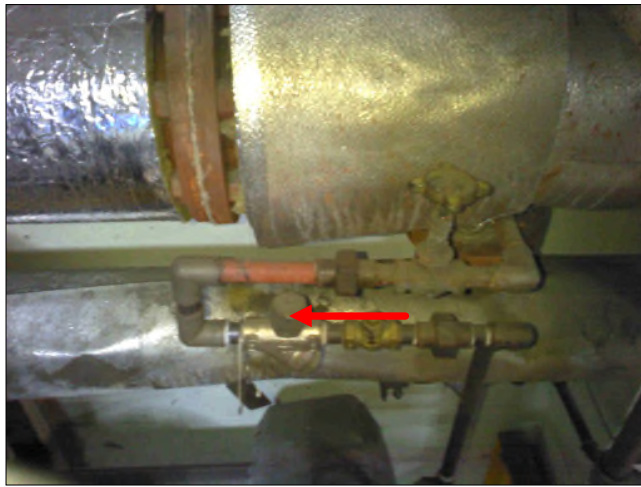
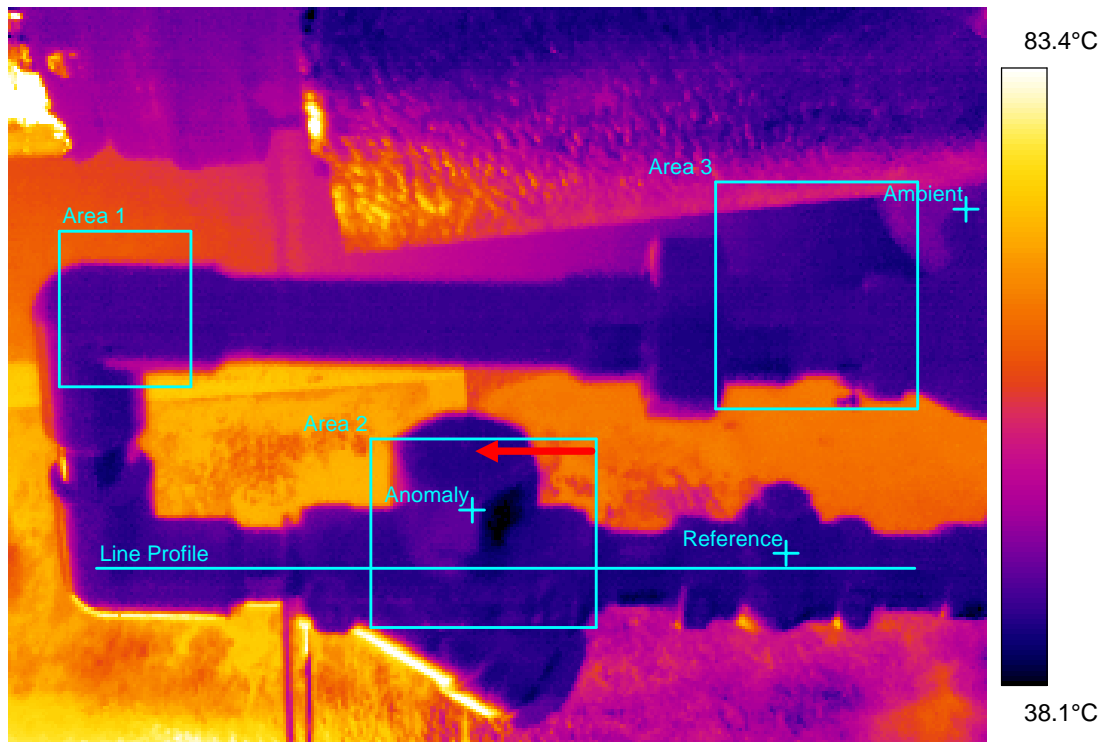
<b>Area</b>	Paper Line A
<b>Equipment</b>	Steam Line Left
<b>Item</b>	Steam Trap

Label	Value
Anomaly	43.0°C
Reference	40.3°C
Ambient	41.9°C

This shows the steam trap has failed closed and the line is backed up with condensate, hence the low steam line temperature.

Additional Information:  
Steam Trap Failed Clsoe - Replace
