Re: JPS Reliability: Vibration Analysis Assessment Report

Pump Set 1

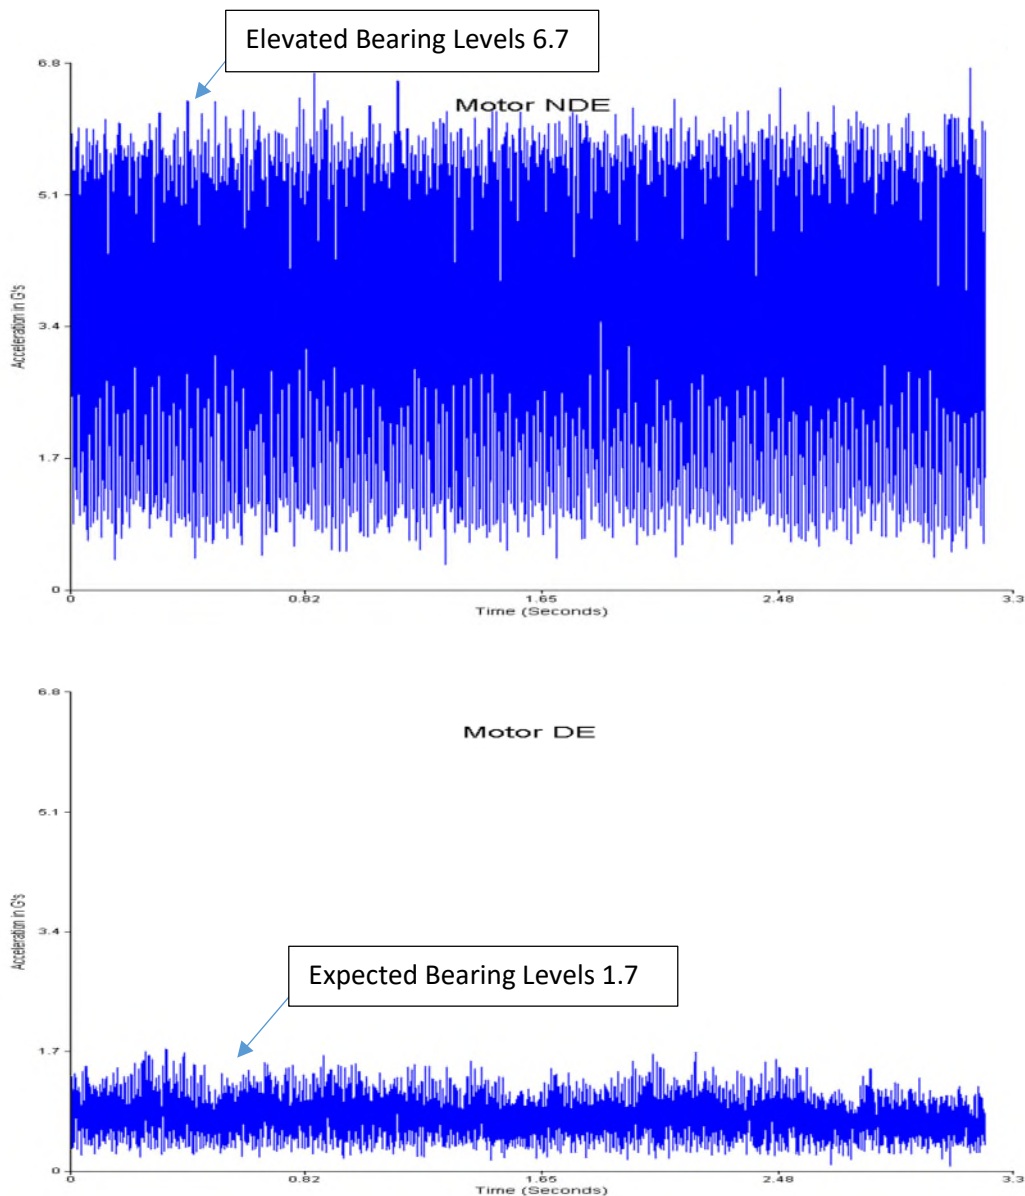
Fig 1:

- Pump Set 1: PeakVue Acceleration levels are elevated across the motor bearings (highest at the motor non-drive end), no bearing frequencies present (**See figure 1**). Increase greasing frequency at the motor bearings/fit auto greasers.

The motor non-drive end (NDE) is running with elevated PeakVue acceleration levels and there is an electrical signature from the drive in the data.

Figure 1 compares the PeakVue time waveforms at the motor drive end and non-drive end. From the time waveforms below, you can see the non-drive end is running with higher stress levels.

Increase greasing frequency/install automatic greasers.

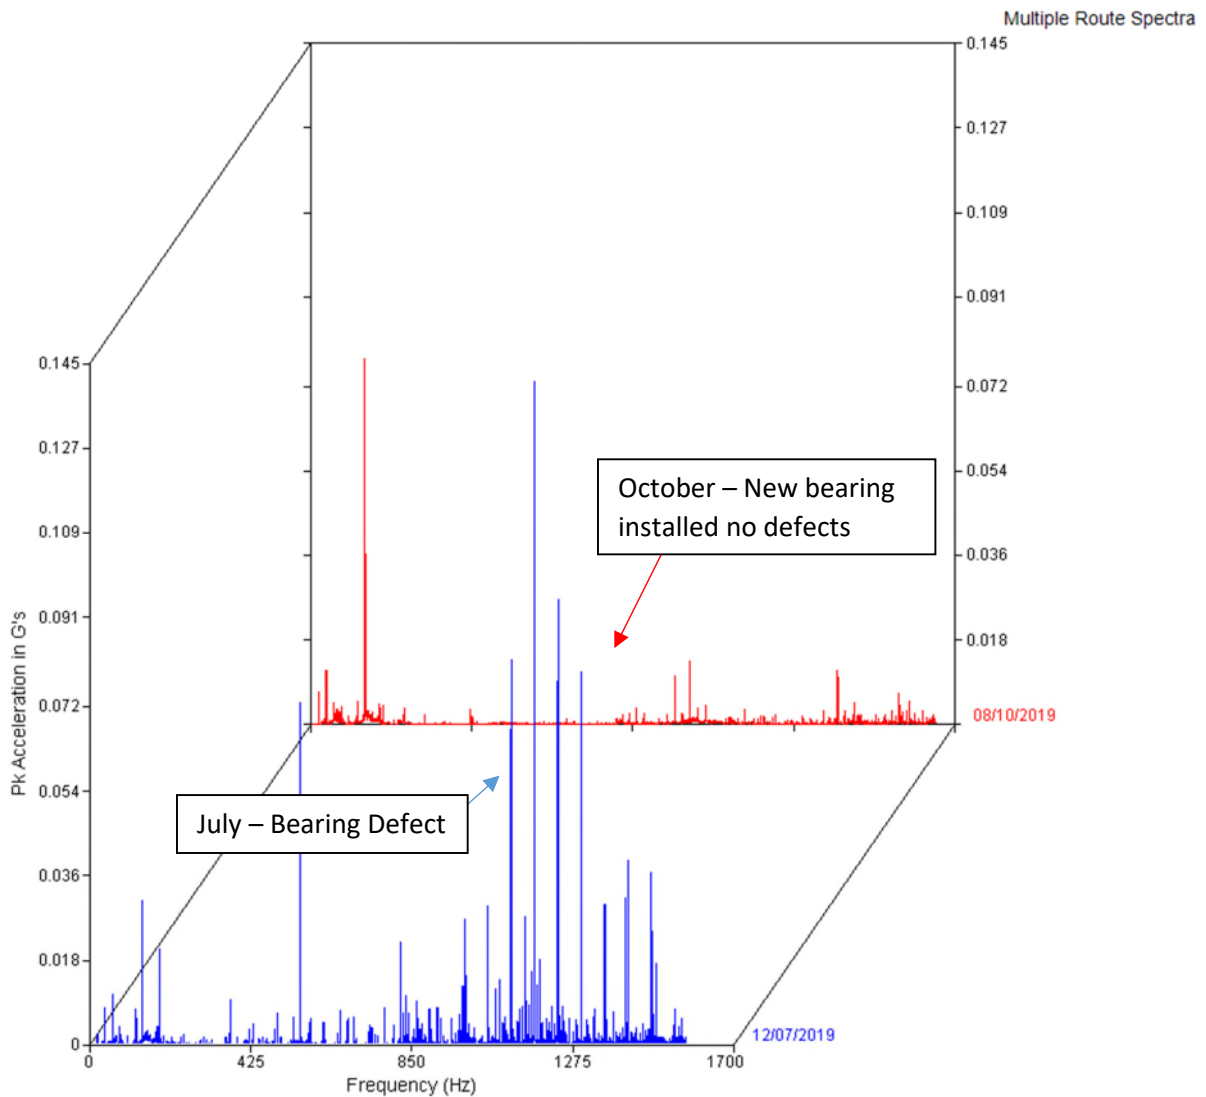
Fig 2:

- Pump set 2: The motor has been overhauled and there are no bearing frequencies in the data (**See figure 2**). Electrical drive frequency throughout the data, increase greasing frequency at the motor bearings/fit auto greasers.

The motor has been overhauled and there are no bearing frequencies present in the data.

Figure 2 compares the Acceleration spectra for the last two surveys at the motor non-drive end. There is an electrical signature in the data and no match for an outer race frequency this survey.

Increase greasing frequency/install automatic greasers.

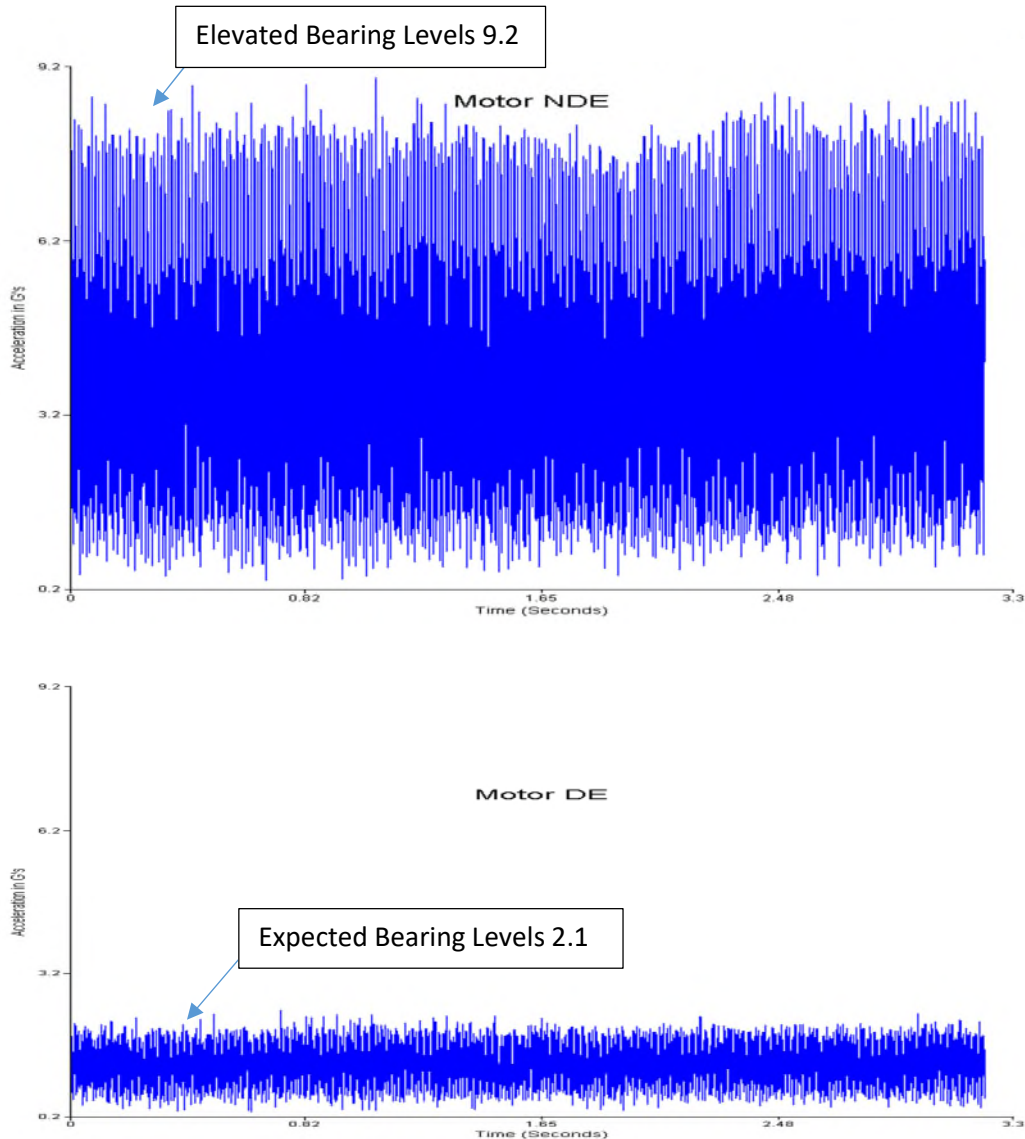
Fig 3:

- Pump Set 3: PeakVue Acceleration levels are elevated across the motor bearings (highest at the motor non-drive end), no bearing frequencies present (**See figure 3**). Increase greasing frequency at the motor bearings/fit auto greasers. Cavitation present at the pump end when running pumps 2&3 together.

The motor non-drive end is running with elevated PeakVue acceleration levels and there is an electrical signature from the drive in the data.

Figure 3 compares the PeakVue time waveforms at the motor drive end and non-drive end. From the time waveforms below, you can see the non-drive end is running with higher stress levels.

Increase greasing frequency/install automatic greasers.
