Re: JPS Reliability: Precision On-Site Fan Balancing Report

I would firstly like to thank you for the courtesy and co-operation shown to JPS Reliability Limited during my recent site visit. Following the survey at your facility I have pleasure in presenting for your attention a comprehensive Precision Fan Balancing and Vibration Analysis report on the Kiln Fan 1.

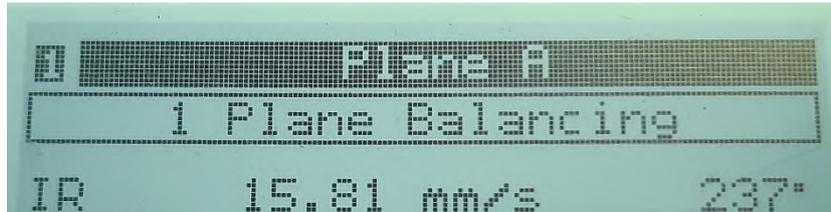
The initial vibration level was extreme at **44.82mm/s RMS**, after the clip on weights were removed, the fan brushed down and the base frame retaining bolts were secure the vibration reduced to **15.81mm/s RMS @237°**, this is due to imbalance of the fan.

As per ISO 10816-3 this is deemed **'Vibration causing damage'**

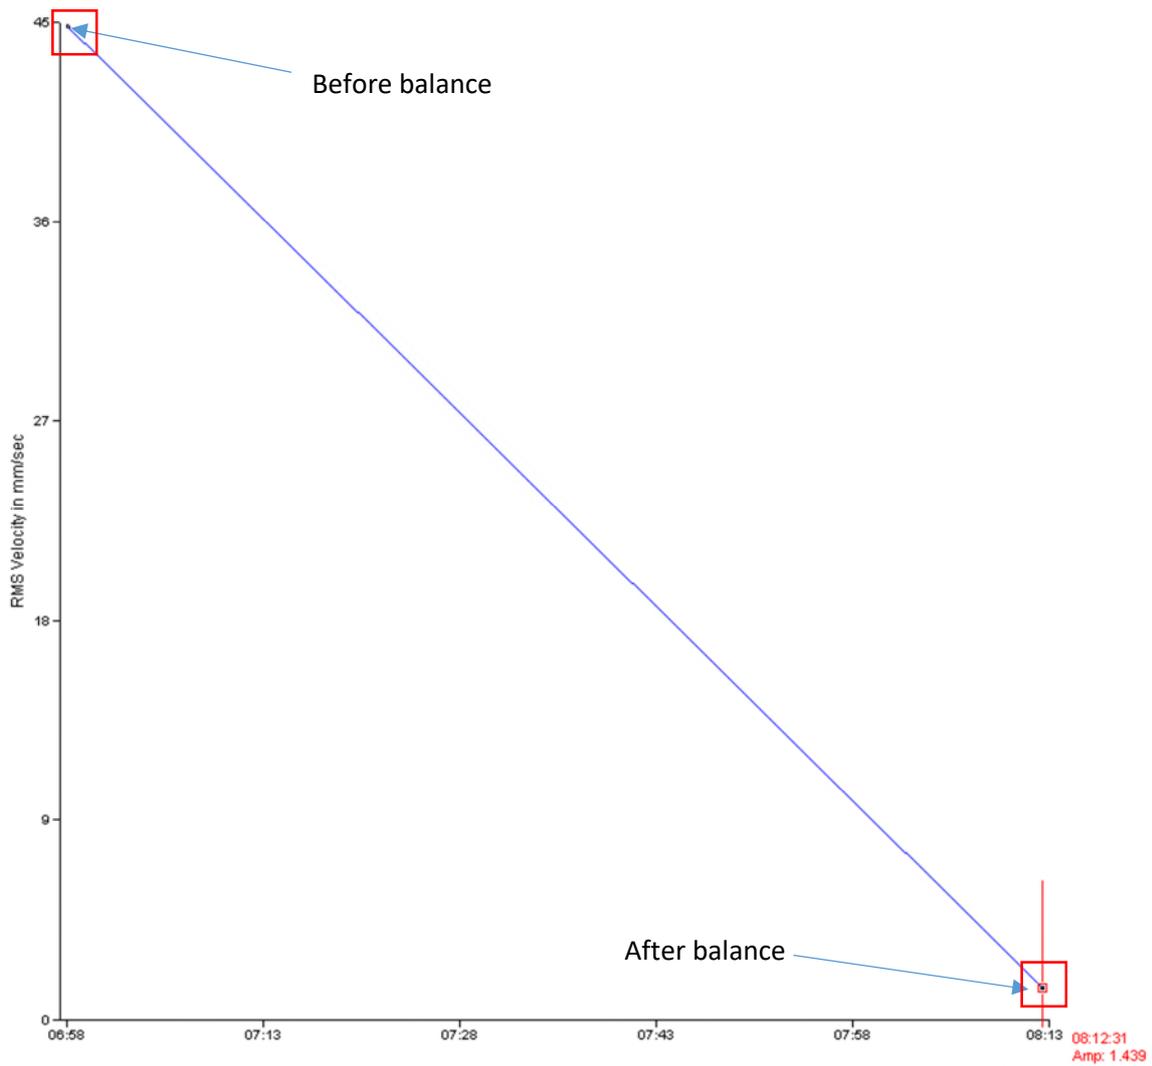
*Fig 1:*

Figure 1 is the overall velocity vibration trend from the fan drive end (DE) bearing in the Vertical direction.

The initial overall vibration level was 44.82 mm/s RMS, after precision balance reduced to 1.439 mm/s RMS.

Now the levels are deemed **'newly commissioned machines'**.

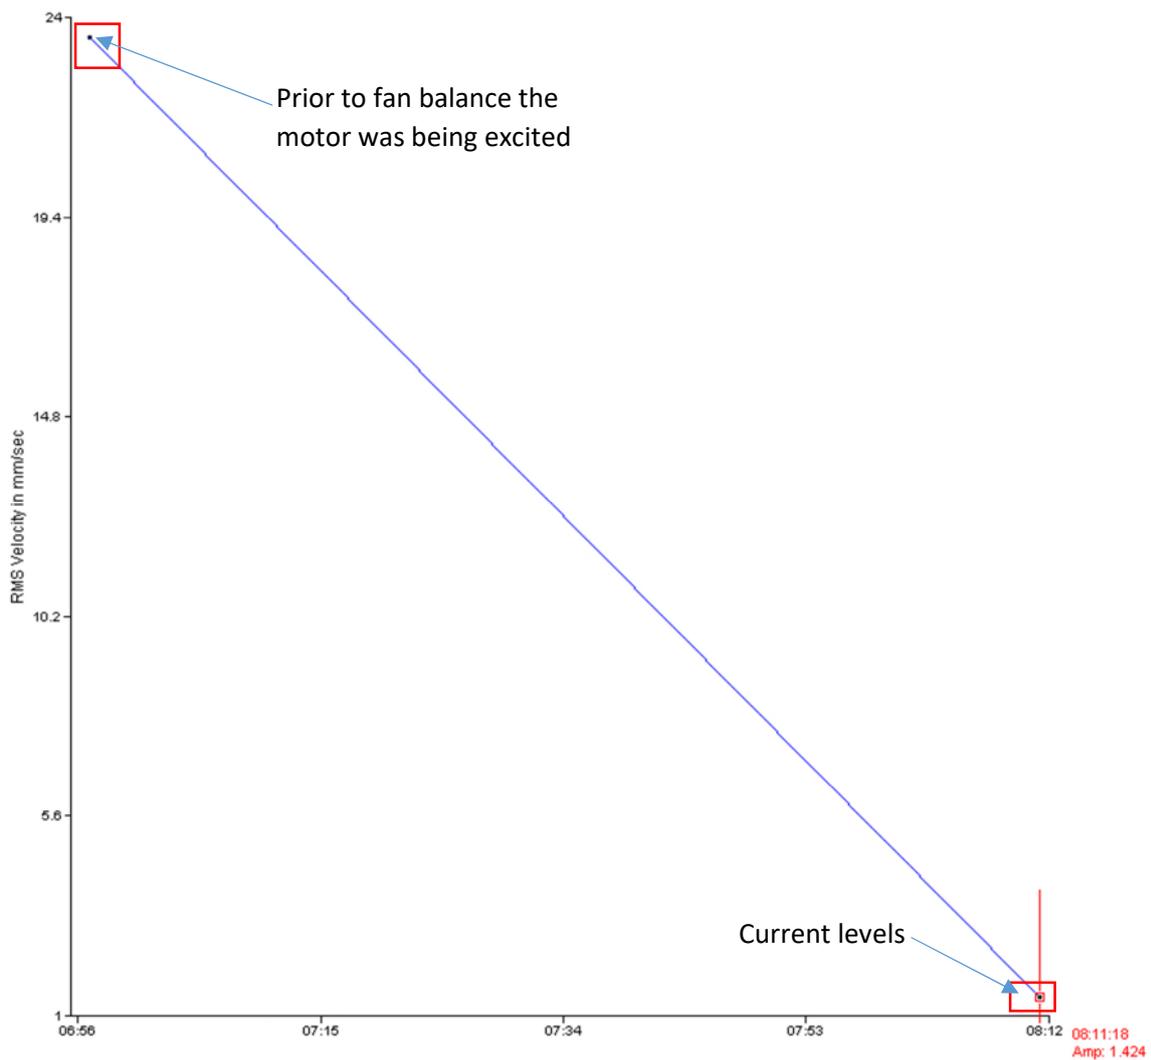
Fig 2:

Figure 2 is the overall velocity vibration trend from the motor drive end (DE) in the Vertical direction.

The motor was being excited by the fan vibration to **damaging levels** at 23.56/ mm/s RMS, and after the fan was precision balance the motor was no longer being excited and had reduced to **'newly commissioned machines'** levels at 1.424 mm/s RMS.
