Example: Centrifuge Motor

As Found: Resistance Imbalance 3.08%

As Left: Resistance Imbalance Zero
Absolute Resistance dropped by 0.21 Ohms.

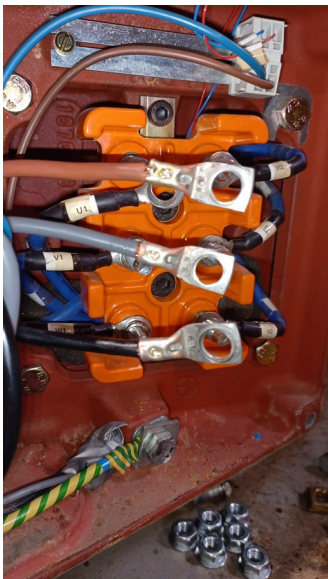
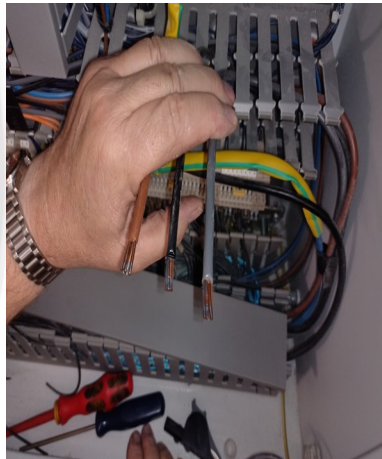
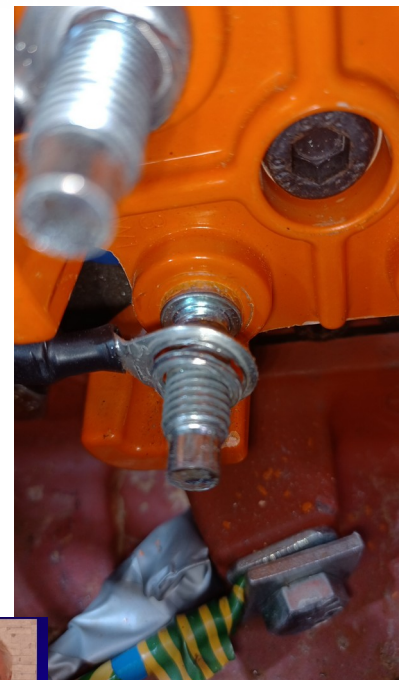
Findings: - Check for loose connections
- Recommend check at motor if tested from MCC

Defects Fixed: Lug size incorrect, Loose Connection at Motor, Loose connection at Drive (Burnt Cable), Lug extruded, Crimping High Resistance and Lug arrangement incorrect.
