# Returning Reliability & Energy Savings

Example: 230HX03P03REFINERYC IOLINGTOWERPUMP

37kW 63 Amp @ Full Load

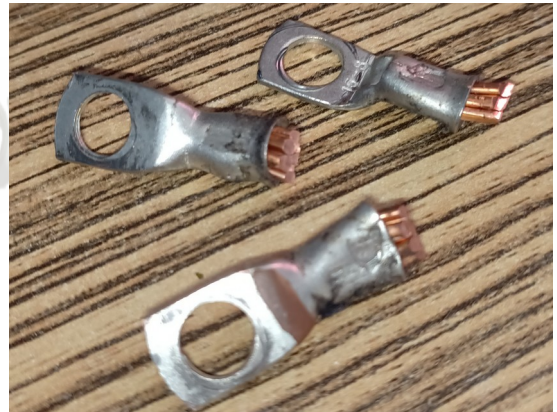
The lug selection is too large, 15-8 lug used on a 6mm Post. Bottom nuts loose and the crimp has not fully compressed. Insulation tape between lug faces.

Resistance after remedial work has dropped from 0.17 Ohms to 0.10 Ohms.

The I<sup>2</sup>R loss at full Load 277 Watts per termination.  
Estimated 60% loading equates to 498 Watts.

498 Watts @ 20p per kWhr estimated 8000 hours per year =  
**796 pounds per year.**
