Re: JPS Reliability: **Shaft Voltage Testing Report**

Date of survey:

- 14/04/2021

Executive Summary:

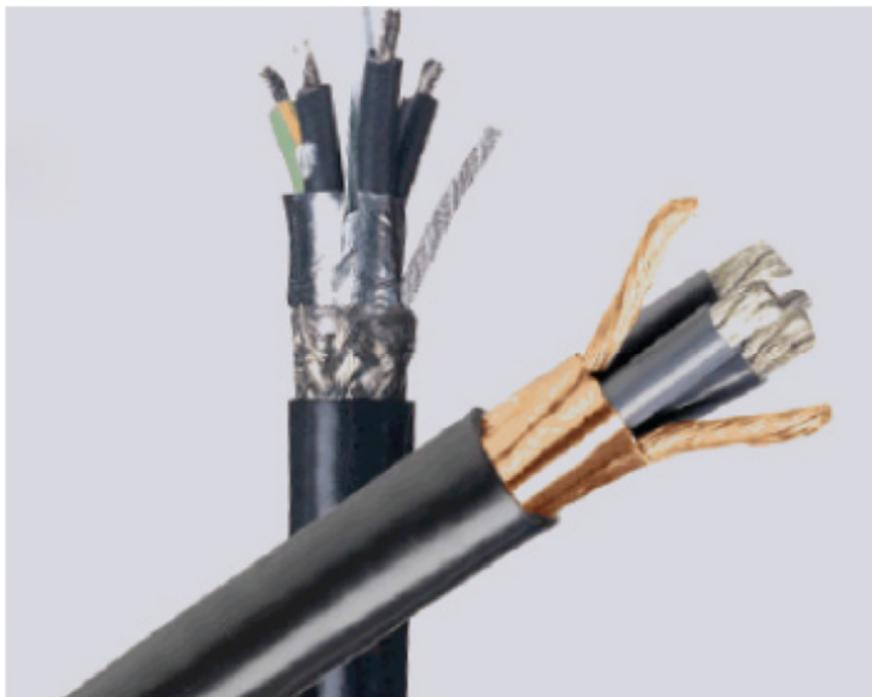
Example of VFD cabling

- Symmetrical multicore VFD motor cables. The earth connector arrangement in the motor cable must be symmetrical to avoid bearing currents at fundamental frequency. This is achieved by an earthing conductor surrounding all the phase leads or a cable that contains a symmetrical arrangement of three phase leads and three earth conductors.
- Short impedance path. The best and easiest way to do this is to use shielded motor cables, the shield must be continuous and of good conducting material and the connections at both ends needs to be made with 360° termination.
- Add high frequency bonding connections between the installation and known earthing reference points to equalise the potential of affected items use braided flat straps of copper 50-100mm wide.
- Fit an insulated bearing at the NDE

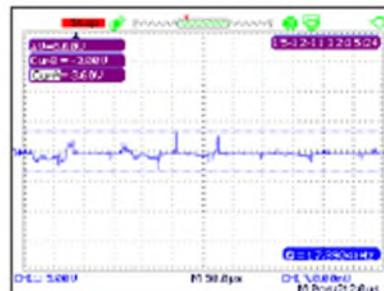
Low amplitude voltage discharge pattern –

Typically the voltages are 4 to 15 volts peak to peak (2 to 8 volts peak). The waveform image shows a more continuous discharge pattern with lower dv/dt frequencies. The lower voltage may be due to greater current flow in the bearings which is the result of the bearing lubrication becoming conductive or could be a function of the motor’s drive, speed, loading or other factors. As discharges occur in the bearings, the lubrication is contaminated with carbon and metal particles. The lower impedance to the shaft voltages results in lower peak to peak voltages. This condition is usually found in motors that have been in operation for many months or years.

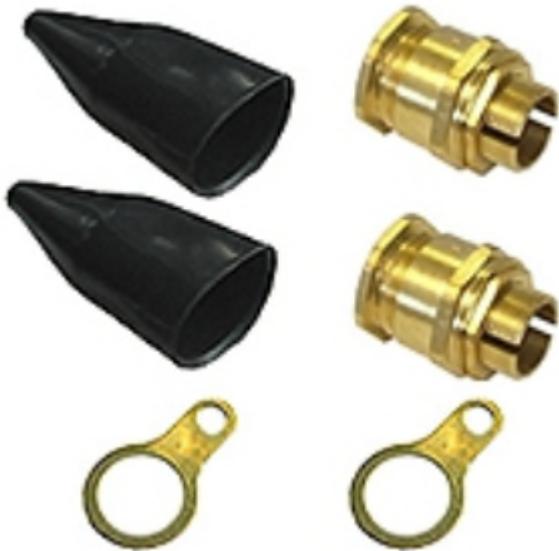
CXT SY Cable Glands.

This gland provides an environmental seal on the outer sheath and internal mechanical retention of wire braid that has been teased and placed into the slot running down the thread which is then held by the locknut.
