Bonus - Case Study #6

Dynamic Vibration Absorber

HISTORY & BACKGROUND

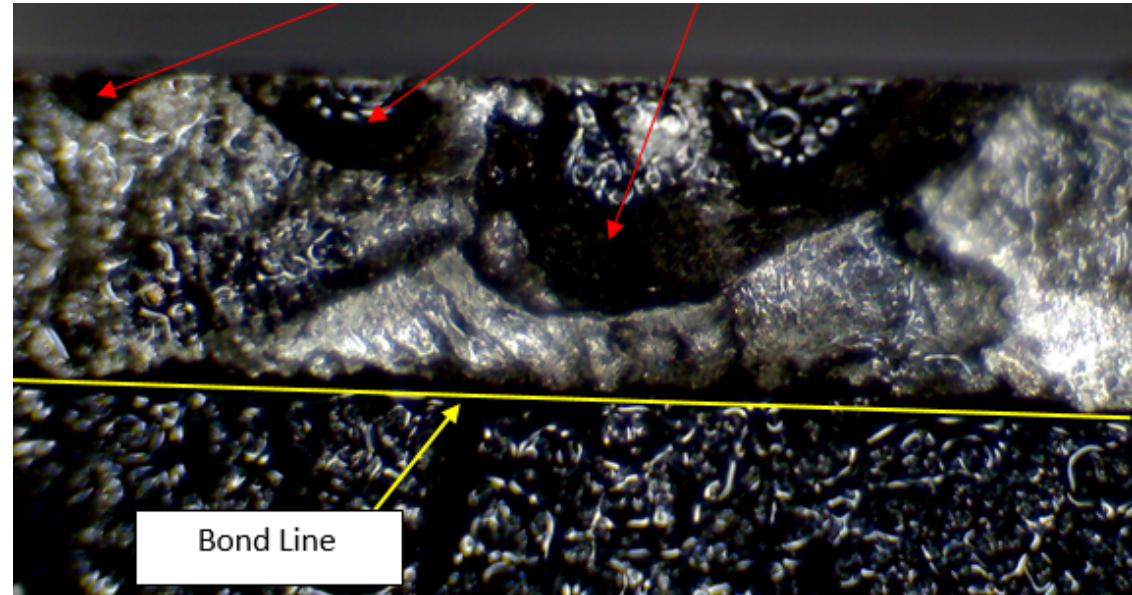
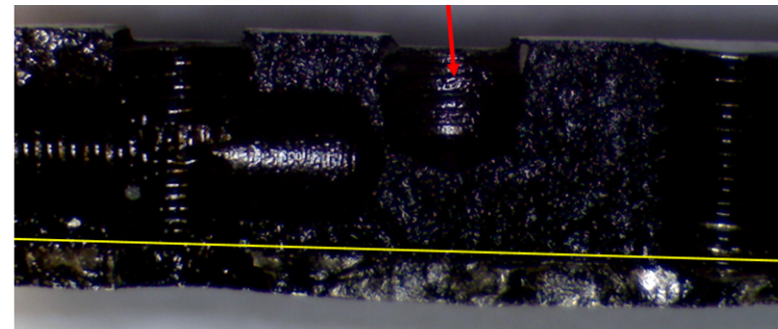
BEARING INSPECTION: TILTING PAD

- Microscopic cross sectional image of the cracked pad
- Bond line intact
- Failure is at the weakest point, the pivot point

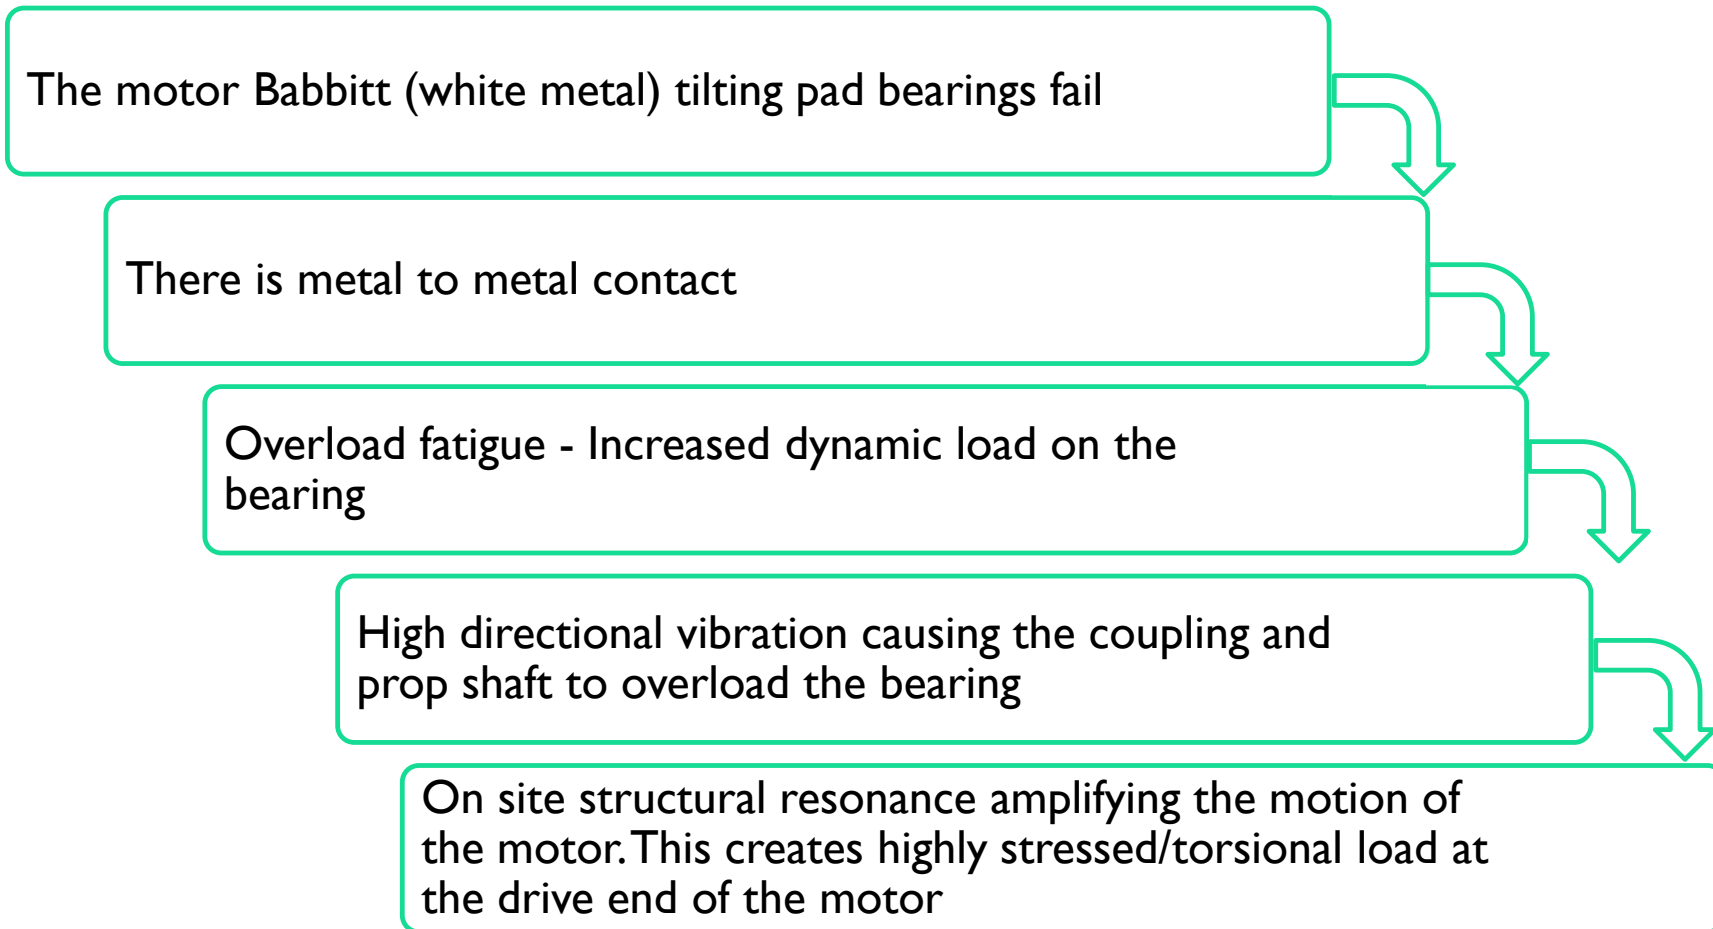
THE 'FIVE WHYS'

- There are no issues with the motor rebuild, the balance and dynamics of the motor when operated unloaded in the test bay, $>4\text{mm/s}$ RMS
- A structural resonance on site is causing an amplification of vibration levels
- This resonance increases the dynamic loads on the drive end bearing
- This then causes Babbitt fatigue, cracking, and Babbitt wiping due to rotor to stator contact

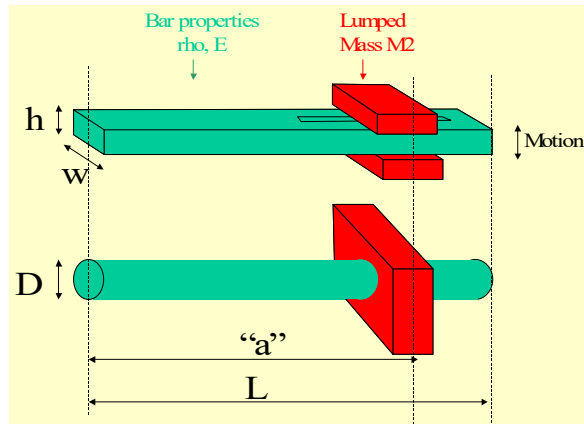
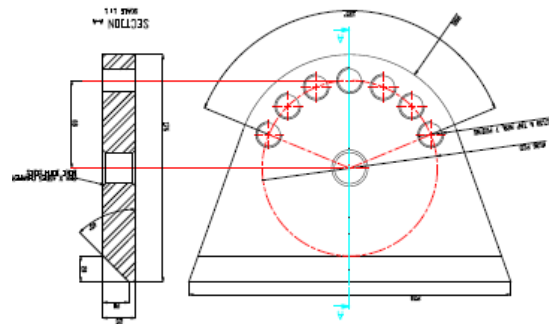
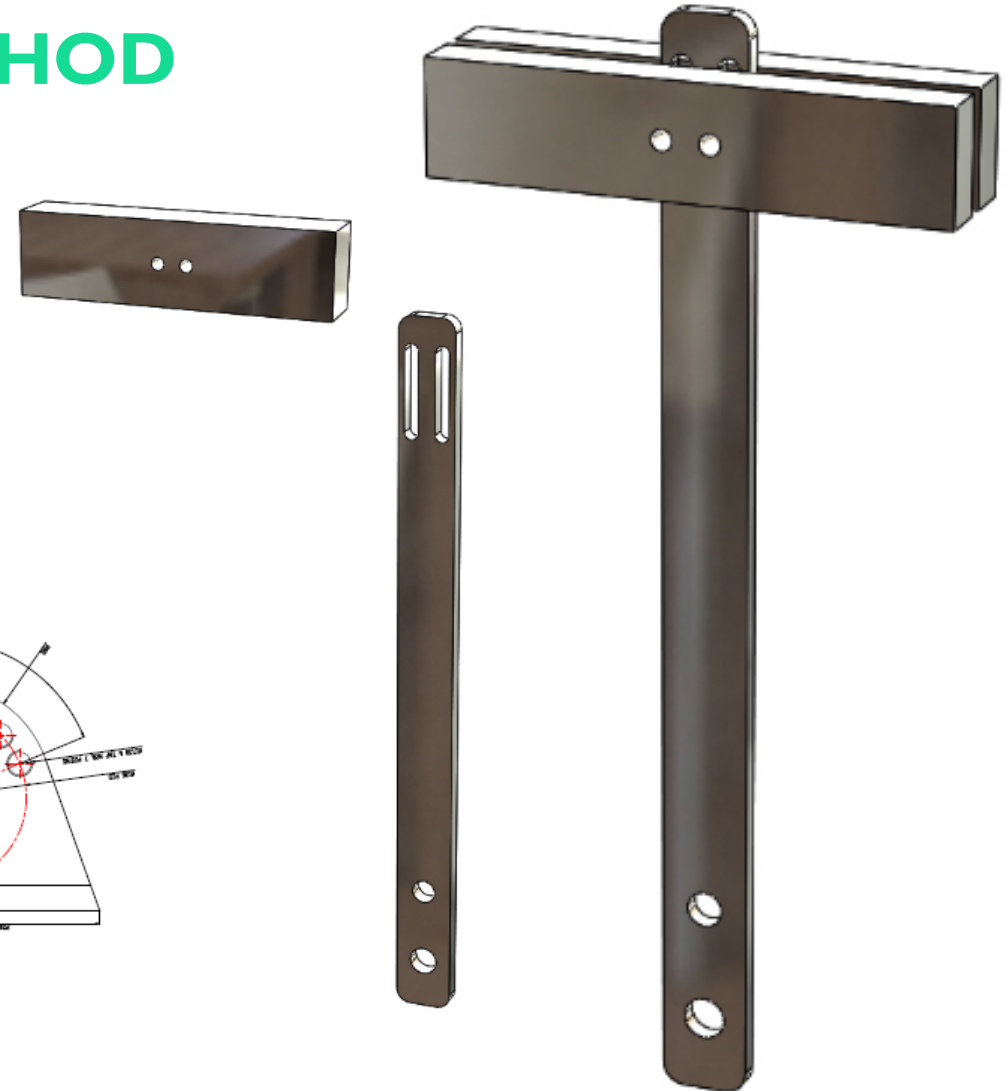
DVA DESIGN: DUNKERLY METHOD

- Bar Cross Section
- Length
- Free Distance to weight
- Bar diameter
- Bar width
- Bar height
- Density
- Young's Modulus
- Target resonant frequency

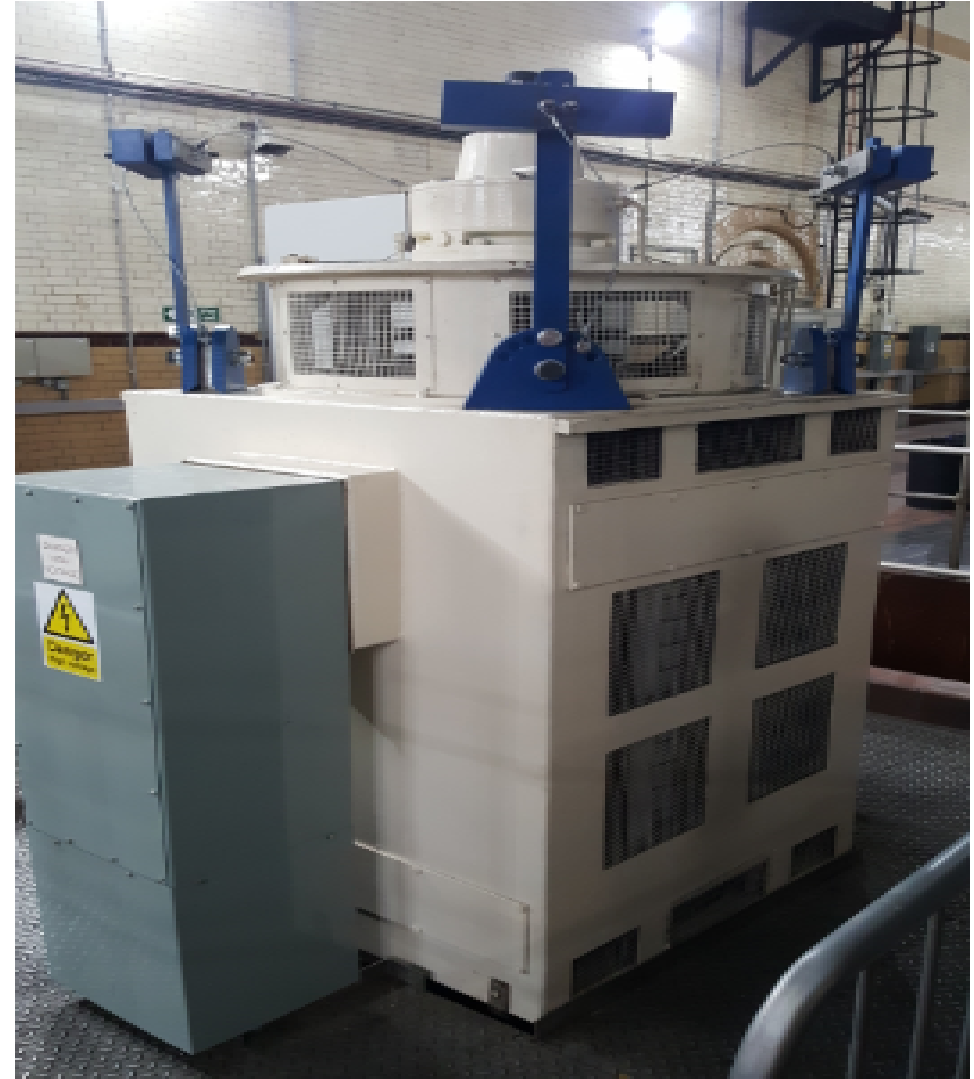
DVA SITE INSTALLATION

Safety
tethers

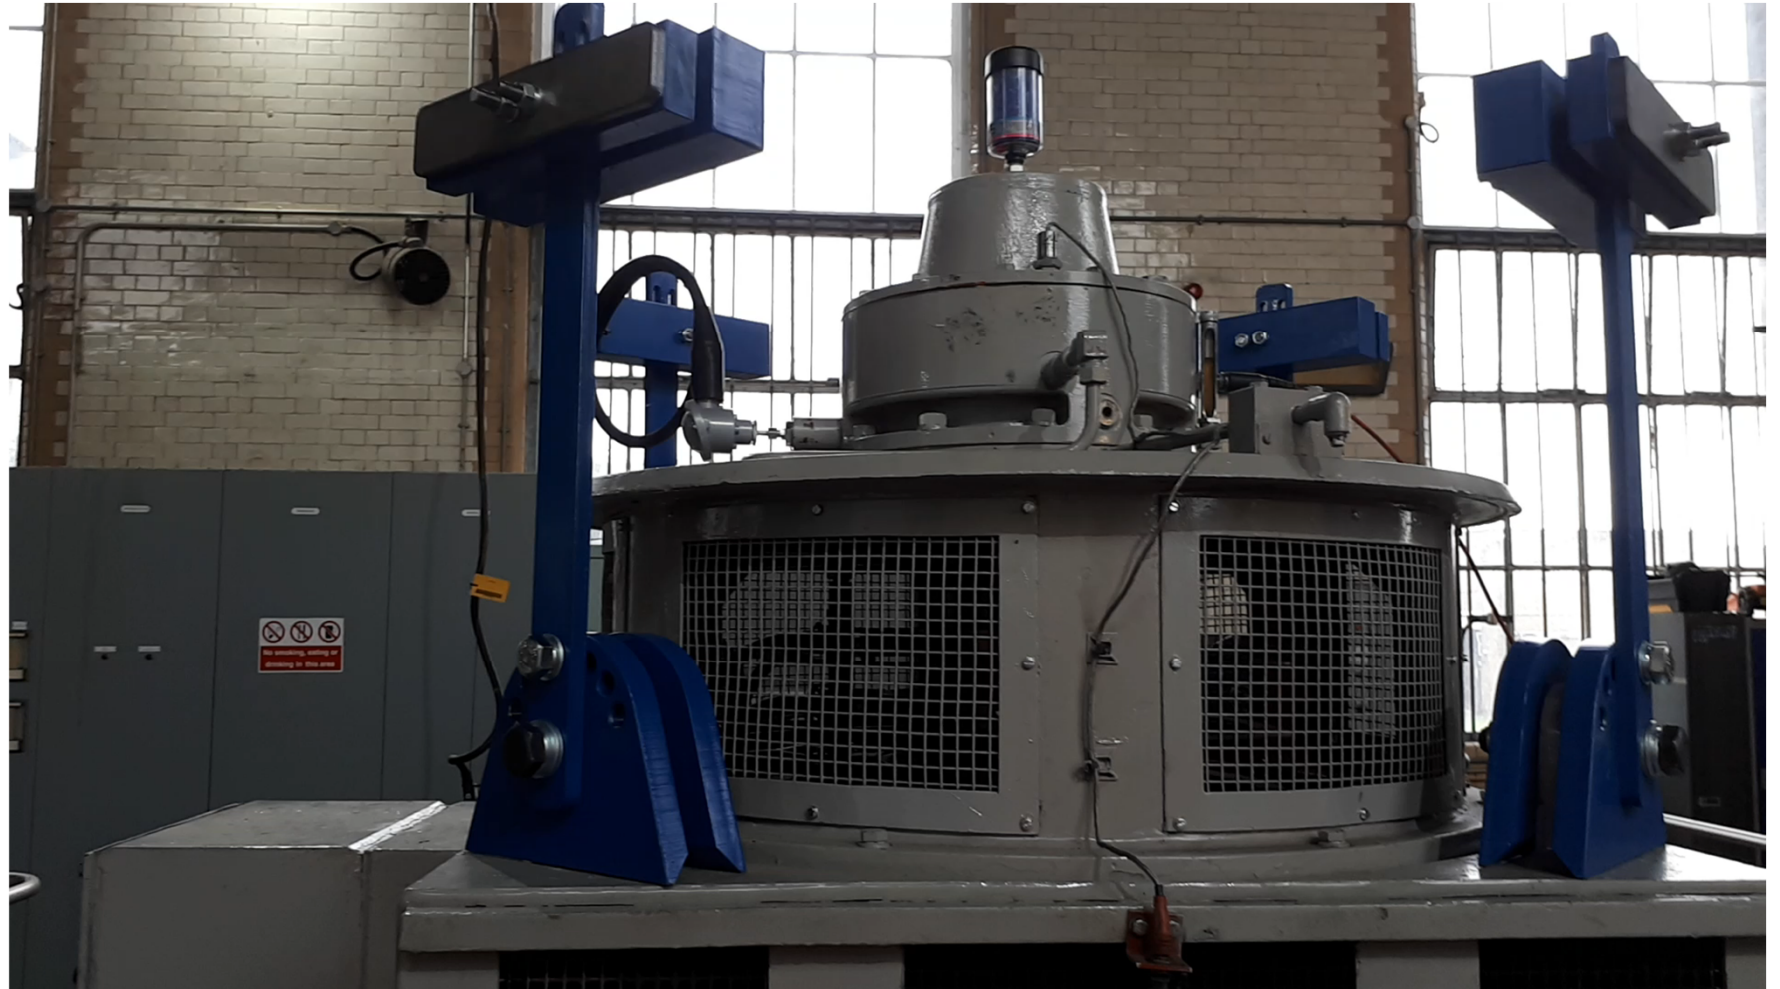
DVA SITE INSTALLATION: VIDEO

- Normal Speed

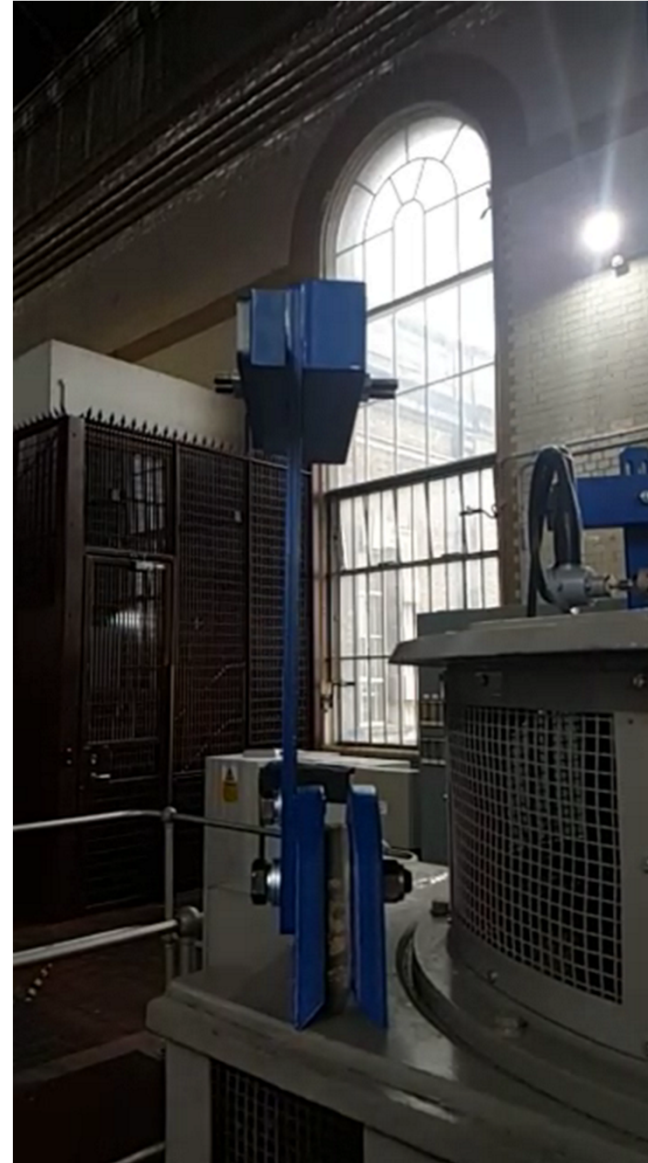
DVA SITE INSTALLATION:VIDEO

- Slow Speed showing the point of flex

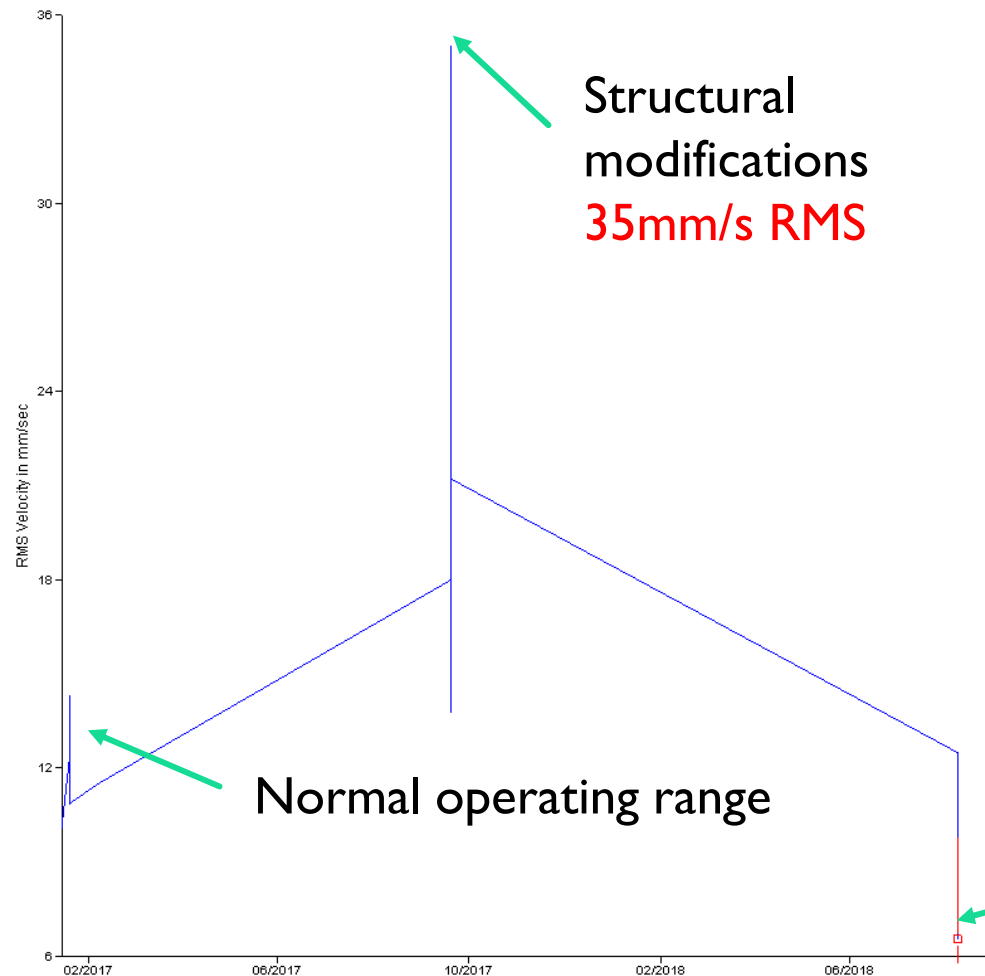
VIBRATION RESULTS: OVERALL LEVELS

Location	Radial (Deg.)	Normal Operational	Structural Mods	DVA
NDE (TOP)	0	10.86	35	5.41
	90	8.21	18.17	5.82
DE (BOTTOM)	0	2.41	9.55	1.27
	90	2.11	5.92	1.57

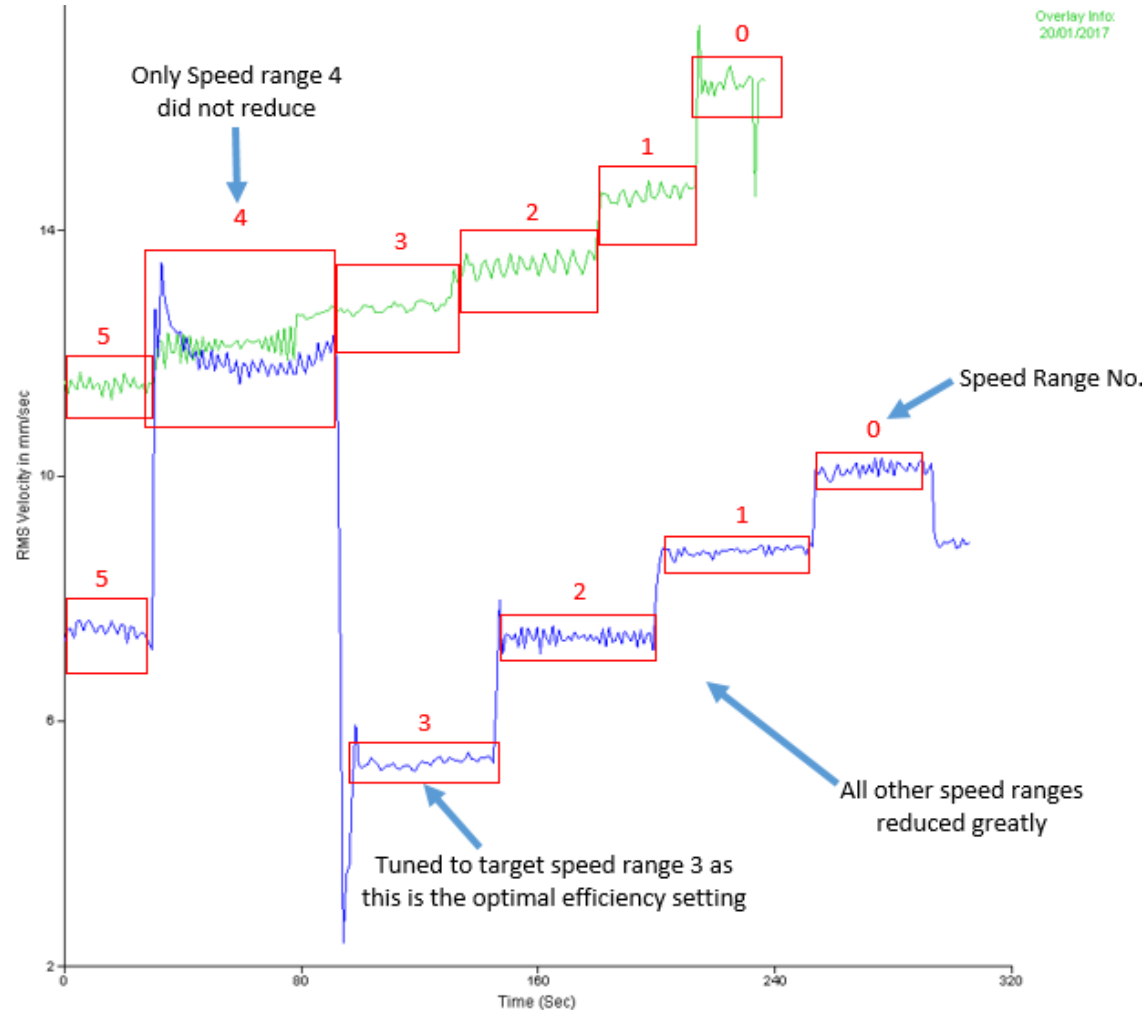
VIBRATION RESULTS: OVERALL WITH SPEED

- This table is the difference in the radial vibration velocity in mm/s RMS (Lower the number the less stress to the bearings)

Location	Normal Operational	Structural Modifications	Vibration Dynamic Absorber
NDE (TOP)	2.65	16.83	0.41
DE (BOTTOM)	0.30	3.63	0.30
