Re: JPS Reliability: Infrared Thermography Report

*Customer name - Site*  
**Thermographic Survey Check List**

## JPS Reliability Services Thermographic Survey For

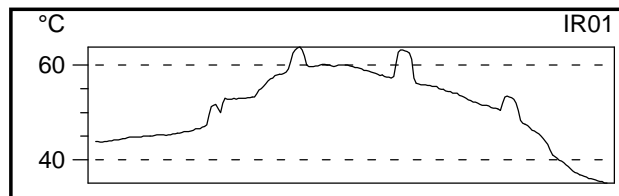
<b>Area</b>	Extruder Line A
<b>Equipment</b>	Main Drive
<b>Item</b>	DC Motor

Additional Information:  
150mm production run.

Label	Value
Anomaly	58.9°C
Reference	43.4°C
Ambient	30.7°C

Label	Max Value
Area 1	63.8°C
Area 2	64.9°C
Area 3	47.4°C

For Trending.

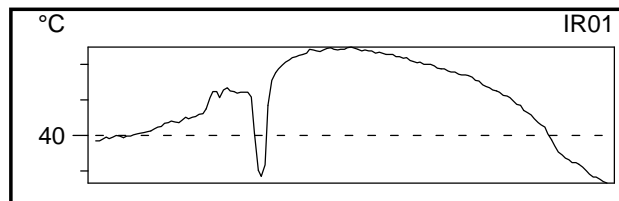
<b>Area</b>	Extruder Line B
<b>Equipment</b>	Main Drive
<b>Item</b>	DC Motor

Additional Information:  
120mm production run.

Label	Value
Anomaly	55.8°C
Reference	38.6°C
Ambient	29.4°C

Label	Max Value
Area 1	52.4°C
Area 2	59.2°C
Area 3	48.9°C

For trending.

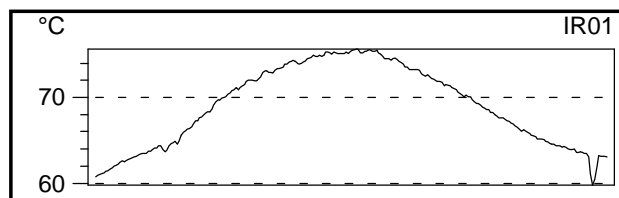
<b>Area</b>	Boiler Room
<b>Equipment</b>	External Lagging
<b>Item</b>	Top Left Area

Additional Information:  
Loss of energy.

Label	Value
Anomaly	74.7°C
Reference	57.6°C
Ambient	29.0°C

Label	Max Value
Area 1	75.6°C
Area 2	76.0°C
Area 3	59.4°C

At next shut replace section of insulation.

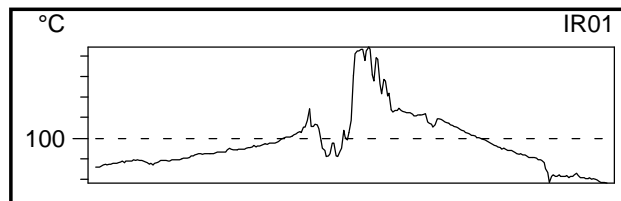
<b>Area</b>	Boiler Room
<b>Equipment</b>	Eternal Lagging
<b>Item</b>	Inlet Left Side

Additional Information:  
Loss of energy.

Label	Value
Anomaly	143.3°C
Reference	93.4°C
Ambient	73.4°C

Label	Max Value
Area 1	144.3°C
Area 2	144.7°C
Area 3	92.4°C

At next shut replace section of insulation.

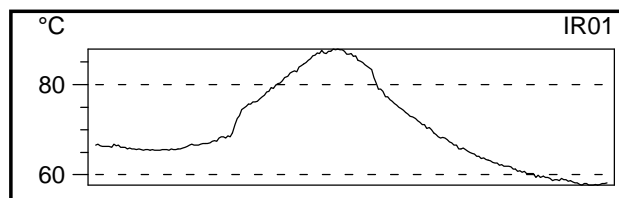
<b>Area</b>	Boiler Room
<b>Equipment</b>	Eternal Lagging
<b>Item</b>	Inlet Right Side

Additional Information:  
Loss of energy.

Label	Value
Anomaly	95.2°C
Reference	58.6°C
Ambient	34.0°C

Label	Max Value
Area 1	87.9°C
Area 2	96.4°C
Area 3	66.8°C

At next shut replace section of insulation.

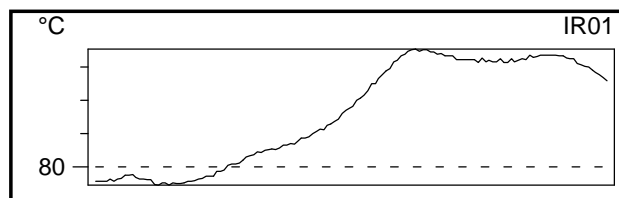
Area	Vessel
Equipment	Vessel
Item	Refractory Condition

Label	Value
Anomaly	103.0°C
Reference	84.0°C
Ambient	28.5°C

Label	Max Value
Area 1	97.7°C
Area 2	106.6°C
Area 3	85.6°C

Loss of energy and safety potential hazard, closely trend the deterioration of the internal refractory.

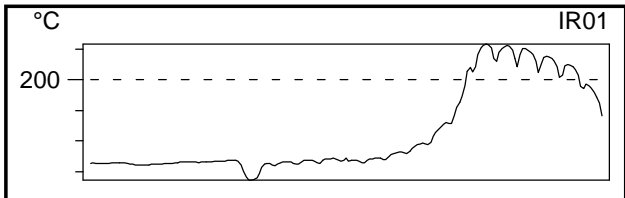
<b>Area</b>	Vessel
<b>Equipment</b>	Inlet Fan
<b>Item</b>	Inlet Ducting Insulation

**Additional Information:**  
Safety risk.

Label	Value
Anomaly	264.5°C
Reference	69.8°C
Ambient	29.4°C

Label	Max Value
Area 1	258.4°C
Area 2	62.9°C
Area 3	269.4°C

There are two areas of concern, the first is the inlet fan ducting to the vessel (Area 3) and the other is the ring of refractory just above the flanged section (Area 1).

Make a safe area around the vessel and repair refractory at the soonest opportunity.

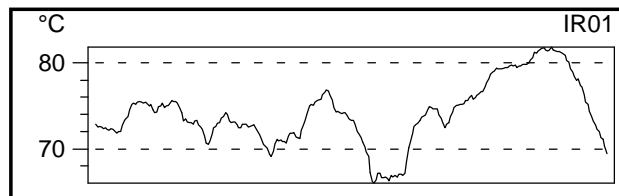
Label	Value
Anomaly	81.9°C
Reference	72.3°C
Ambient	24.3°C

Label	Max Value
Area 1	81.8°C
Area 2	77.1°C
Area 3	82.4°C

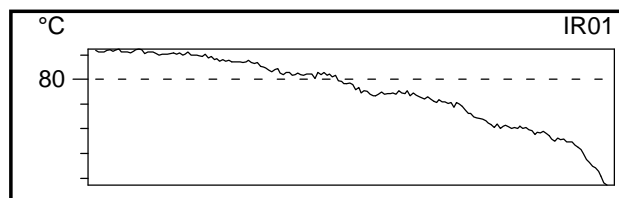
Label	Value
Anomaly	82.6°C
Reference	70.9°C
Ambient	26.8°C

Label	Max Value
Area 1	82.5°C
Area 2	79.0°C
Area 3	83.2°C

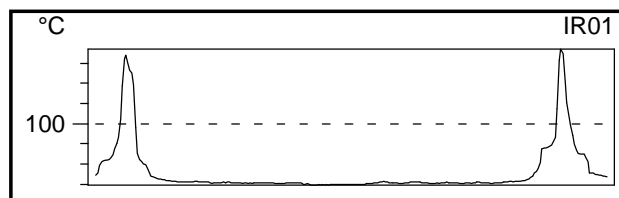
Label	Value
Anomaly	163.3°C
Reference	51.3°C
Ambient	39.2°C

Label	Max Value
Area 1	173.9°C
Area 2	53.8°C
Area 3	172.3°C

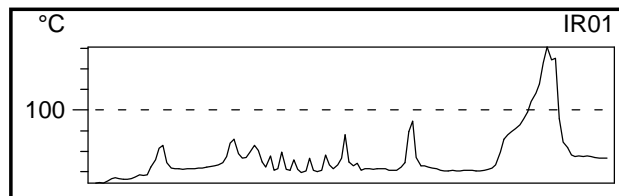
Label	Value
Anomaly	190.7°C
Reference	46.4°C
Ambient	25.6°C

Label	Max Value
Area 1	161.2°C
Area 2	197.0°C
Area 3	128.0°C

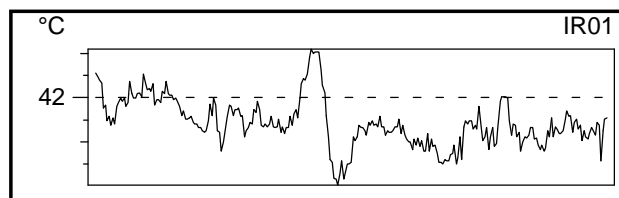
Additional Information:  
Steam Trap Failed Clsoe - Replace

Label	Value
Anomaly	43.0°C
Reference	40.3°C
Ambient	41.9°C

Label	Max Value
Area 1	43.1°C
Area 2	62.2°C
Area 3	57.6°C

This shows the steam trap has failed closed and the line is backed up with condensate, hence the low steam line temperature.
